Identifying and prioritizing barriers to Atlantic salmon habitat connectivity in Napu'saqnuq (St Mary's River), Mi'kma'ki (Nova Scotia, Canada)

Submitted in partial fulfillment of the requirements for the degree of Bachelor of Science in
Environmental Science

Dalhousie University

April 2024

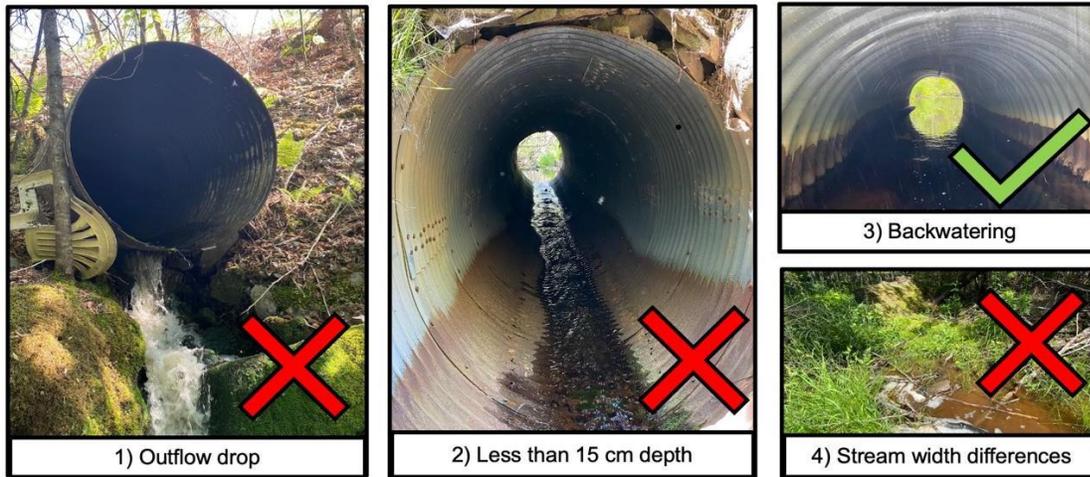
Figure 3.3 Culverts corresponding to rapid assessment criteria

Each culvert was assessed to be either passable, a partial barrier, or a barrier fish passage and all characteristics were recorded. This determination was informed by the NSSA’s culvert assessment field sheet (Appendix A). First, the four questions that comprise a rapid assessment were answered (Figure 3.3):

1. Is there a visible outflow drop?
2. Is water depth less than 15 cm in at least one location inside culvert?
3. Is the culvert not fully backwatered?
4. Is the stream width noticeably different above and below the culvert?

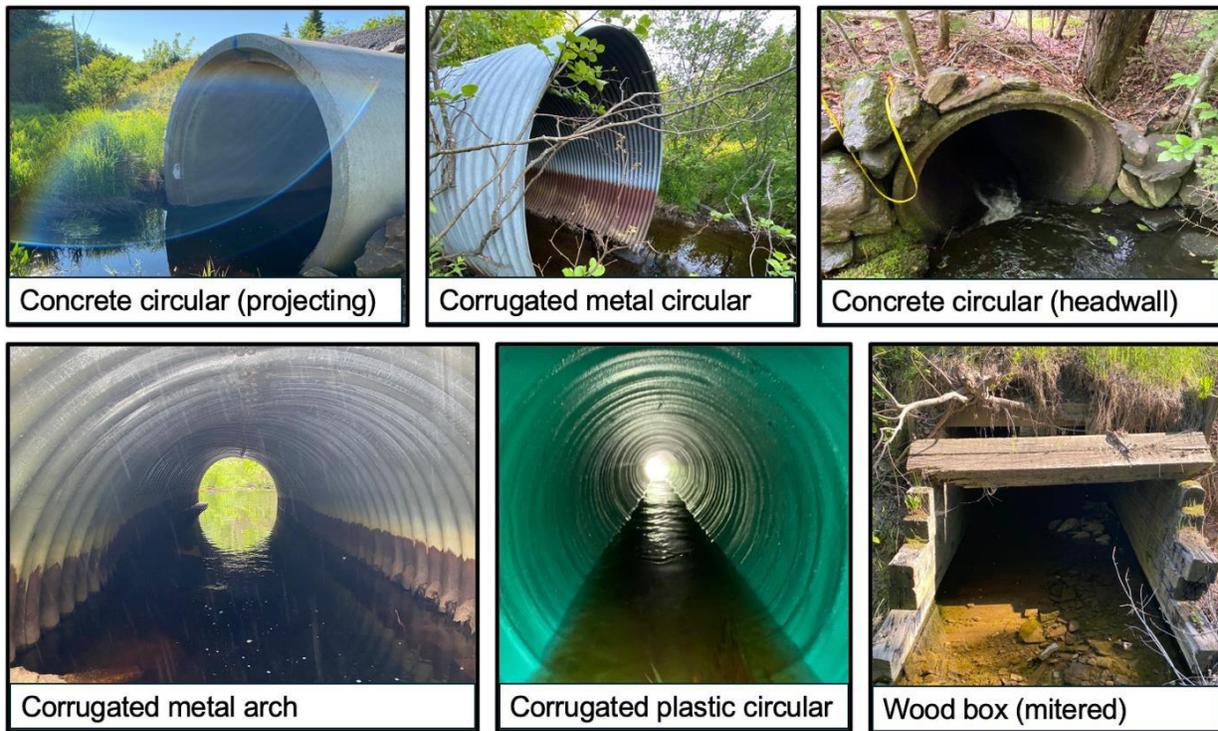
Figure 3.4 Culverts visited in Napu'saḡnuk

Next, culvert characteristics such as material, shape, current state of deterioration, entrance type, and dimensions (Figure 3.4) were recorded, and the locations of all culverts assessed in the field were recorded using a Garmin GPS unit.

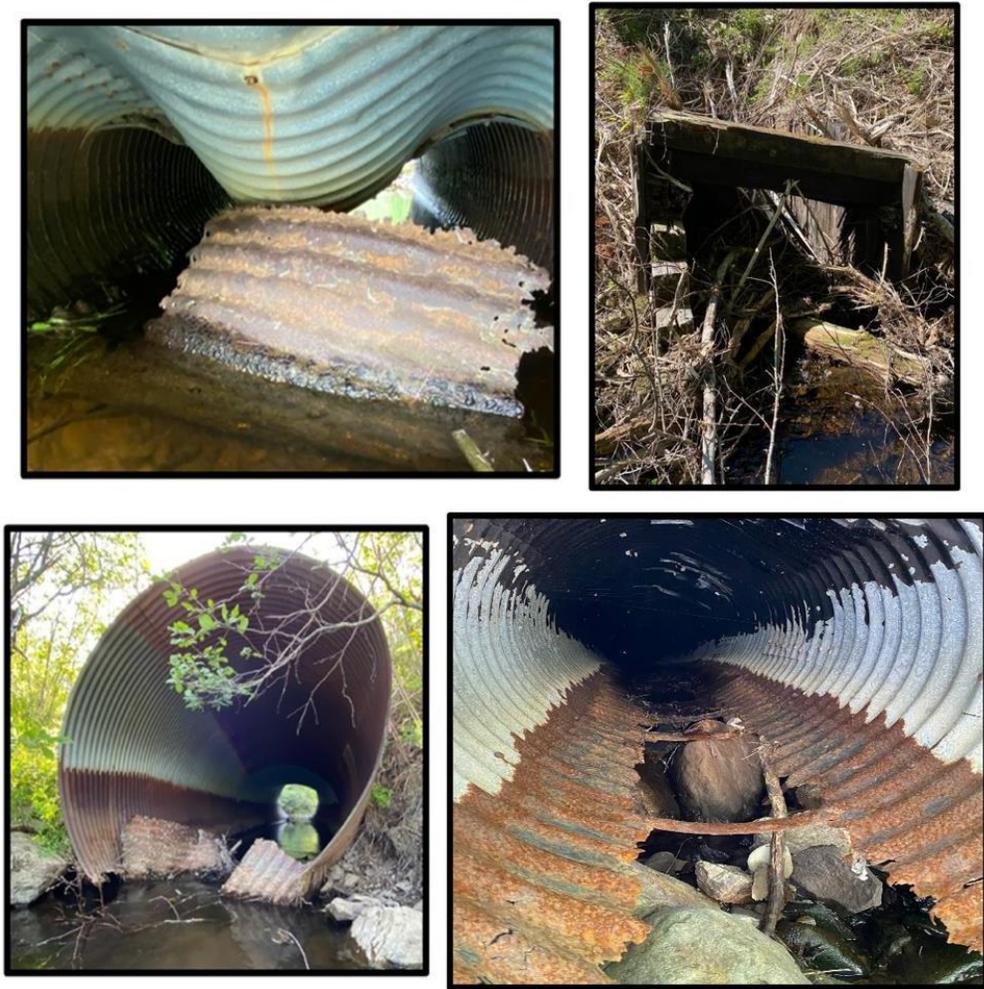
Figure 4.2 Severely deteriorated culverts in Napu'saqnuk

Assessments of culvert condition for the entire sample (n = 104) showed that 38% were significantly blocked with debris; the remainder were clear. Sixty-nine percent of culverts were severely deteriorated, 17% were moderately deteriorated, and 13% had no

deterioration. Many severely deteriorated culverts were crushed with bent or protruding pieces of material thus causing extreme variation in slope and debris accumulation throughout the structure (Figure 4.2). These conditions observed were often at sites where there was clear habitat fragmentation and even road wash outs.

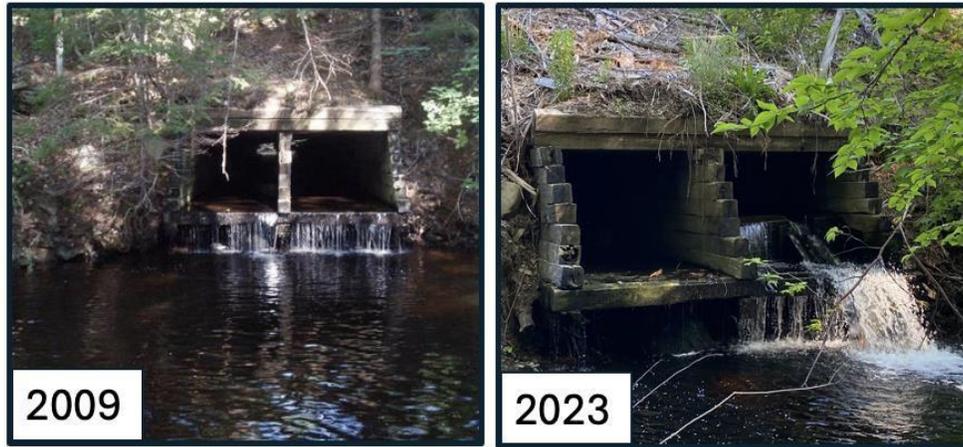
Figure 4.7 SMRA site #55

Of the eight sites recommended for remediation by the SMRA, only 4 are within the West Branch. SMRA site #68 at Hattie Brook was found to have been replaced by a bridge through our field assessments although it was not noted in spatial data used for field work planning or analysis. Nearly fourteen years after their original assessment, the three other sites prioritized remain either partial or full barriers (Figures 4.7-4.9). Culvert #55 at the McLeod Lake outflow was identified as having an outflow drop and depth issues (Mitchel, 2010). The same issues were identified in the 2023 assessment (Figure 4.7).

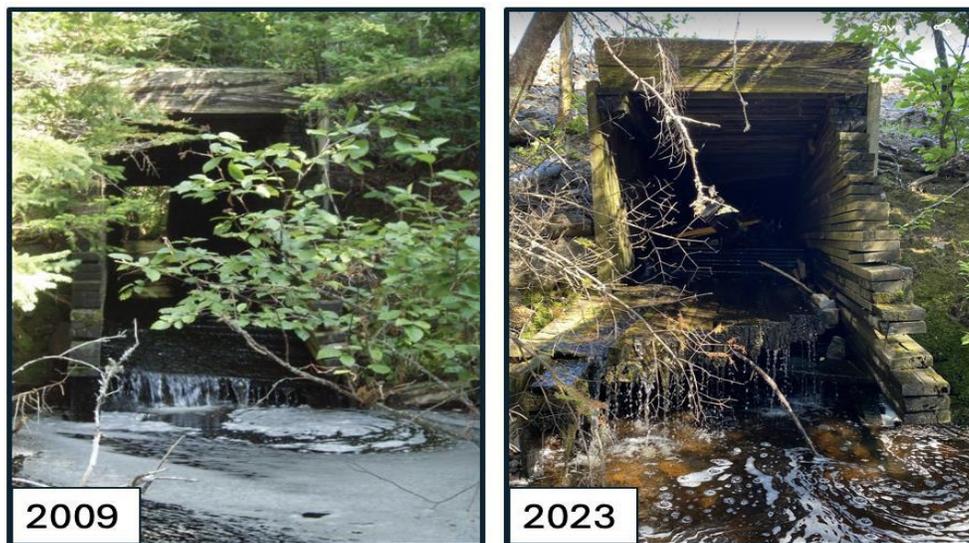
Figure 4.8 SMRA site #57

Similarly, culvert #57 was identified by the SMRA to have an outflow drop and insufficient water depth (Mitchell, 2010). The same issues were identified this past field season with no evidence of remediation work being completed (Figure 4.8).

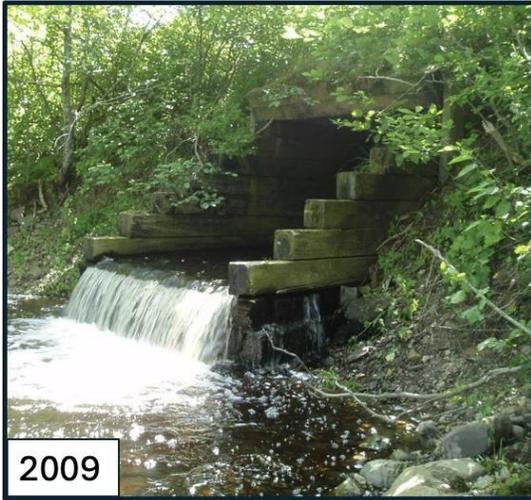
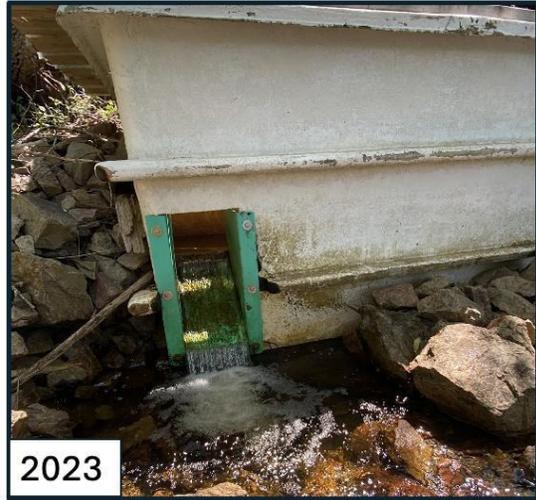
Figure 4.9 SMRA Site #80

Site #80 identified by the SMRA for remediation was assessed to remain a partial barrier after the installation of a fish ladder (Figure 4.9). Although the outflow drop is no longer a complete barrier to adult salmonids who can use the fishway, depth within the culvert itself remains a concern. In their recommendation of the fishway, the SMRA notes that success of any installed structure at this site should be monitored for success (Mitchell, 2010).

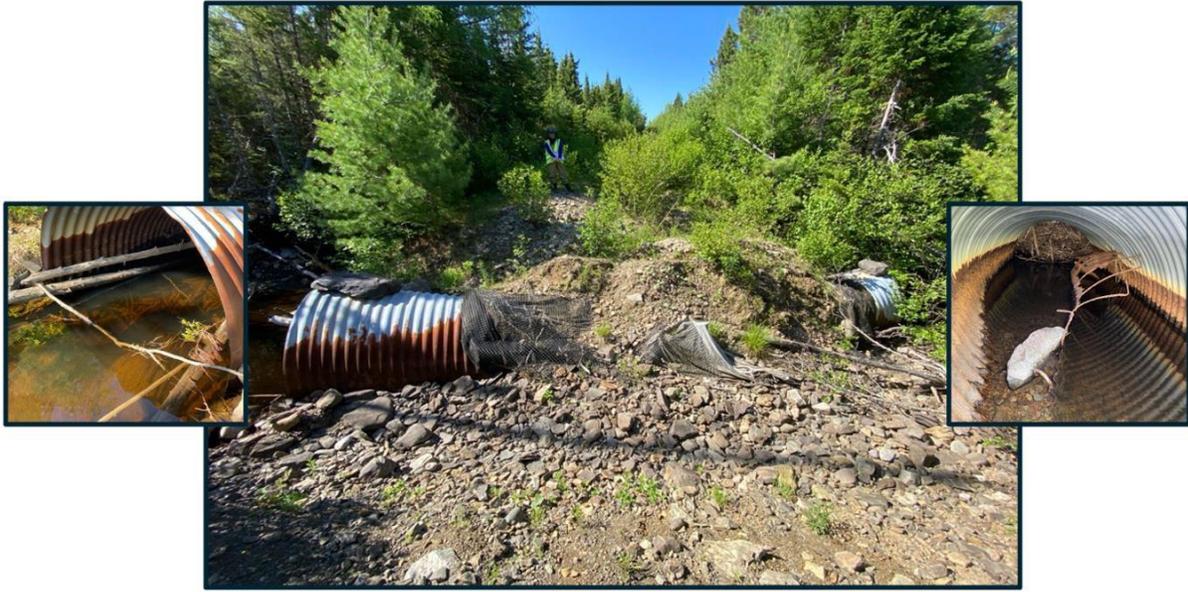
Figure 5.1 Debris clogged culvert causing road washout

The results of my passability assessments in Napu'saqnuq align with NSSA's estimation that 60 to 80% of culverts in the province are barriers to some or all fish species (Nova Scotia Salmon Association, 2020). This is congruent with previous studies in and outside of the province that have found upwards of half of culverts to contribute to fragmentation (Hicks & Sullivan, 2008; Langill & Zamora, 2002; Poplar-Jeffers et al., 2008). The combined 86% of culverts that were either moderately or severely deteriorated is indicative of the lack of timely replacement and monitoring occurring on both public highways (348, 347, 374) and active forestry roads on leased crown land. Neglect is further evident in the prevalence of sites with debris blockages (38%) which contribute to reduced passability and can precipitate road washouts and flooding (Figure 5.1).

Finally, persistent barriers to fish passage I observed throughout the field assessments were debris blockages and severe deterioration. Without data on installation dates and maintenance, it is impossible to predict the state of blockages and deterioration, meaning this must be assessed in person and culverts clogged with branches and leaf litter can quickly become passable again post debris removal. As seen with this example of debris blockages,
