Dalhousie University Bicycle Parking Audit 2012

ENVS and SUST 3502 April 13, 2012

Executive Summary

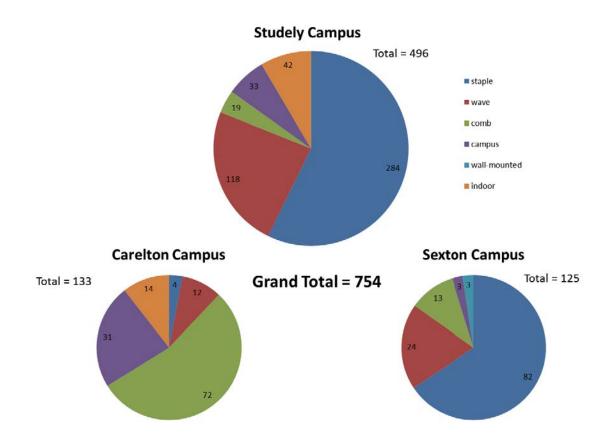
It was determined that there are a total of 754 bicycle parking spots at Dalhousie University (Figure 2). The findings indicate that at Studley campus there are a total of 496 bike parking spots, with the majority being staple racks (Figure 2). At Carleton, there are 133 parking spots, and the dominant rack type is comb (Figure 2). At Sexton, there are 125 spots, and these are also primarily staple racks (Figure 2).

Figure 2: Number of bicycle parking spots based on rack type at Dalhousie University's three campuses: Studley, Carleton, and Sexton. Data collected in March, 2012.

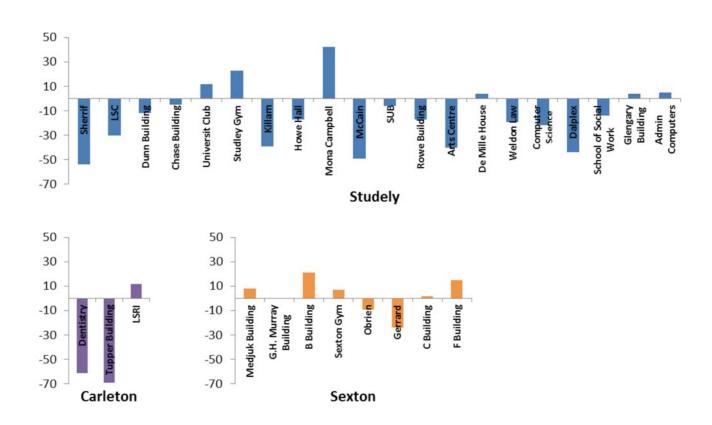
As such, it can be seen that on Studley campus, the only buildings with ample bike parking are the University Club, Studley Gym, Mona Campbell, De Mille House, Glengary Building, and Admin Computers (Figure 3). On Carleton, only the LSRI has ample parking while on Sexton the Medjuk Building, B Building, Sexton Gym, C Building and F Building have enough bicycle parking based on the HRM bylaw (Figure 3).

Figure 3: Number of bike parking spaces above or below the HRM bylaw for new buildings, requiring one parking spot for every 250 m² of building space, for all buildings at Dalhousie University's three campuses with existing bicycle racks. Data on number of parking spots collected March 2012, data on building sizes obtained from the Director of the Office of Sustainability.

Further, attention should be given to increasing the capacity at sites by buildings far below the goal of one spot for every 250 m2, such as Sheriff Hall, LSC, Killam Library, McCain Building, Arts Centre, Dalplex, Dentistry Building, and Tupper Building. As seen in Figure 3, these buildings all have a deficiency of 30 or more bicycle parking spots, and would benefit significantly from the placement of new racks in close proximity. Finally, efforts should focus on fixing or replacing all racks identified as being below standard in terms of condition (See Appendix II). These recommendations will allow bike parking infrastructure to be improved where needed most in the near future.

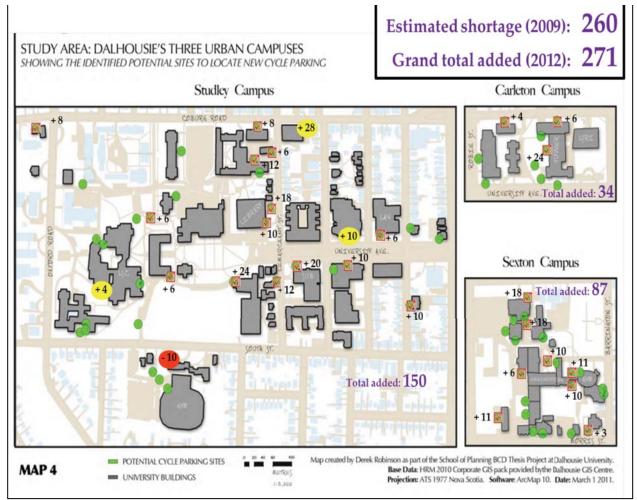
Bicycle parking capacity at Dalhousie has increased over the last year, as can be seen when comparing the results of our audit to the extensive audit and report compiled by Derek Robinson in March 2010. Robinson noted an estimated shortage of 260 bicycle parking spots across all three Dalhousie campuses, and indicated 63 potential sites where new parking can be added (Robinson, 2010). These recommendations were based on multiple criteria, including proximity to building entrance, lighting (daytime and nighttime), and estimated population within 100 m, among others. The results indicate that the Dalplex is the only site that has fewer spots than were present at the time of Robinson's audit (Figure 4). As such, we have determined the total number of bicycle parking spots added since Robinson's audit to be 271 spots, with 150 added on Studley campus, 34 added on Carleton, and 87 added on Sexton (Figure 4).

Figure 4: Recommended sites for new bicycle racks at all three Dalhousie campuses as indicated by green circles (Robinson 2011), and sites where new racks have been installed as indicated by red check marks. The number of additional parking spots per site is also displayed. Yellow ovals indicate sites where new racks have been added at sites not identified by Robinson, the red oval indicates a site where fewer bicycle parking spots now exist. Updated data collected in March 2012.

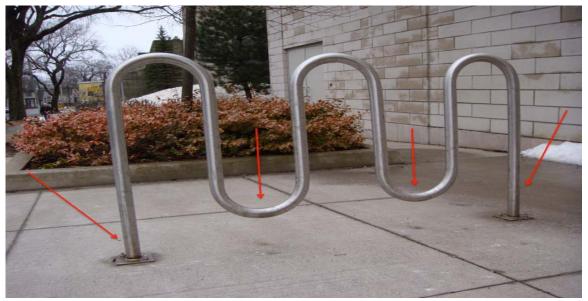
Figure 1: An example of a typical wave rack. The red arrows indicate spots where the researchers assumed that one bicycle could be stored. Thus, for all wave racks the capacity was determined by counting the end posts and the dips in the wave.

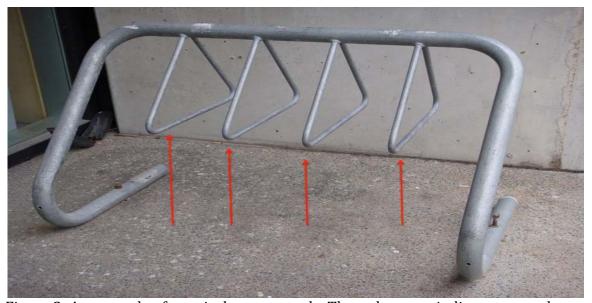
Figure 2: An example of a typical campus rack. The red arrows indicate spots where the researchers assumed that one bicycle could be stored. Thus, for all campus racks the capacity was determined by counting each hoop extension.

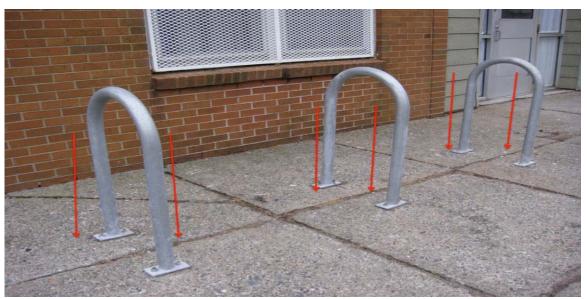
Figure 3: An example of typical staple racks. The red arrows indicate spots where the researchers assumed that one bicycle could be stored. Thus, for all staple racks the capacity was determined by assuming that each inverted-U could support two bikes.

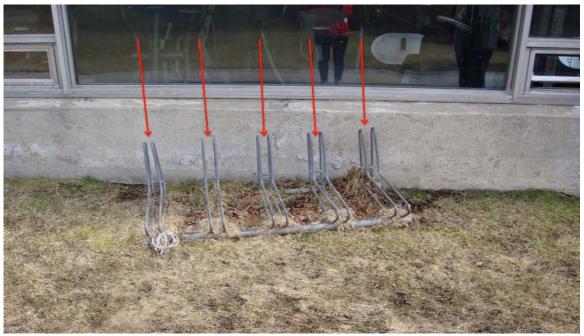
Figure 4: An example of a typical comb rack. The red arrows indicate spots where the researchers assumed that one bicycle could be stored. Thus, for all comb racks the capacity was determined by assuming that each parallel section could support one bike.

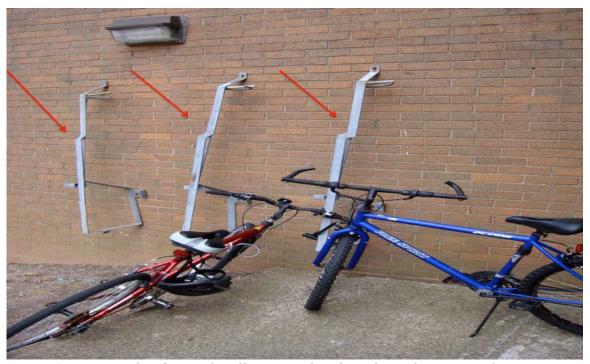
Figure 5: An example of typical wall-mounted racks. The red arrows indicate spots where the researchers assumed that one bike could be stored. Thus, for all wall-mounted racks the capacity was determined by assuming that each wall-mounted rack could support one bike.

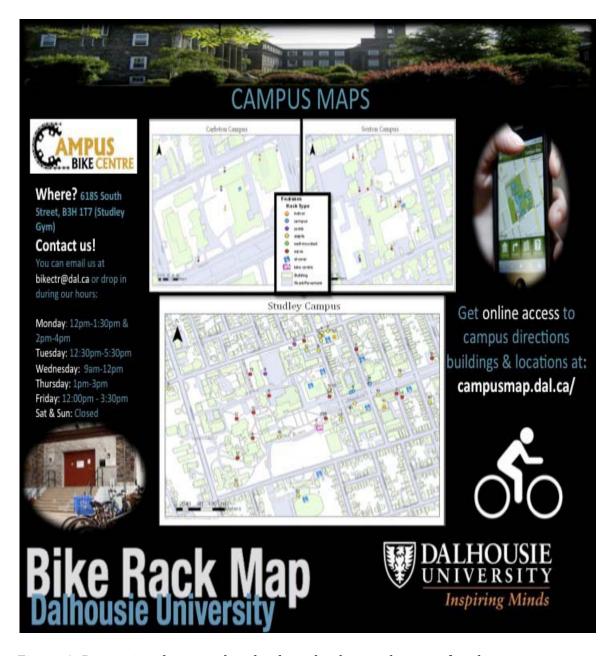
Figure 1: Promotional poster that displays the digitized maps of each campus created using GIS software. Each map displays the spatial orientation, design, and capacity of all audited racks. The map also displays bicycle facilities, such as showers and the Campus Bike Centre.

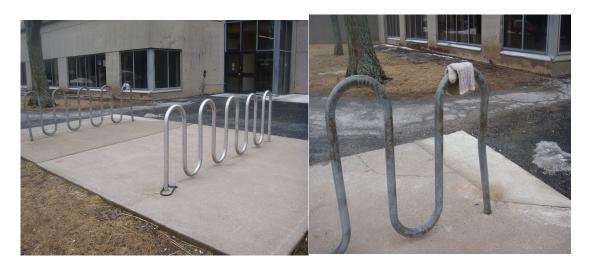
2.

Location: Outside LSC Biology and Earth Sciences

Type: 2 waves Number of spots: 12

Condition: one is in good condition; the other is a bit rusty and bent

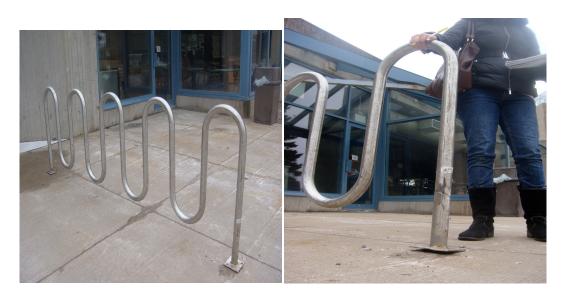
4.

Location: Outside LSC cafeteria Type: wave Number of spots: 6

Condition: not sturdy and one end is not firmly attached to the ground

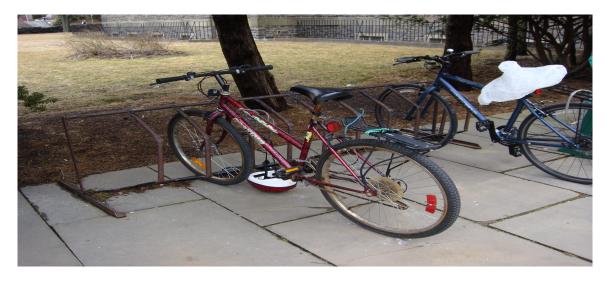
Location: Behind Dunn building
Type: comb Number of spots: 9

Condition: appears old and rusty, but is sturdy

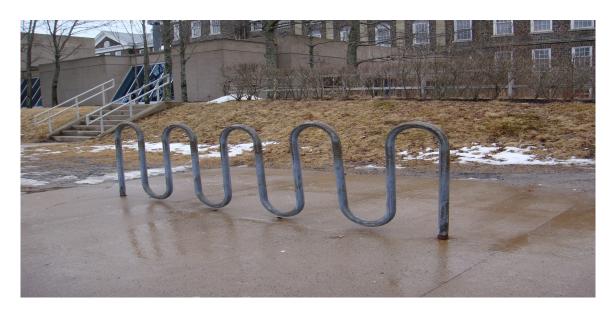
6.

Location: Outside Chase building Type: wave Number of spots: 6 Condition: okay condition, but rusty

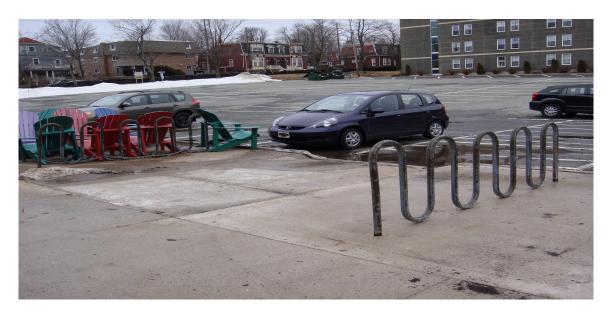
Location: In front of the Dunn building Type: 2 waves Number of spots: 12

Condition: a bit rusty and bent, but sturdy; one rack is poorly placed close to chairs

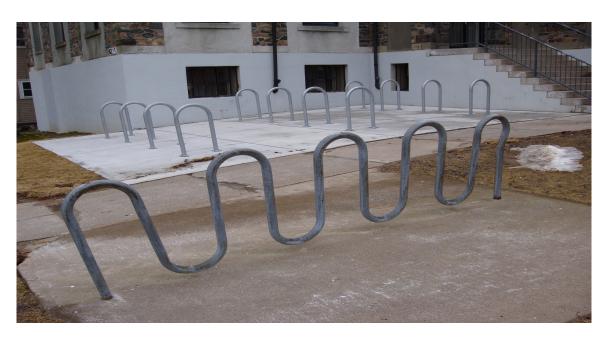
10.

Location: Outside Studley Gym

Type: 12 staples and 1 wave Number of spots: 30

Condition: staples are new and in good condition, but wave is a bit bent

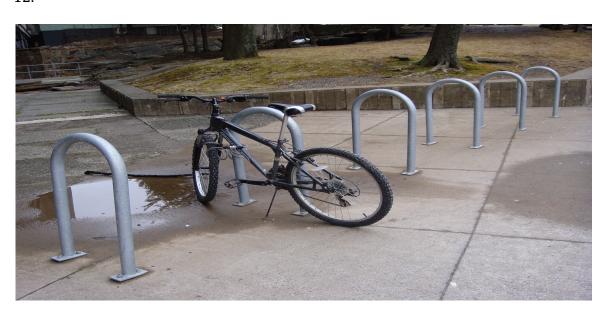
12.

Location: Outside side of Killam Library Type: 6 staples Number of spots: 12 Condition: good, but one is shaky

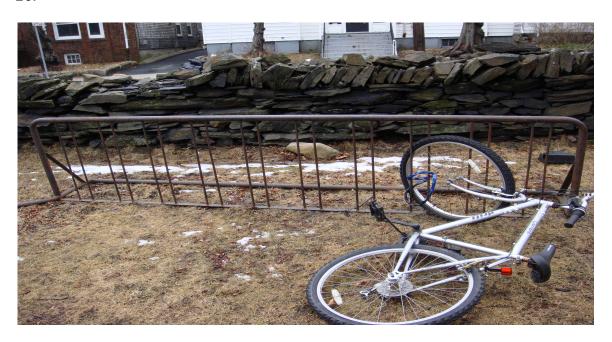
20.

Location: Outside Howe Hall front entrance

Type: comb Number of spots: 10

Condition: bad and not attached to the ground

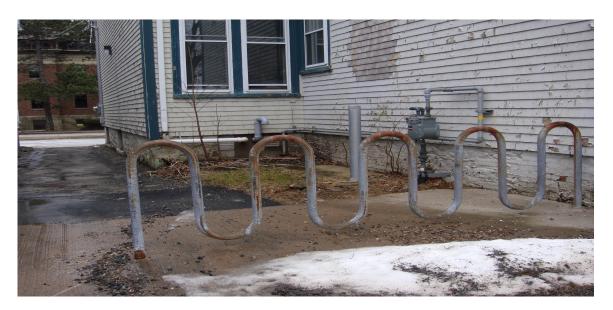
30.

Location: Behind Admin Computing Building

Type: wave Number of spots: 6

Condition: very rusty

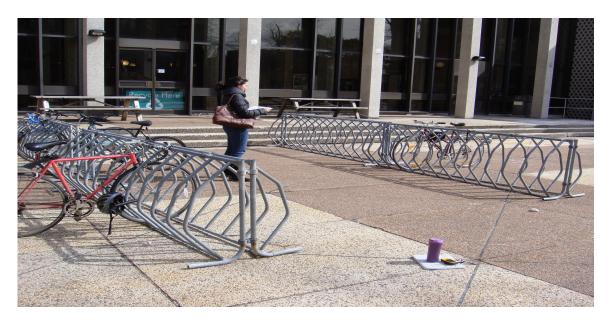
Location: In front of Tupper Building
Type: 4 combs Number of spots: 48

Condition: good, but not attached to ground

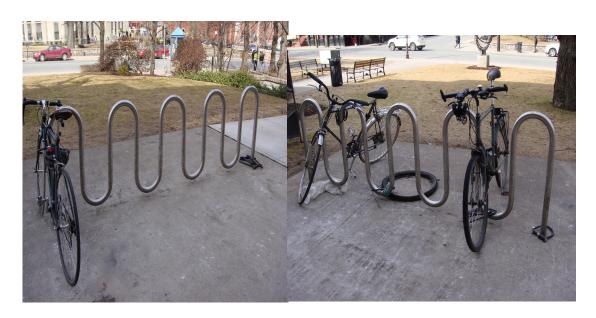
42.

Location: In front of Ralph Medjuck Building facing Spring Garden

Type: 2 waves Number of spots: 12

Condition: good, but a bit rusty

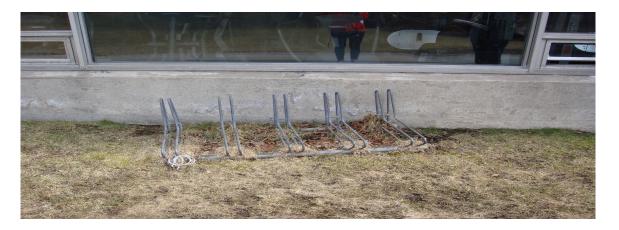
46.

Location: Outside Sexton Gym Type: comb Number of spots: 5

Condition: bad, not attached to ground, and grass is growing over it

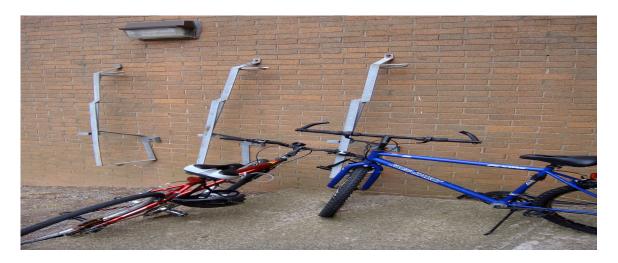
48.

Location: Outside Obrien cafeteria

Type: 3 wall-mounted Number of spots: 3

Condition: okay, but awkward design and somewhat bent

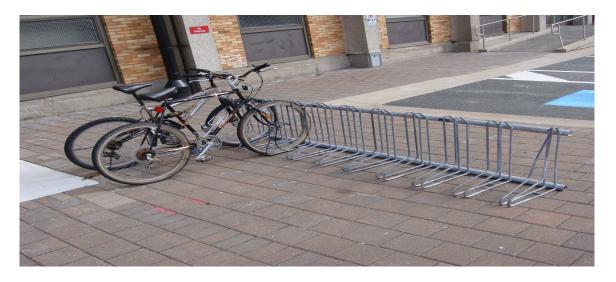
Location: Outside of Gerard Hall Type: comb Number of spots: 8

Condition: bad because one end is bent and rack is not attached to the ground
