Determination of Failure Criteria for Suspended Ceiling Tile Systems  
and Thermal Resistance Provided Prior to Failure

Submitted in partial fulfilment of the requirements  
for the degree of Master of Applied Science

Dalhousie University  
Halifax, Nova Scotia  
April 2022

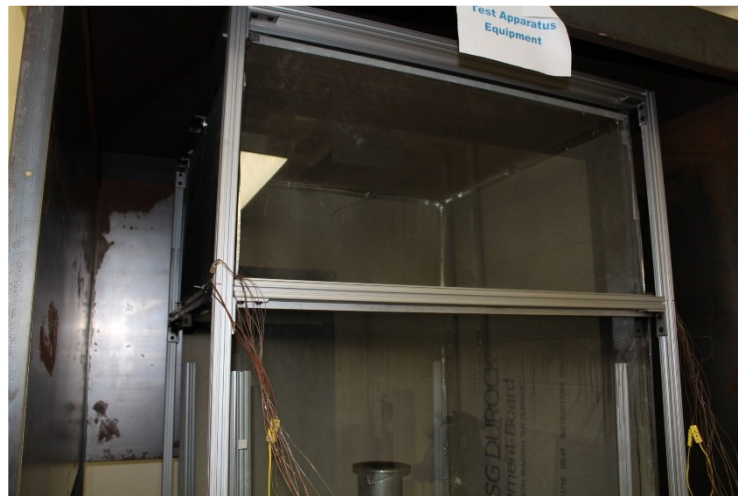
Figure 5 Testing apparatus frame and cavity space.

The frame for the apparatus was made from square aluminum T-slotted framing. T-slotted framing is modular and easy to assemble because all joints are held together with brackets and bolts, thus allowing for the apparatus to be easily reconfigured. The apparatus had a footprint of approximately 1 320 mm × 1 360 mm, with an overall height of approximately 2 380 mm. This height provided adequate space for a cavity above the tiles as well as sufficient working space below the tiles for the height of the heat source to be adjusted. An image of the apparatus frame and cavity space is provided in Figure 5.

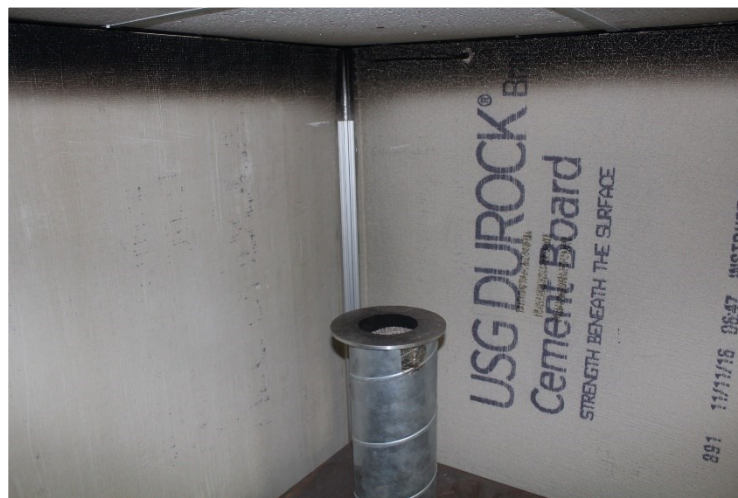
Figure 6 Cement board walls of the apparatus, as viewed from the interior.

ceiling tile array and framework. The left-hand side wall of the apparatus was also made of fiberglass reinforced cement board and open below the ceiling tiles, only covering the cavity above the tile assembly, to allow an exit for smoke from the apparatus. Cement board was chosen as a material for the walls of the apparatus due to its relatively low thermal conductivity, fire resistance, and similarity to drywall materials used in building construction. An image of the apparatus walls is provided in Figure 6.

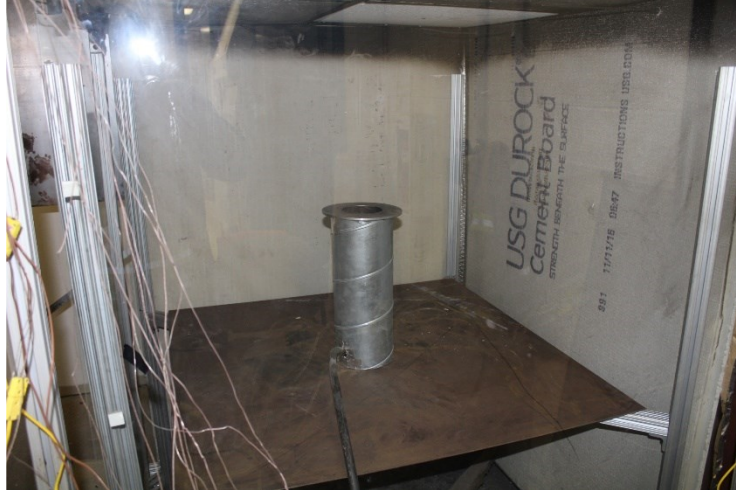
Figure 7 Adjustable platform surface and heat source within the apparatus.

such as a gas burner, wood cribs, or an electrical heating element. The adjustable platform frame and surface is shown in Figure 7.

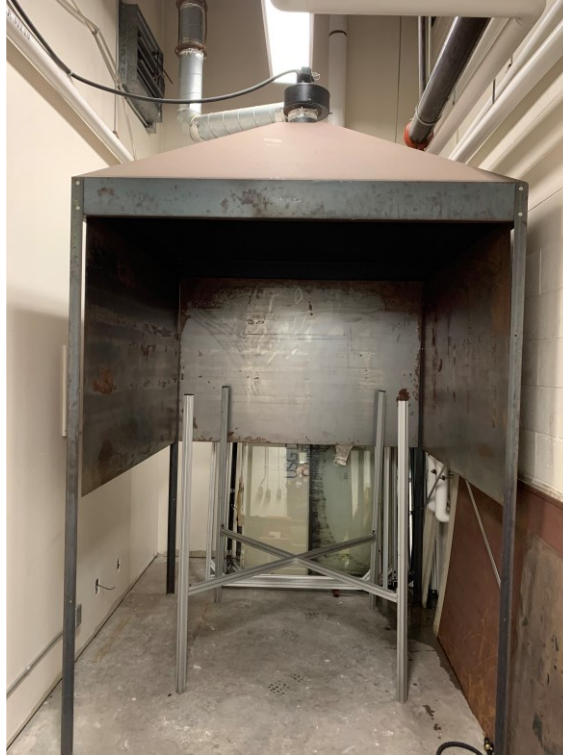
Figure 8 Smoke exhaust system with apparatus removed except for the adjustable platform framing.

The apparatus was contained below an 1 830 mm square extraction hood to assist in removing smoke from the testing area. Skirts made of 1.02 mm sheet steel extended down from the hood a distance of 1 220 mm on three sides to assist in the entrainment of air into the exhaust ducting. The venting of exhaust gases was aided by a  $525 \text{ m}^3 \text{ h}^{-1}$  electric blower attached to the top of the extraction hood and connected to the exhaust ducting. The exhaust system was designed to accommodate the future addition of a means for measuring heat release rate using oxygen depletion calorimetry, requiring measurement of exhaust gas composition as well as the exhaust mass flow rate. To facilitate these additions, the duct system was built based on the dimensional guidelines set out in ASTM E1354 [15]. The smoke exhaust system is shown in Figure 8.

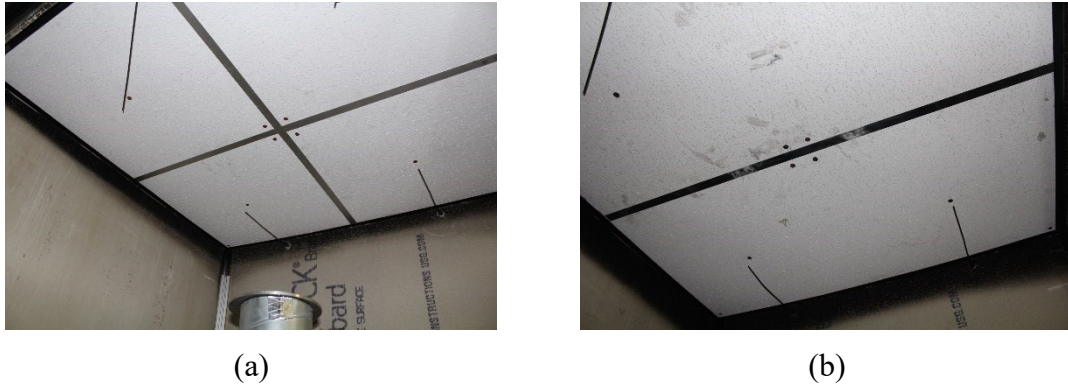
Figure 10 Installed (a) four-tile and (b) two-tile arrangements, viewed from below.

An image of the installed ceiling tiles is provided in Figure 10. The cavity space above an installed four-tile arrangement is shown in Figure 11.

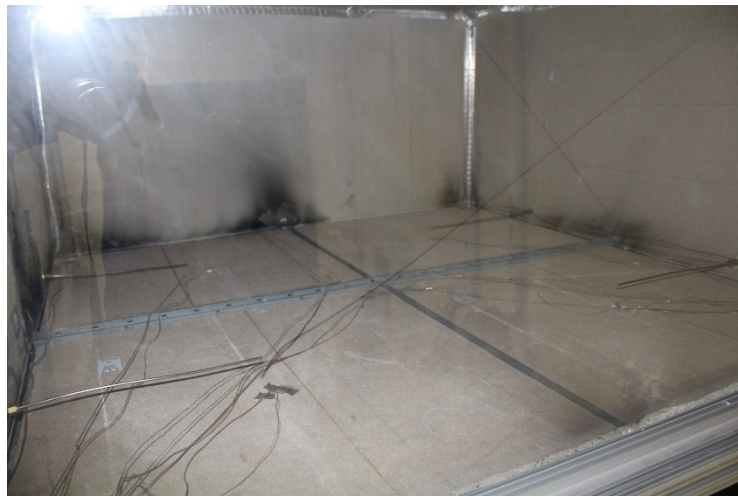
Figure 11 Cavity space above the ceiling tiles for an installed four-tile arrangement.

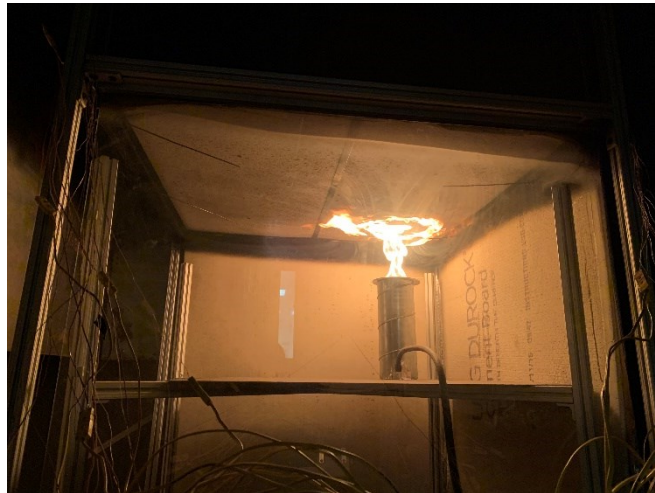
Figure 13 Propane burner in operation at a heat release rate of 13.5 kW with flame impingement on the ceiling tile system.

While the flow rate controller used in this experiment was indicated to have a maximum flow rate of 20.0 SLPM, which is equal to a HRR of 27.6 kW using propane, after conducting preliminary tests it was found that this flow rate decreased throughout the duration of a full test. After some further preliminary testing, it was found that a consistent flow rate of 10.0 SLPM, which is equal to a heat release rate of 13.8 kW using propane, could be maintained throughout the course of a test. It is noted that, while studying heat transfer to ceilings from an impinging diffusion flame on a similar scale, Kokkala [23] used heat release rates of 2.9–10 kW. Based on the similarities of this research and that of Kokkala [23], it was decided to move forward using an HRR of 13.8 kW. A sample image of the propane burner in operation is provided in Figure 13.

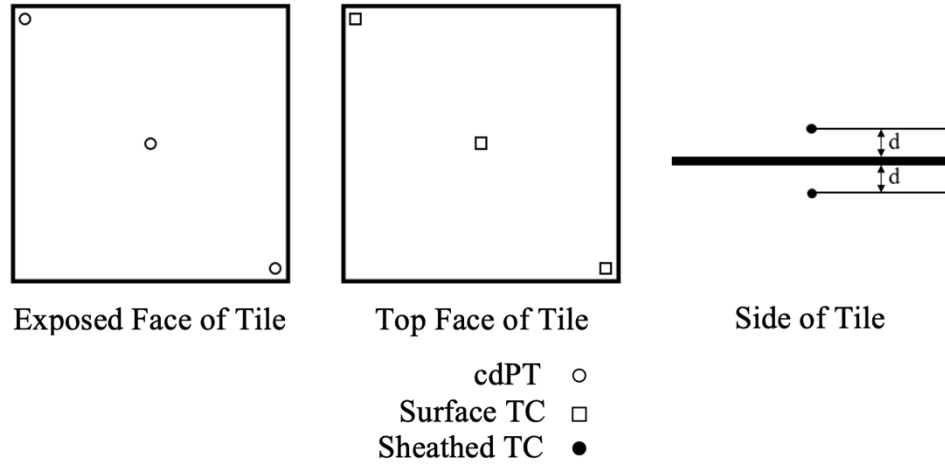
Figure 15 Type, number, and location of thermocouples used to measure temperature above and below each tile.

Surface temperatures were measured using thermocouples located above and below on the center-of-the-apparatus, as well as the corner, middle, and far side corner of each tile. Gas temperatures were measured above and below the center of each tile at a distance,  $d$ . The thermocouples used to measure surface temperature were located directly above one another, allowing for calculation of heat transfer rates through the tiles at each location. The thermocouple arrangement for each tile is shown in Figure 15.

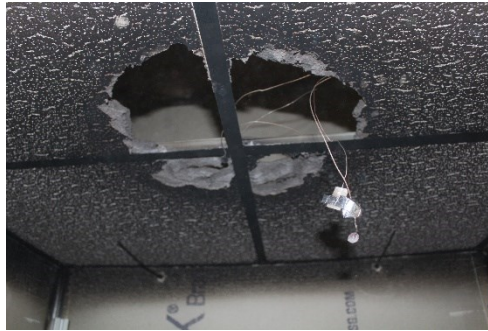
Figure 23 Endpoint condition of the NCTS from Test 2, with the delicate areas of the tile removed using minimal force by a pen.

With respect to the condition of the tile material at the end of each test, the area directly above the burner was found to be very fragile/delicate. This area of the tile, approximately the same size as the heavily charred circle, had an almost dust-like consistency and could be easily removed with a pen or finger as shown in Figure 23.
