THE EFFECT OF PERLITE AND MINERAL WOOL LEACHATE SOLUTIONS ON
THE CORROSION BEHAVIOURS OF PIPELINE STEELS

Submitted in partial fulfilment of the requirements
for the degree of Master of Applied Sciences

Dalhousie University
Halifax, Nova Scotia
August 2023

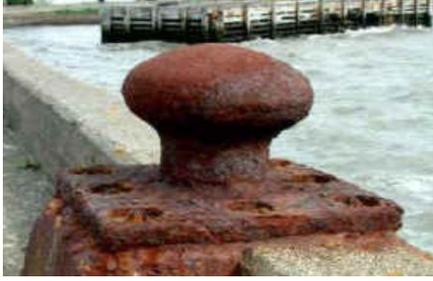
Figure 3 - Uniform corrosion [5]

Uniform corrosion occurs with the uniform thinning of a metal, without any specific pinpointed cause, and does not commonly affect the substrate from deep within. A frequently occurring and common example is when steel rusts in open air (Figure 3). This results in a corrosion attack that creates a substantial loss of the metal weight. This most commonly occurs when steel structures are unused and left to rust. A uniform attack is generally easy to detect and has a predictable outcome. Therefore, it is less detrimental than the other types of corrosion [4].

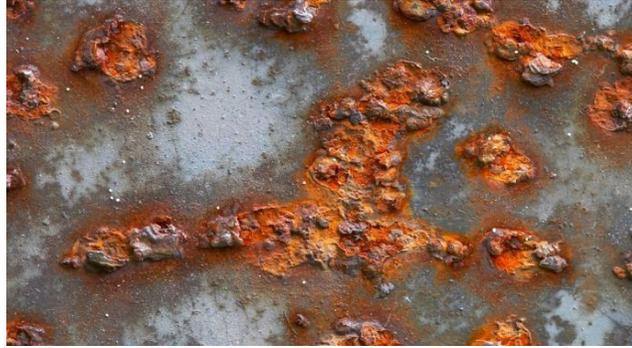
Figure 5 - Localized attack of intergranular corrosion [9]

Intergranular corrosion is a localized form of corrosion where a tapered path is oxidized along a metal's grain boundaries, where a tapered path is oxidized preferentially along a metal's grain boundaries (Figure 5) [1].

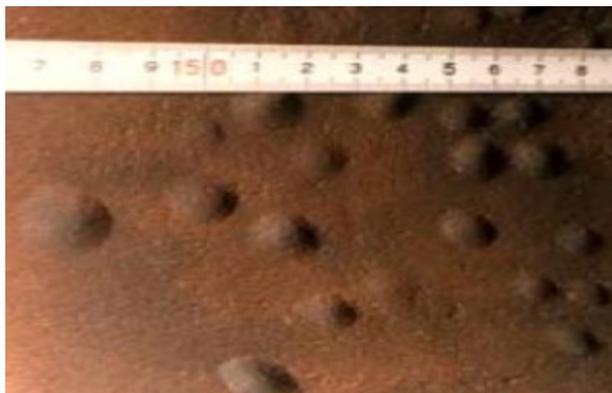
Figure 6 - Hydrogen blistering [10]

Hydrogen damage occurs when atomic hydrogen diffuses back into the metal, resulting in either blistering if it forms molecular hydrogen in internal voids or embrittlement if it permeates in the lattices. In the natural corrosion processes, the formation of atomic hydrogen can occur as a cathodic reaction (Figure 6) [4].

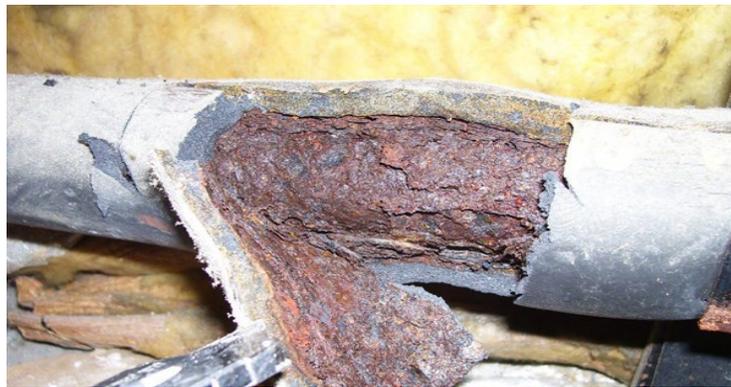
Figure 7 - corrosion under insulation process [14]

CUI generally occurs on low-carbon alloy steel, and austenitic stainless-steels surrounded by thermal insulation e.g. piping systems, pressure vessels, and tanks (Figure 7) [11]. CUI occurs when water or contaminants penetrate the insulation or fireproofing materials. The water ingress is mostly through damaged weather jacketing systems and weather barriers, resulting in the creation of annular space between the insulation and the pipe surface, where these agents can be held for a long duration of time. As a result, corrosion begins on the insulated surface of metal and an unpredicted and spontaneous failure could take place [12]. In addition, the materials used for insulation, such as calcium silicate and polyurethane foams, have varying amounts of fluoride, chloride, bromide, and sodium ions. When moisture penetrates these insulations, these ions are leached from the material, causing an increase in the rate of corrosion under insulation systems as solutions with low pH may form [13].

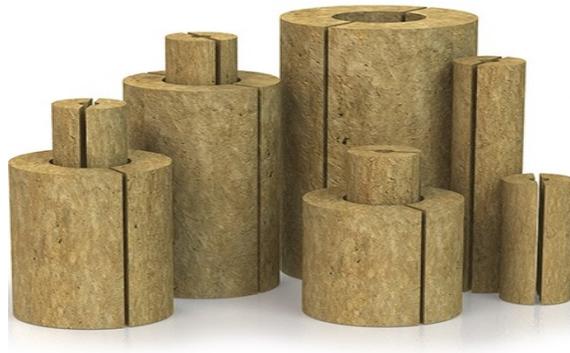
Figure 13 - Mineral wool insulation

The second insulation type is mineral wool insulation. Mineral wool insulation is made from natural minerals like basalt, diabase, and slag. These minerals are heated to high temperatures, spun into fine fibers, and then formed into sheets or blankets. A small amount of binder may be added to help the fibers stick together. It is classified into glass, stone, and slag wool, and is a widely used thermal insulation material Figure 13. Mineral wool's characteristics include fire-resistant property, acoustic insulation, resists moisture, and provides mechanical strength [37], [38].

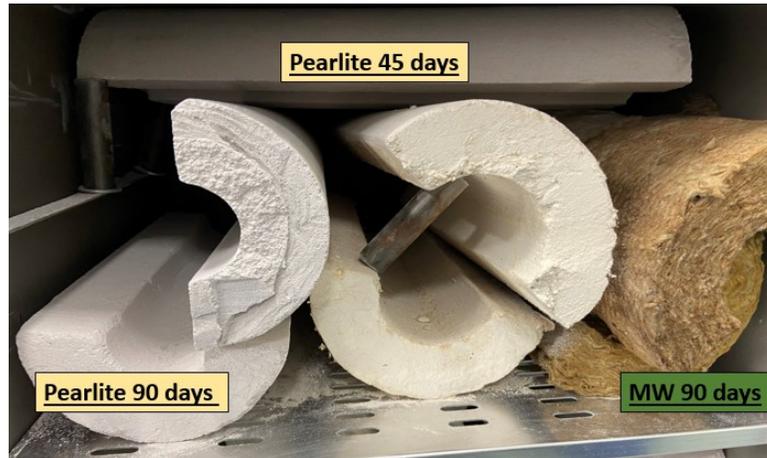
oven at 150°C for approximately 45 and 90 days respectively (Figure 14). This accelerated aging process was to simulate a phenomenon known as binder burnout, which occurred when insulation is in contact with the "hot" surface of the pipeline. Over time, the insulation adjacent to the pipe surface darkens due to the decomposition of organic binders [40].

Figure 14 - The insulation will be placed in a furnace to undergo artificial aging for durations of 45 and 90 days.

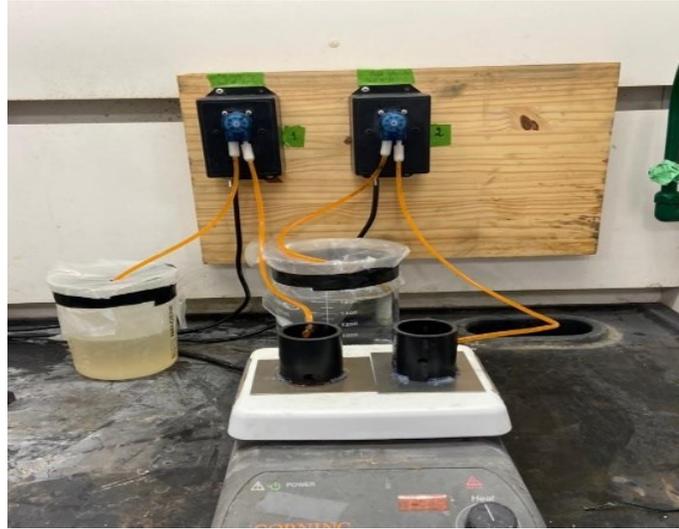
using a peristaltic pump adjusted to dispense 250 mL/day. The experimental setup is shown in Figure 15.

Figure 15 - Test coupons are placed on a hot plate and supplied with fluid using a peristaltic pump.
