Investigating Sources of Elevated Lead in Drinking Water

Submitted in partial fulfilment of the requirements  
for the degree of Master of Applied Science

Dalhousie University  
Halifax, Nova Scotia  
May 2013

DALHOUSIE UNIVERSITY  
DEPARTMENT OF CIVIL AND RESOURCE ENGINEERING

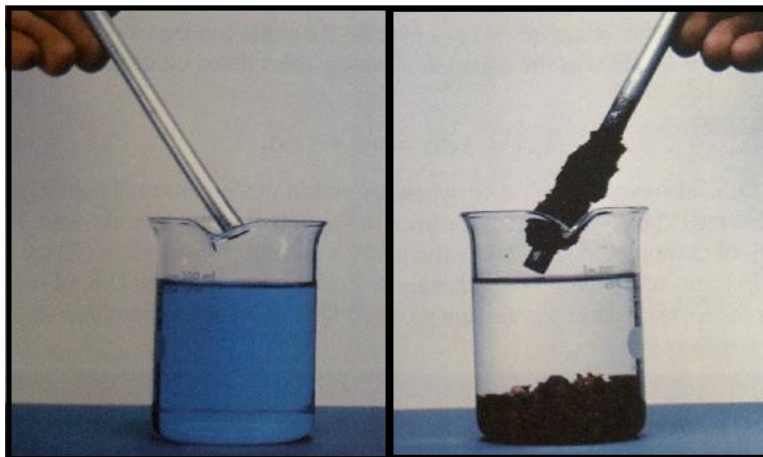
**Figure 2.1:** Zinc electrode immersed in an aqueous copper solution (Petrucci et al, 2002)

Corrosion is an undesirable and spontaneous electrochemical reaction that requires the presence of an anode, a cathode, an internal circuit, and an electrolyte, and results in the destruction of a metal through redox reactions (Snoeyink and Wagner, 1996). A redox reaction is a reaction which must involve both oxidation and reduction half-reactions concurrently, and the number of electrons associated with the oxidation must be equal to the number of electrons associated with the reduction (Petrucci et al, 2002). An example of a redox reaction is demonstrated in Figure 2.1, which illustrates the result of dipping a zinc rod in an aqueous copper solution (Petrucci et al, 2002). The zinc is oxidized, releasing electrons and increasing its oxidation state to 2+, and in the process releasing zinc ions into solution. The  $\text{Cu}^{2+}$  ions are drawn to zinc rod where they are reduced from 2+, gaining an electron and forming a solid deposit on the zinc rod. The removal of  $\text{Cu}^{2+}$  ions is demonstrated by the colour change of the solution from blue to clear.

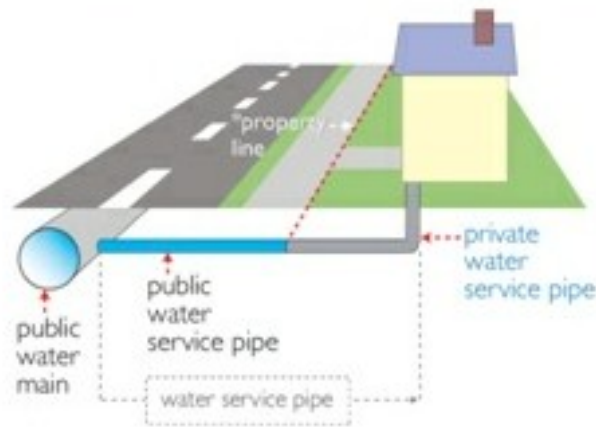
**Figure 2.4:** Schematic diagram of typical residential water service (DC Water and Sewer Authority, 2012).

**Lead Service Lines.** An illustration of a typical residential water service connection is shown in Figure 2.4. The supply pipe, also referred to as a service line, is the pipe which connects the home plumbing to the water main. The service line comprises of two sections: the public portion, which is owned by the utility and connects the water main to the property line; and the private portion, which extends from the property line into the residence and is the possession of the property owner. Newer water service lines in Canada are made of copper or polyethylene tubing; although prior to 1975, the use of lead pipes was common (Health Canada, 2009). In the United States, the use of lead pipes continued into the 1980's and it is estimated that over 3 million continue to exist (Boyd et al, 2004). Depending on site conditions such as the length of the service line, presence of lead solder, types of brass devices used in building plumbing, and the water quality, the service line is estimated to contribute roughly 50 – 75% of the mass of lead measured at the tap at sites with lead services (Sandvig et al, 2008).

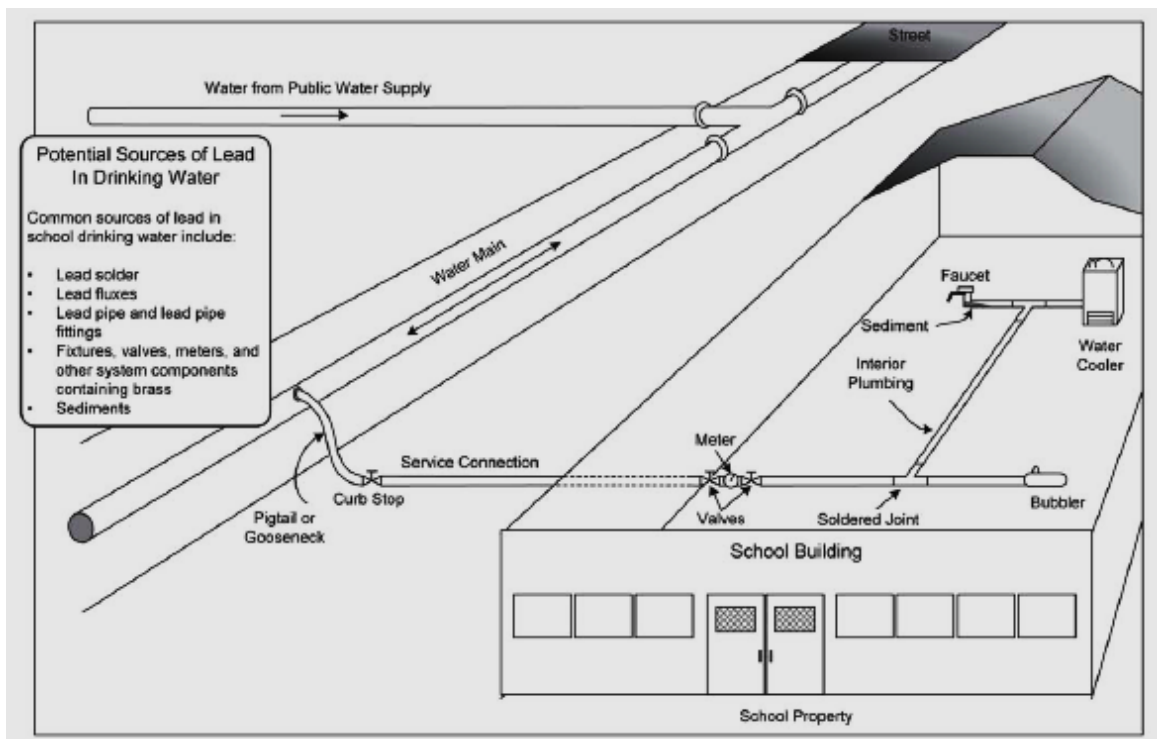
**Figure 3.1:** Sources of lead in a non-residential building (USEPA, 2006)

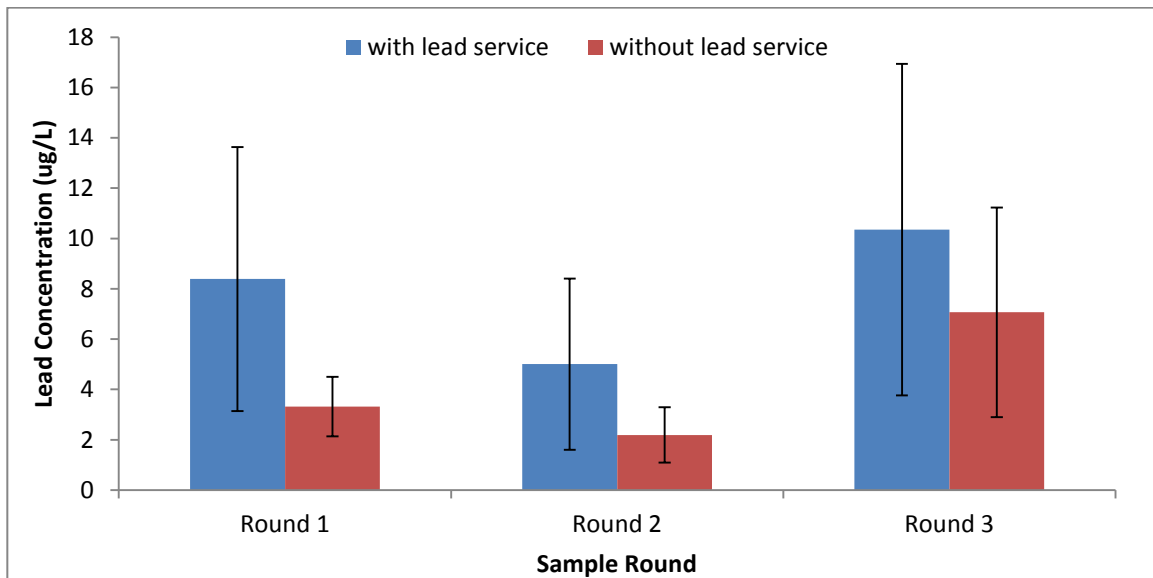
**Figure 3.6:** Residential testing average first draw lead concentrations from sites with and without lead services

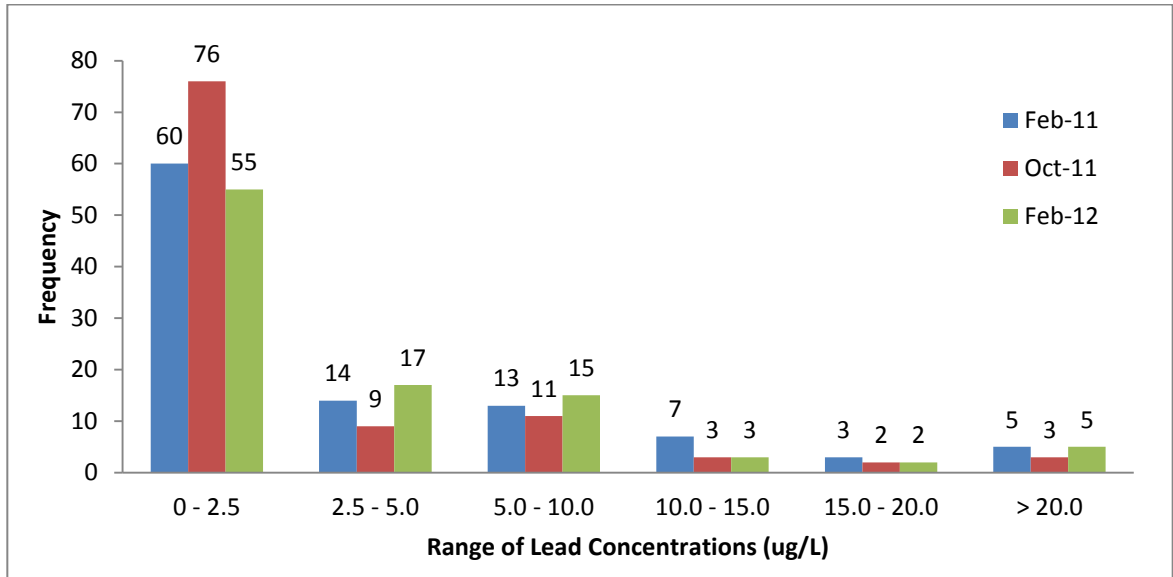
**Figure 3.10:** Distribution of lead concentrations found in three rounds of non-residential sampling

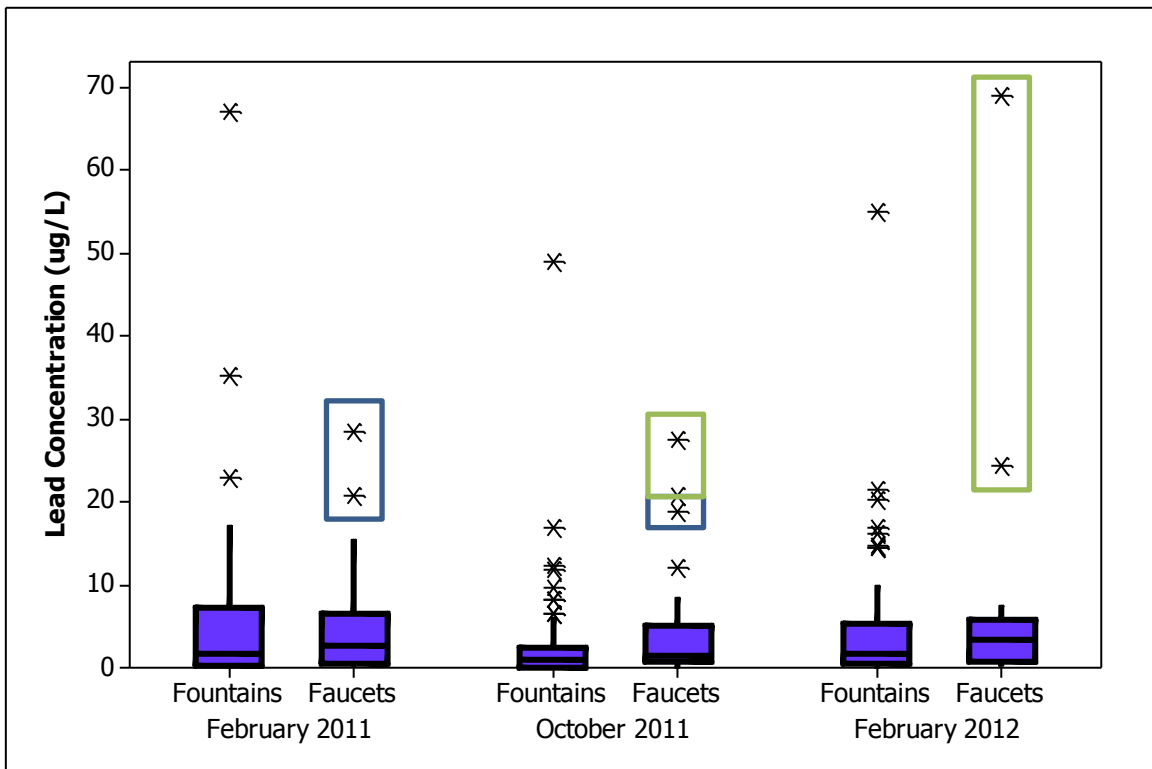
Figure 3.13: Comparison of lead concentrations from fountains and faucets in each round of non-residential testing

Figure 3.13 presents boxplots of lead concentrations from samples collected during the non-residential monitoring, and compares lead levels which were obtained from sites with fountains and faucets. Sites with faucets above the action level were found either in kitchenettes which were evidently rarely used, or from bathroom faucets where regular use would be for washing hands and not for purposes of consumption. These sites are highlighted in Figure 3.13, where the outlier lead concentrations from bathroom faucets where risk of exposure would be low are highlighted in blue, and the sites in residence kitchenettes which appeared to experience very infrequent use are highlighted in green.

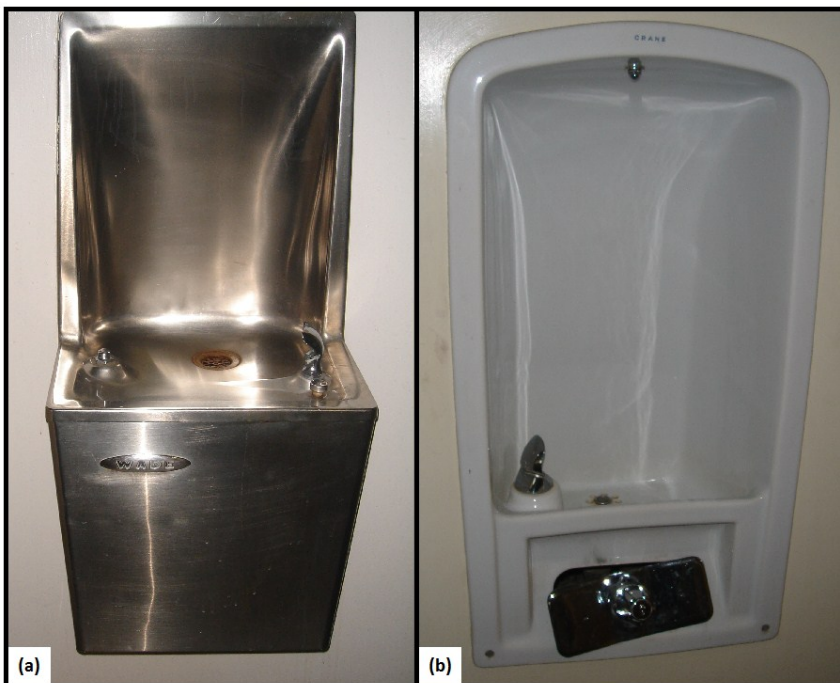
**Figure 4.1:** The fountains at the focus of this study (a) Halsey Taylor RWM model and (b) Crane

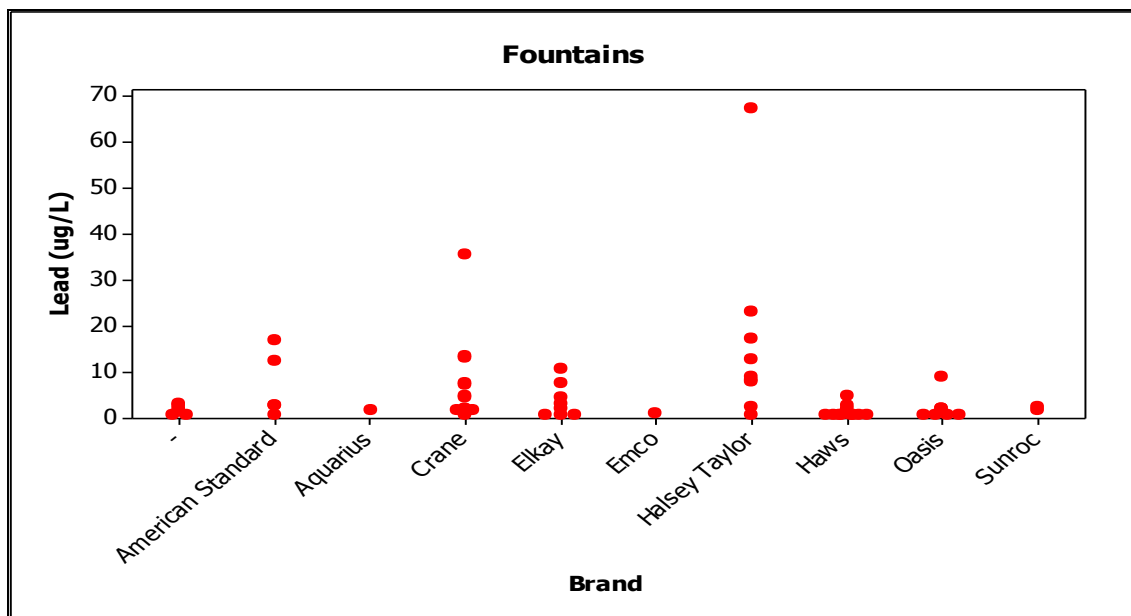
Figure 4.2: Summary of lead concentrations from drinking fountains in first round of non-residential lead monitoring

**Leaded Cooling Tanks.** The first round of the campus-wide lead monitoring program unveiled the presence of a lead issue in several larger, non-residential buildings, particularly with certain drinking fountains. One fountain manufacturer in particular, Halsey Taylor, was associated with three of the four highest lead concentrations encountered from drinking fountains in the first round, as shown in Figure 4.2.

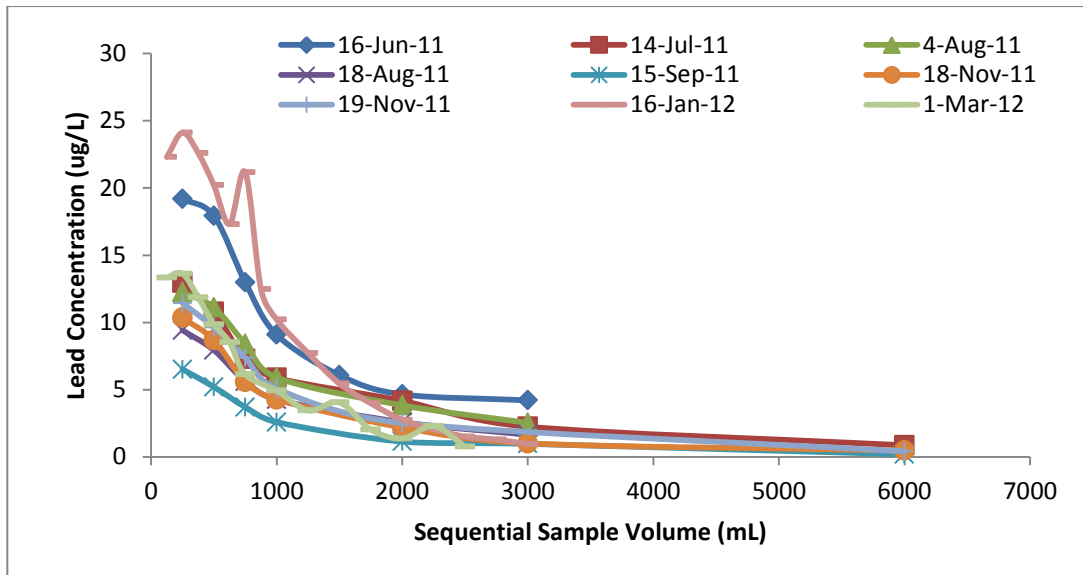
**Figure 4.3:** Sequential sampling lead results from RWM model fountain from site A1

Lead results of sequential sampling from an RWM fountain located on the first floor in building A (A1), are presented in Figure 4.3. Consecutive sample volumes are displayed on the x-axis, and the lead concentrations are presented on the y-axis. To help understand the lead profiles, a photograph of the interior of the RWM fountain is shown in Figure 4.4. Additionally, the schematic diagram in Figure 4.5 provides an estimate of the location of sequential sample volumes in order to determine the sources of lead, copper, and zinc. It should be noted that the volumes with respect to location of stagnation have not been confirmed. The diagram is used to provide an estimate of the source of metals and was developed based entirely on interpretations of the data.

From the lead profiles (Figure 4.3), elevated lead levels in the initial 500 mL found in repeated sampling suggested the presence of the leaded cooling tank. The peak was followed by a decrease in lead concentration through the subsequent litre, which was then followed by a relatively stable lead concentration through the following samples. Throughout the year of sampling, it is clear that the profile remained quite consistent; however, the quantity of lead in the first litre varied quite dramatically from concentrations as high as 25  $\mu\text{g/L}$  in a January 2012 sample, to as low as 5  $\mu\text{g/L}$  in samples collected in September 2011.

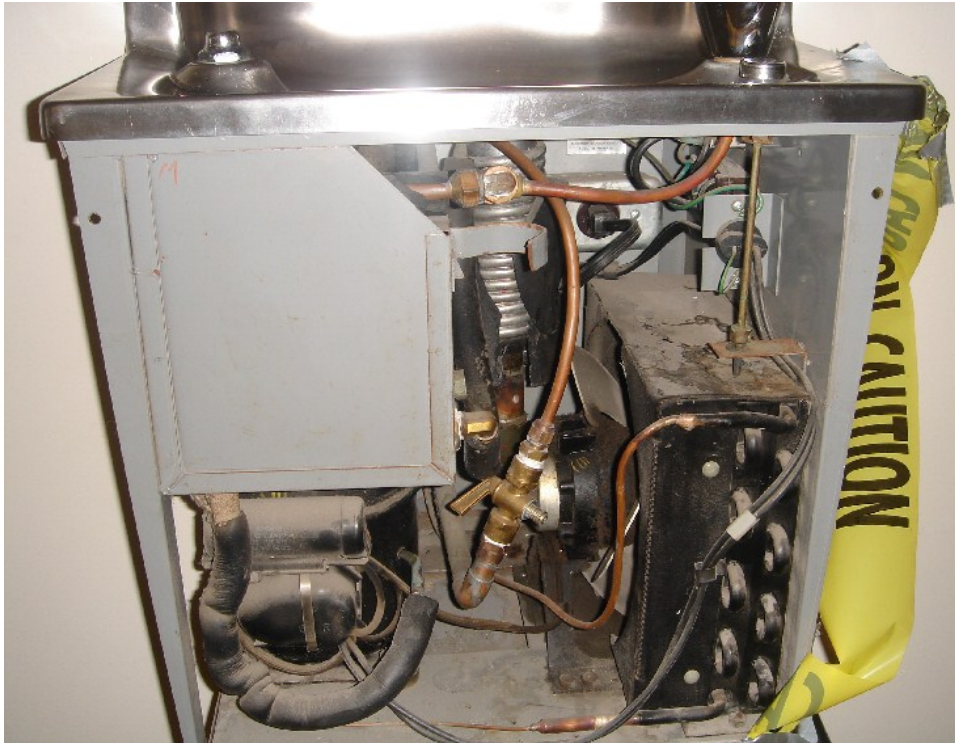
**Figure 4.4:** Interior of RWM model fountains

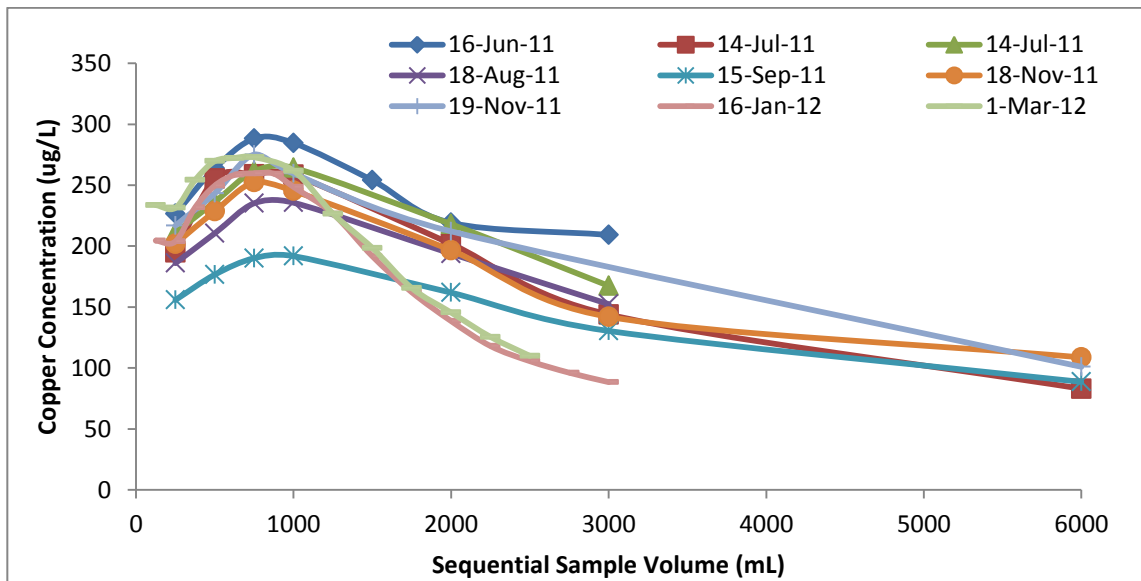
Figure 4.6: Sequential copper concentrations from RWM model fountain located at site A1

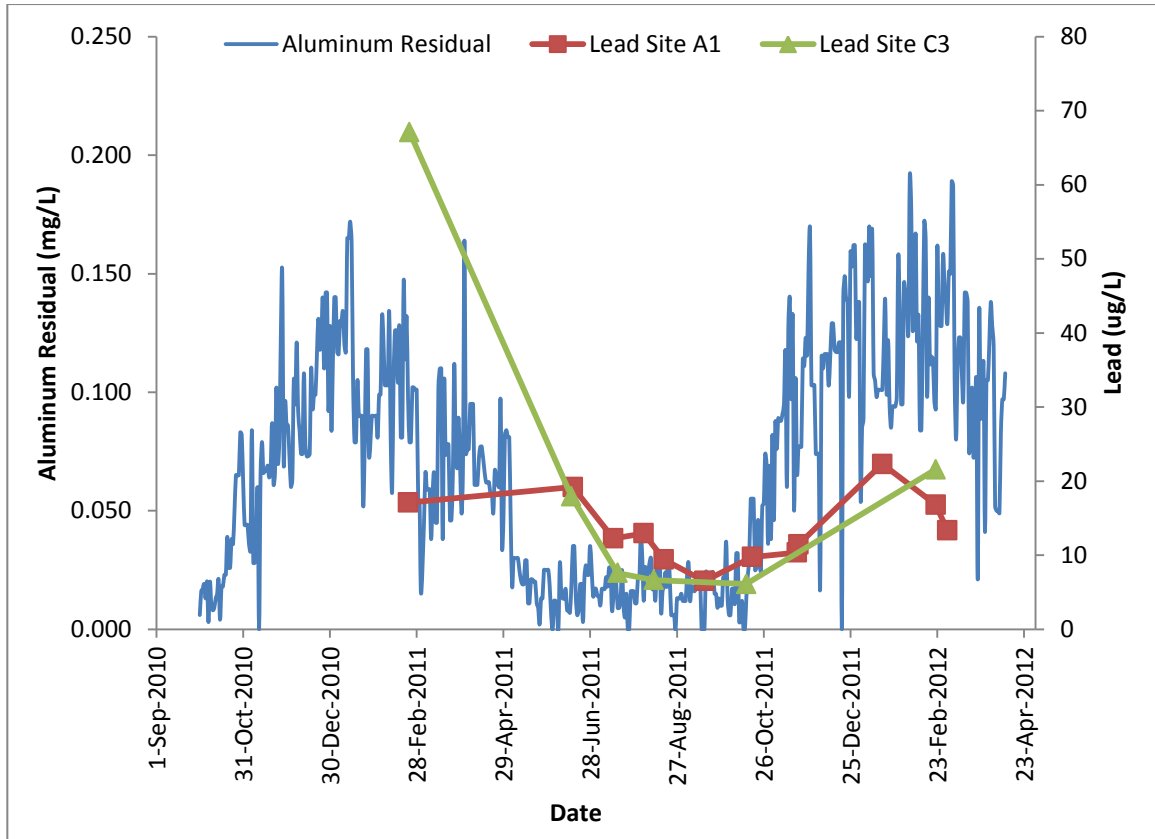
**Figure 4.8:** Aluminum residual concentrations in water leaving JDKWSP paired with lead measurements at select sites tested throughout the given timeframe

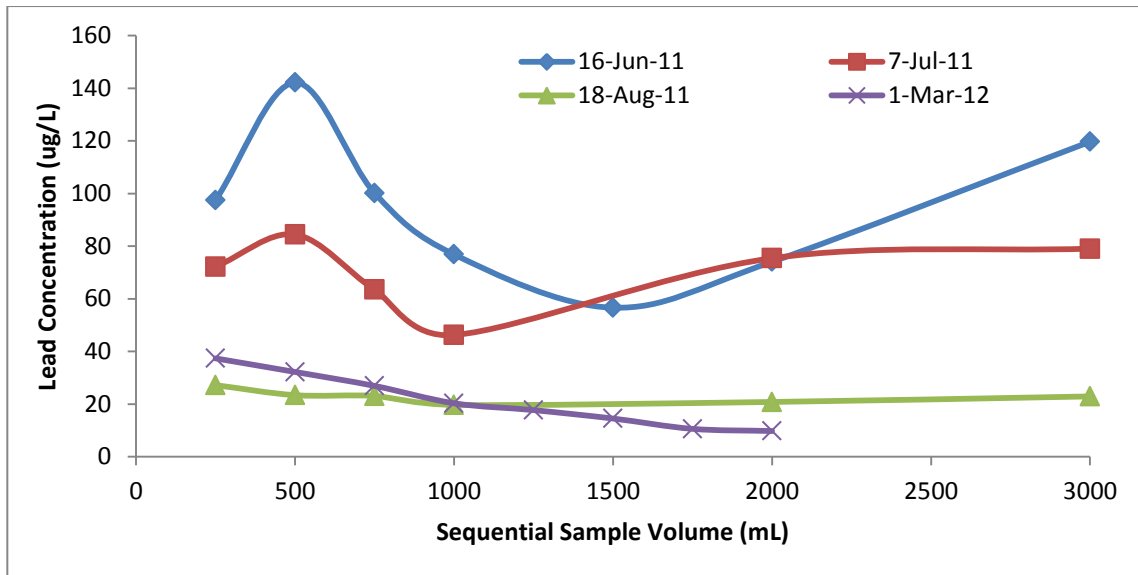
**Figure 4.9:** Sequential sampling lead concentrations from RWM model fountain, site A3

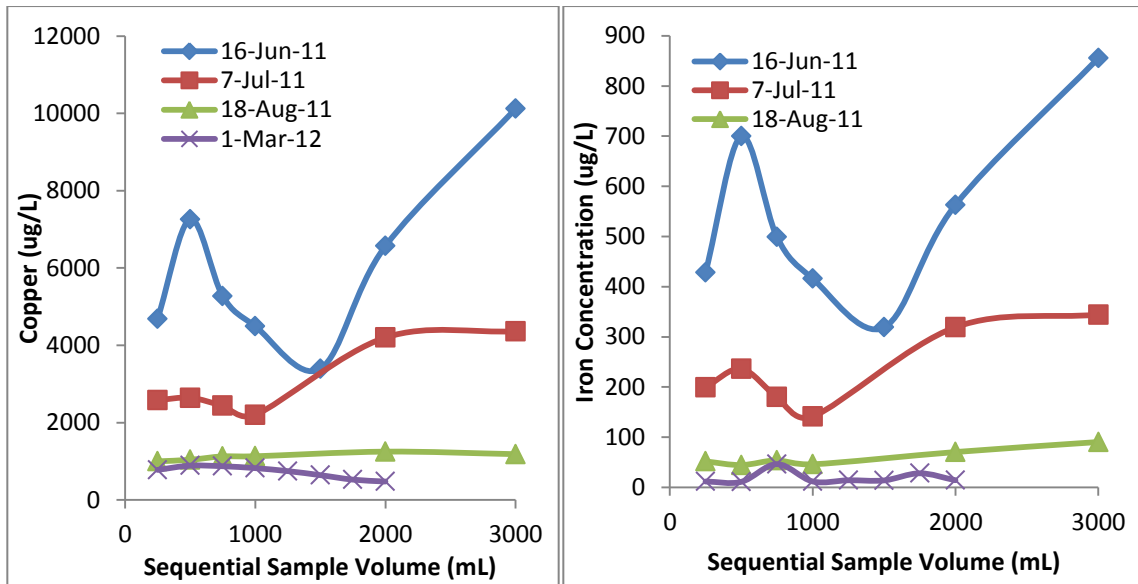
**Figure 4.10:** Sequential sampling copper and iron concentrations from RWM model fountain, site A3

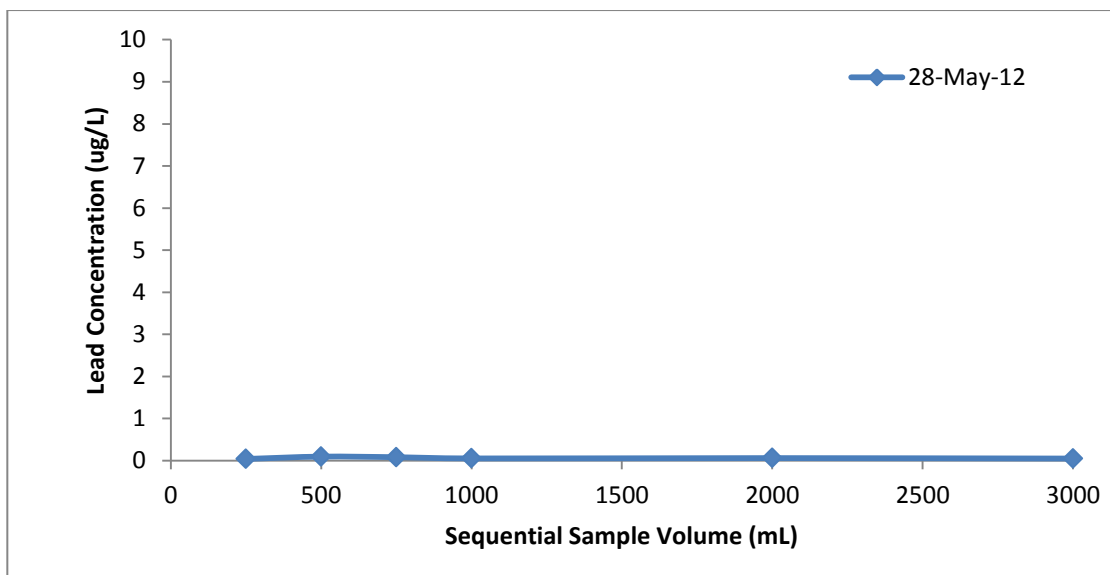
**Figure 4.11:** Sequential sampling lead concentrations from fountain which replaced the RWM model fountain, site A3

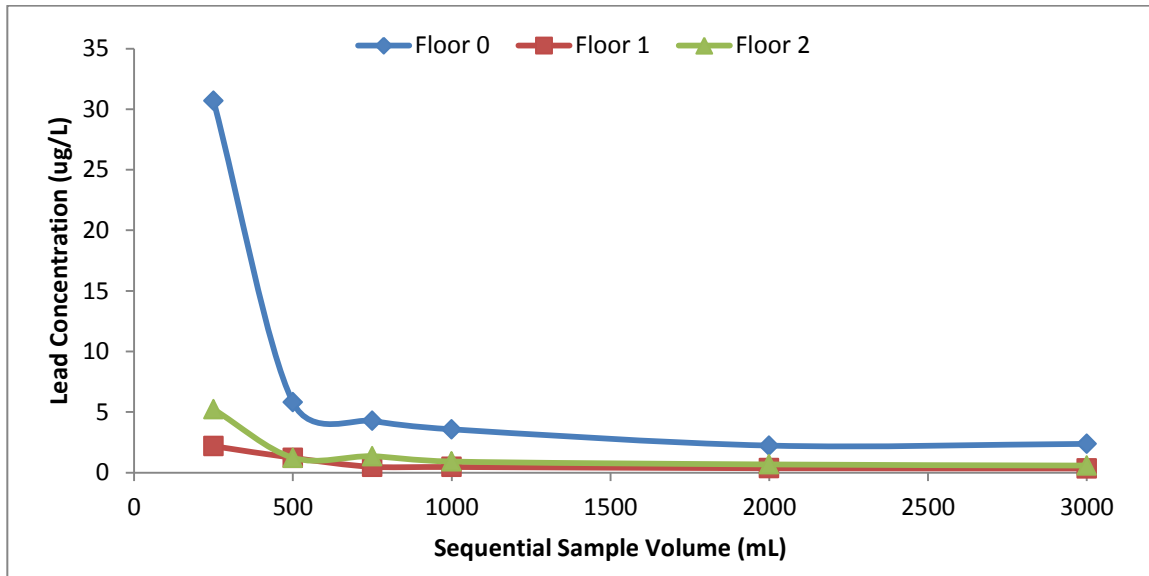
Figure 4.12: Sequential sampling lead results from three fountains of same model, located in building D

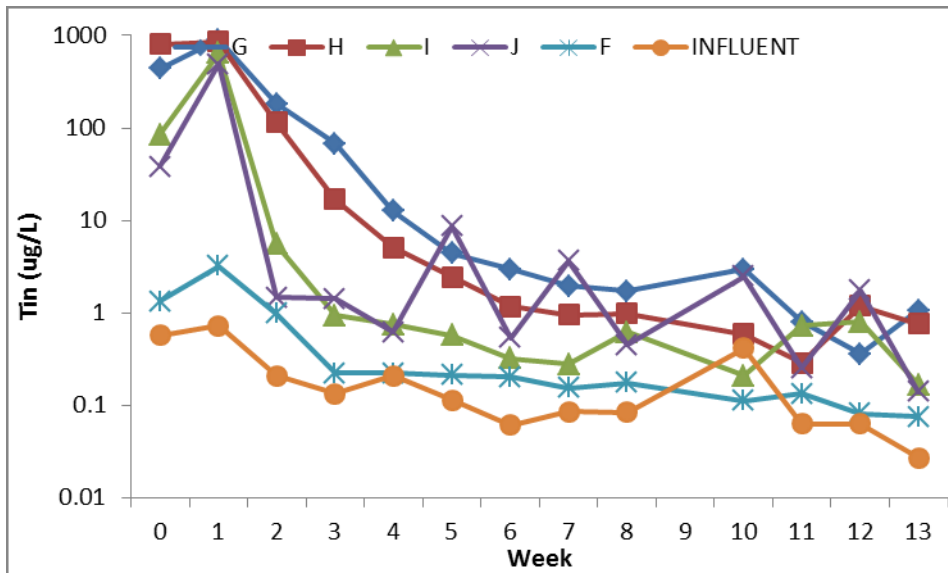
Figure C.4: Tin concentrations under high flow conditions
