Publisher's version: 5. Jamshidi, R., Lake, C.B., and Barnes, C. 2015.
Evaluating impact resonance testing as a tool for predicting hydraulic conductivity
and strength changes in cement-stabilized soils, ASCE Journal of Materials in
Civil Engineering, 27(12): 04015051-1- 04015051-9, 10.1061/
(ASCE)MT.1943-5533.0001318, 04015051.

16 In this paper the impact resonance (IR) test method is used as a non-destructive tool to examine
17 the curing progression, freeze/thaw (f/t) resistance, and healing potential of cement-stabilized
18 soils. Resonant frequency (RF) measurements on specimens moist-cured for up to 241 days
19 indicate that the main portion of the hydration process is completed after about 60 days. Results
20 of RF measurements on immature (i.e. cured for 16 days) and mature (i.e. cured for over 110
21 days) specimens exposed to 12 cycles of f/t indicate that the initial f/t exposure had a significant
22 effect on the degradation of the structure. After the initial f/t cycle, some specimens exhibited
23 continued reductions in RF values to as low as 10 percent of the initial measurements, while
24 several specimens showed signs of recovery leading to minor increases in the

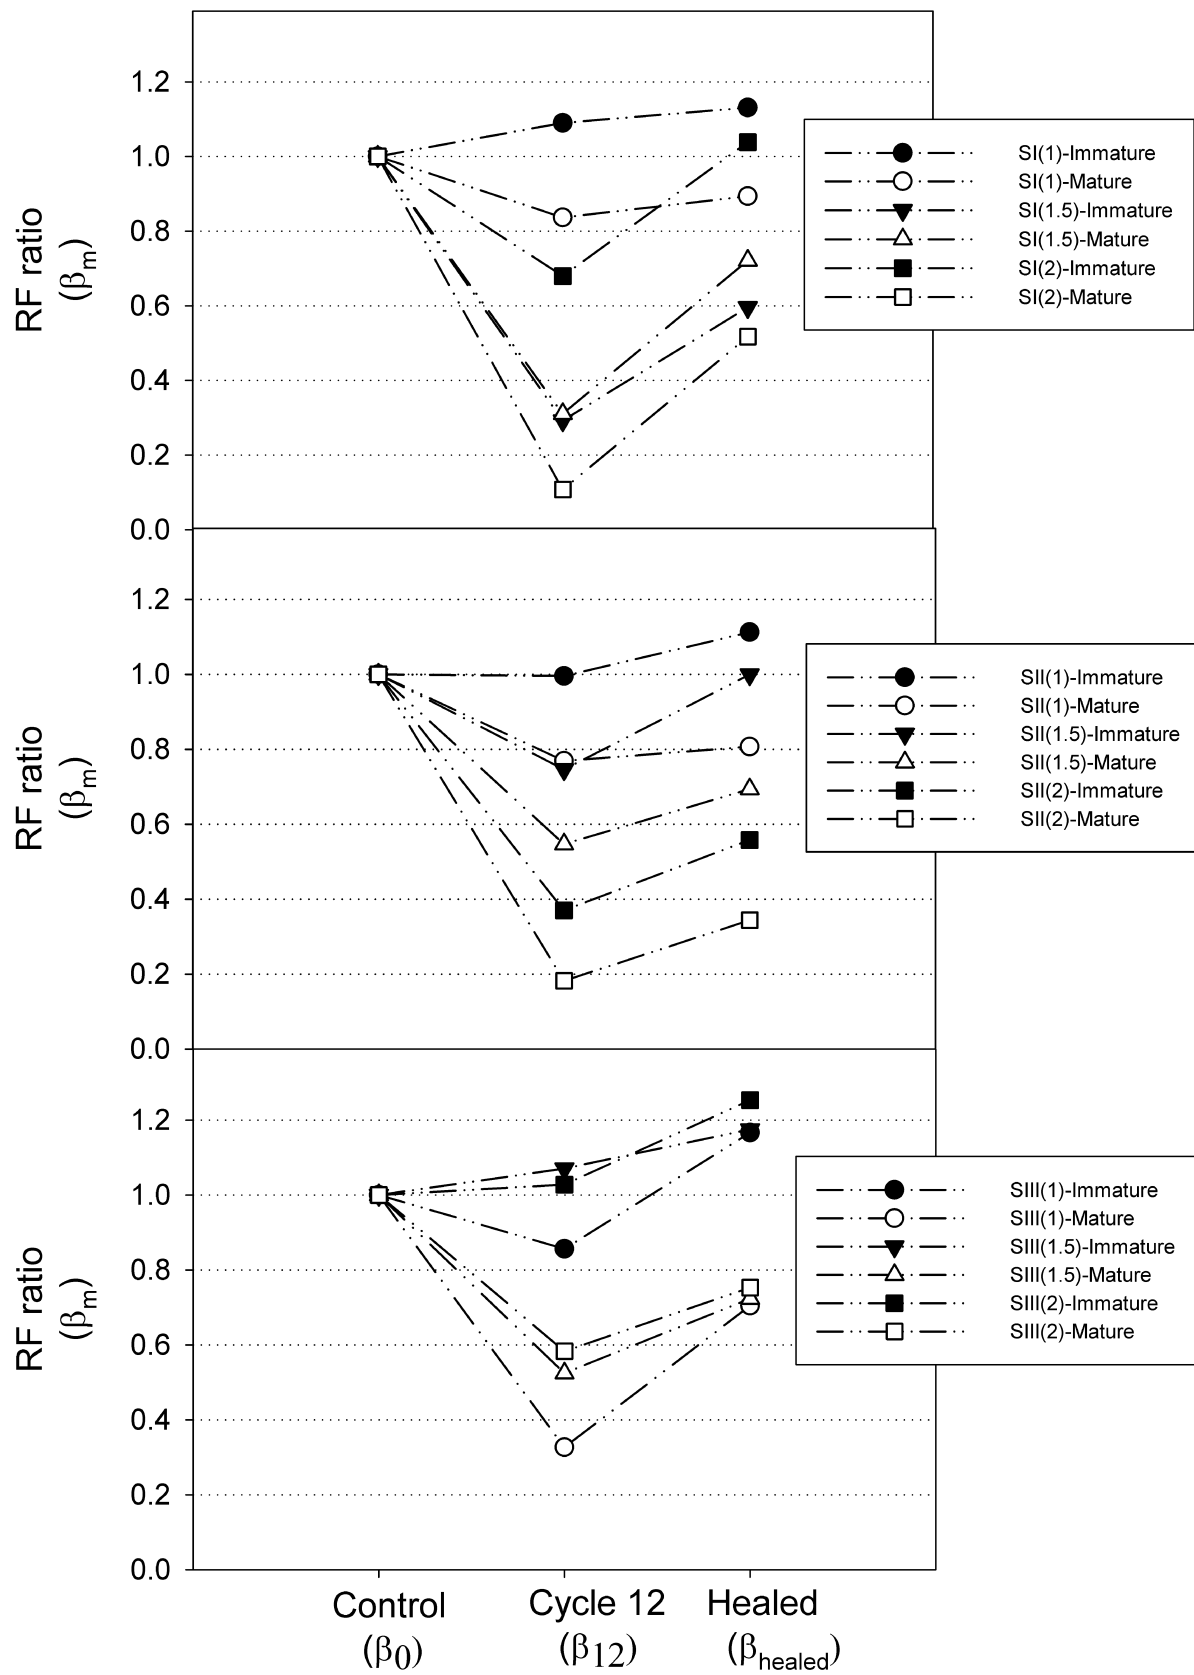
Fig. 7: Frequency ratio after 12th f/t cycle and post-exposure healing period.

314 After exposure to the 12th f/t cycle, previously tested specimens were kept in a moist room for
315 over 120 days. Fig. 7 shows that all specimens exhibited some improvement in their structure
316 after the post-exposure healing period (i.e. $\beta_{\text{healed}} > \beta_{12}$). For most cases of immature specimens,
317 with the exception of SI(1.5) and SII(2), average RF values at the end of the healing period
318 reached or exceeded the values obtained as control measurements prior to f/t damage (i.e. β_{healed}
319 ≥ 1). SI(1.5) and SII(2) specimens also showed a noticeable increase in the RF values after the
320 healing periods resulting in an average β_{healed} value of about 0.6.

327 Fig. 7 shows that specimens with similar RF ratios after the 12th f/t cycle (β_{12}) do not necessarily
328 exhibit similar recovery potential after the healing period. SII(1)-mature and SII(1.5)-immature
329 both showed a RF ratio of about 0.8 at the end of the 12th cycle; but after the healing period, the
330 RF ratio (β_{healed}) of SII(1.5)-immature increased to a value of about 1, while the RF ratio of
331 SII(1)-mature showed only a small increase. Also, mature specimens from SIII(1), SIII(1.5), and
332 SIII(2) had a RF ratio (β_{12}) ranging from 0.3 to 0.6 at the end of the 12th cycle, however after the
333 healing period, all these specimens reached an average RF ratio (β_{healed}) of about 0.7.

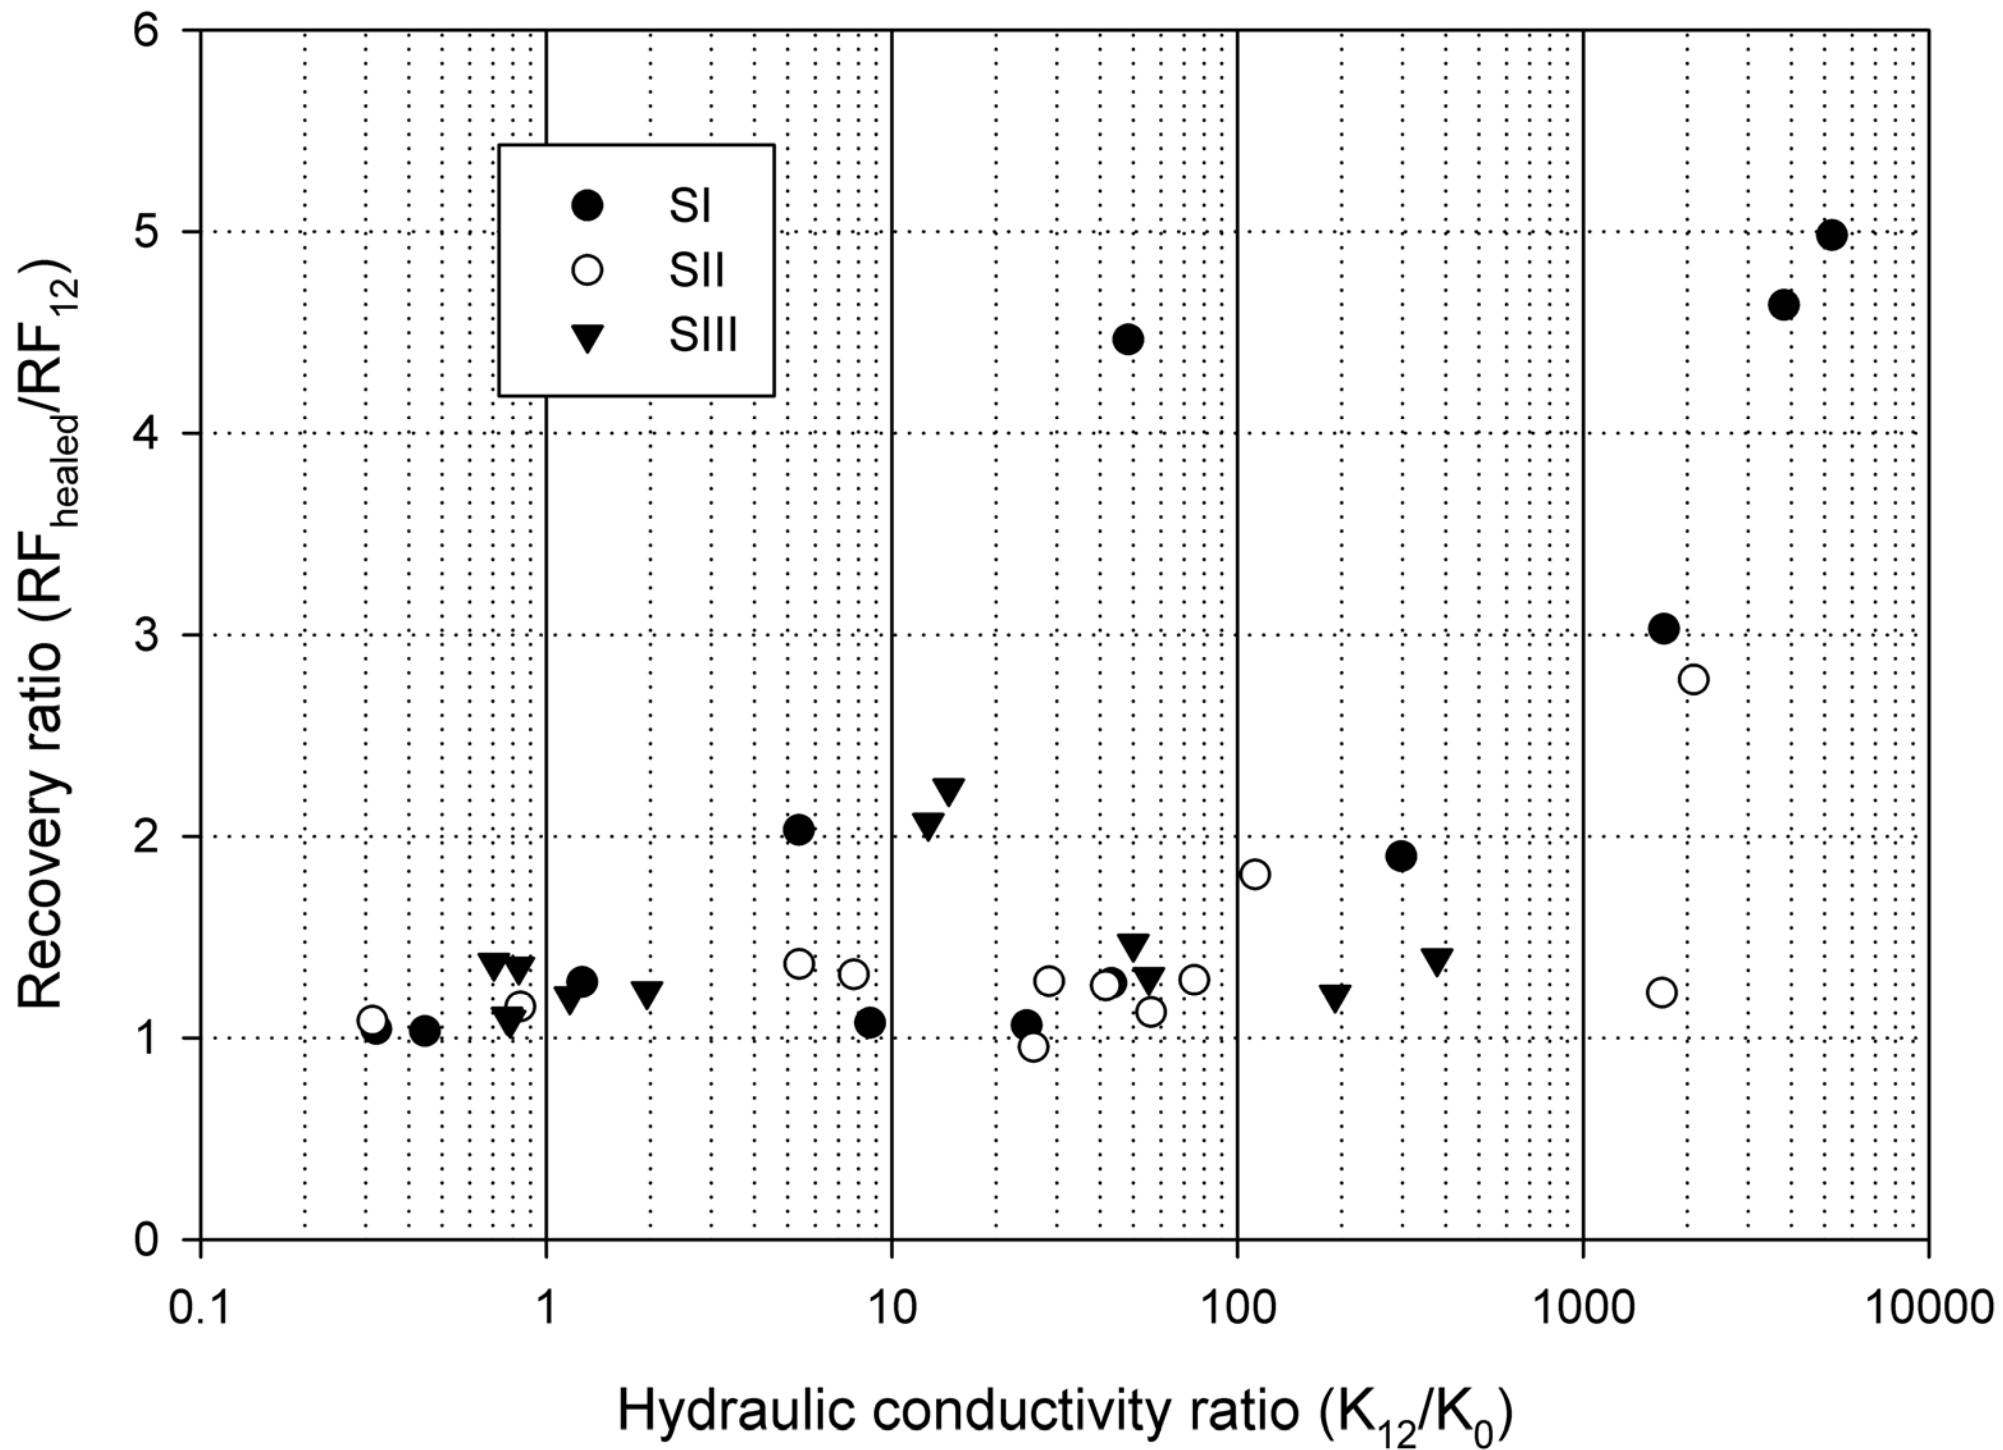
Fig. 8: Recovery ratio of specimens compared to the hydraulic conductivity ratio measured after 12th f/t cycle.

347 The recovery ratio, defined as the ratio of RF after the healing process (RF_{healed}) divided by RF
348 measured at the end of the 12th f/t cycle (RF_{12}), was calculated and plotted against the hydraulic
349 conductivity ratios (i.e. K_{12}/K_0) in Fig. 8. There seems to be a scattered trend suggesting that

350 specimens with higher hydraulic conductivity ratios (K_{12}/K_0), which indicates higher amount of
351 damage in their structure, also show a higher potential for healing (in terms of recovery of RF
352 values). This observation is likely due to the presence of more cracks/micro-cracks in the highly
353 damaged specimens, which creates a better potential for RF gain during the healing period.
354 However, it should be noted that the superior recovery potential of highly damaged specimens
355 does not necessarily result in a better final performance of these specimens. Considering the case
356 of immature and mature specimens in Fig. 7, mature specimens have an inferior performance
357 under f/t exposure, compared to immature specimens within each mix design. Despite the higher
358 recovery rate for some of the mature specimens (for instance about five times increase in RF for
359 SI(2)-mature between healed conditions and cycle 12), they still exhibit lower RF ratios at the
