# *St. Paul's Presbyterian Church, Hamilton, Ontario*

By Alan Seymour and Walter Peace

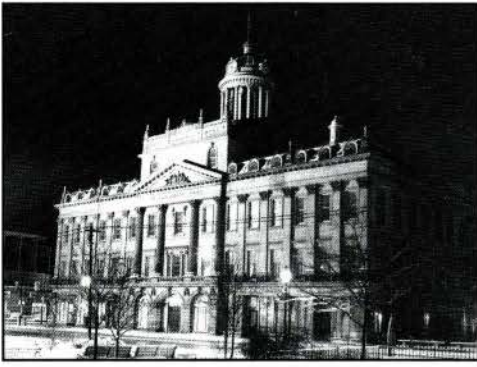
Figure 4 (above). St. Lawrence Hall, Toronto, designed by William Thomas and built in 1850-51 (restored in 1967). (Glenn McArthur)

were St. Lawrence Hall, St. Michael's Cathedral (figures 4, 5), and the Don Jail, all in Toronto, and the Sir Isaac Brock monument at Queenston Heights.

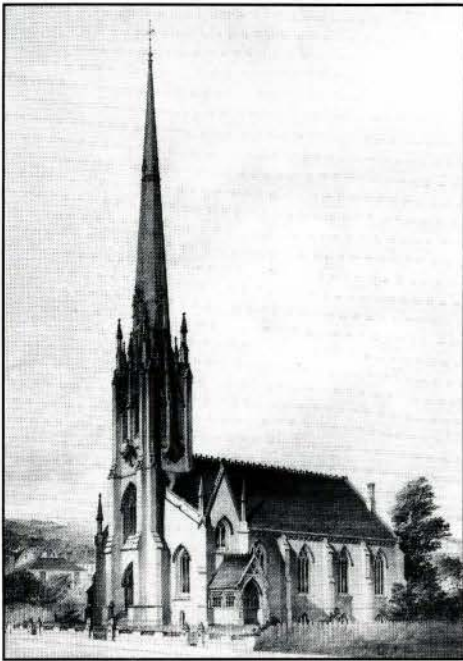
Figure 7 (left). Lithograph of William Thomas' original design for St. Andrew's (now St. Paul's) Presbyterian Church, Hamilton. (Maclure & Macdonald, Lithographers, Glasgow, 1855/Canadian Historical Reproductions)

The congregation of St. Andrew's Presbyterian Church, responding to the appeals of Robert Smiley, announced its intention to build a new structure at the corner of James Street South and Jackson Street to replace the original wooden building. Thomas was chosen to design the church, possibly because of his earlier work on Undermount for John Young, a wealthy merchant who was an elder, trustee, and founder of St. Andrew's. Soon began the construction of one of the city's finest buildings and Thomas' most successful composition (figure 7).<sup>22</sup>

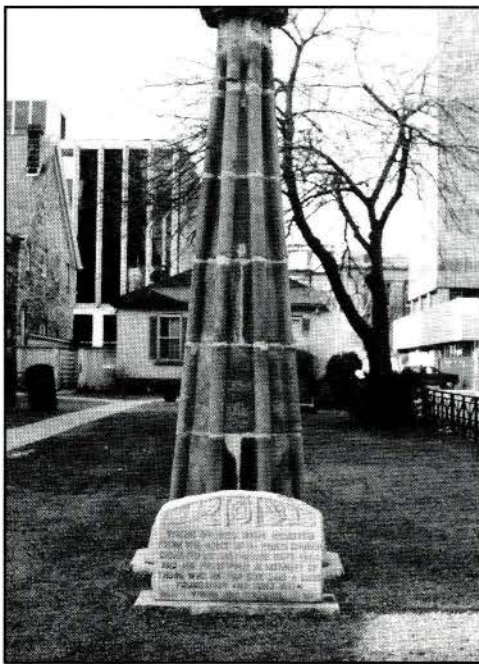
Figure 9 (top). The original sandstone courses which were removed from the spire in 1944 and rebuilt in the churchyard as a monument. (Walter Peace)

The forces of nature caused considerable anguish for the congregation when, on 5 September 1944, a piece of the stone spire beneath the weather vane fell to the front steps as a result of an earthquake. A few weeks later, movement of the spire was observed during a high wind storm.<sup>36</sup> Scaffolding was erected and the top six courses of the spire's sandstone were removed. These courses were rebuilt in the churchyard as a monument (figure 9). The top of the spire was then rebuilt using limestone.

The choice of limestone in 1944 as a replacement for the original sandstone masonry was an error which 19th century masons would have avoided: acidic rainwater running across the limestone removes carbonates and redeposits them in the sandstone below. These carbonates, now in the surface pores of the sandstone, react with pollutant oxides to form dangerous concentrations of water-soluble salts. The conservation consultant recommended the immediate erection of a special scaffold with hoardings and safety nets to encase the masonry materials and make possible a thorough scientific and technical examination.

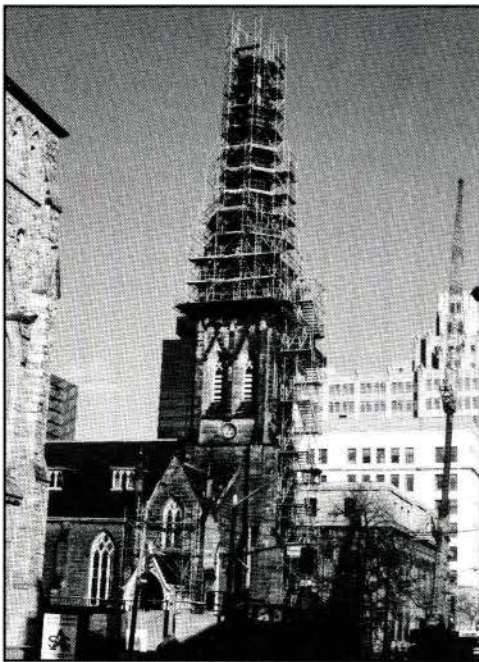
Figure 10 (bottom). The spire of St. Paul's, Hamilton, encased in scaffolding. (Walter Peace)

Architect Alan Seymour was retained in November 1987 to carry out the conservation program. By December the scaffold had been designed and erected (figure 10), and on 22 December the first thorough inspection of the outside of the spire took place. The findings of the initial inspection were confirmed in dramatic fashion. Some decorative stone finials were completely loose and were removed by hand without effort. Bedding mortar was completely missing from some joints, or had deteriorated to a moist powder. Nearly all the pinnacles (the tallest is 20 feet high) and finials were loose and could easily be moved by hand. Some had split because of the expansion of corroding iron dowels. Several were kept in place simply by their own weight, without proper restraint by dowels or cementing mortar.

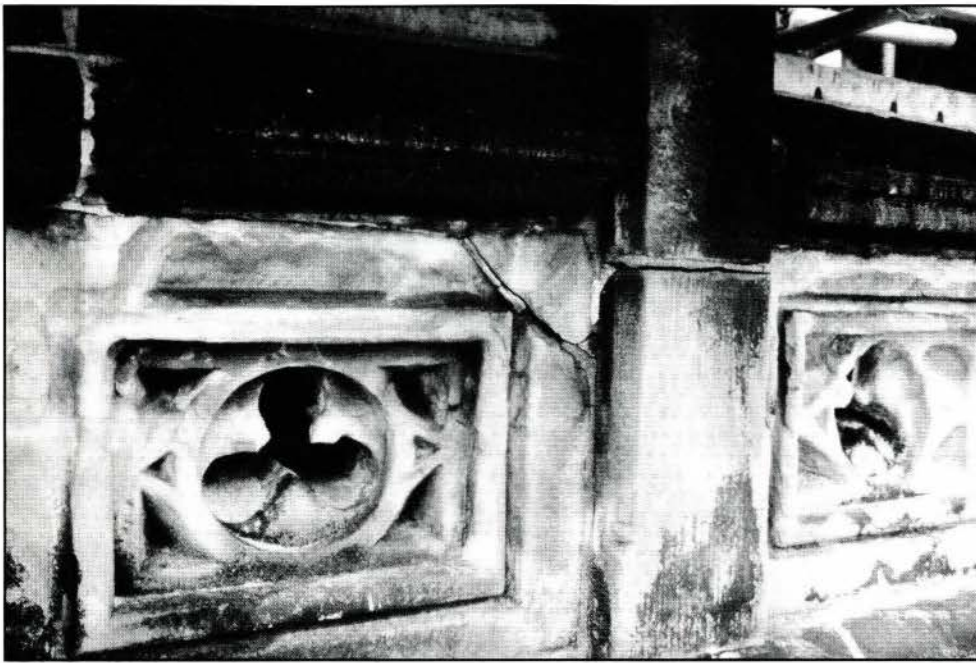
Figure 11 (top left). The parapet stones were beyond repair, so new units were carved. (Alan Seymour)

Excessive pollution from Hamilton's iron and steel works and more distant sources resulted in the addition of large quantities of sulphates, which were destroying the masonry in the form of massive deposits of efflorescent and subflorescent salts. Some of the sandstone blocks in the spire had lost more than a third of their thickness, and possibly more of their bearing surfaces. The slate roofs, flashings, rainwater disposal systems, and stained glass windows were also in serious need of repair.

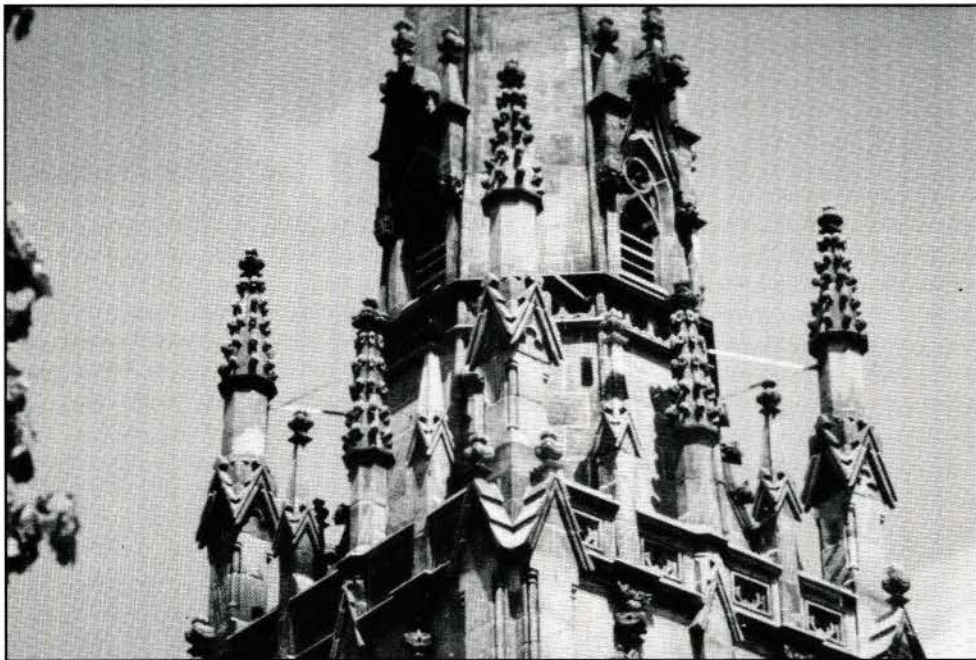
Figure 13 (bottom left). The parapet and pinnacles after restoration. Note the rods bracing the corner pinnacles. (Walter Peace)

stainless steel mast, which was connected at its base to the strapping already installed. All decorative stone elements were then remounted with stainless steel pins, cramps, and dowels (figure 13). The spire, tower, nave, and sanctuary were cleaned and repointed. Selected stained glass windows were removed and the frames were stripped and repainted. The windows were cleaned, and the lead comes repaired or replaced. New louvres and bird screens were installed in the belfry and spire. The two wooden porches were also repaired and restored (figure 14). Phase III commenced in October 1989 and addressed the slate roofs, flashings, and rainwater systems. Finally, in 1991, a maintenance manual was prepared, listing maintenance procedures, the equipment required, and frequencies of inspection, all supported with as-built drawings and specifications.

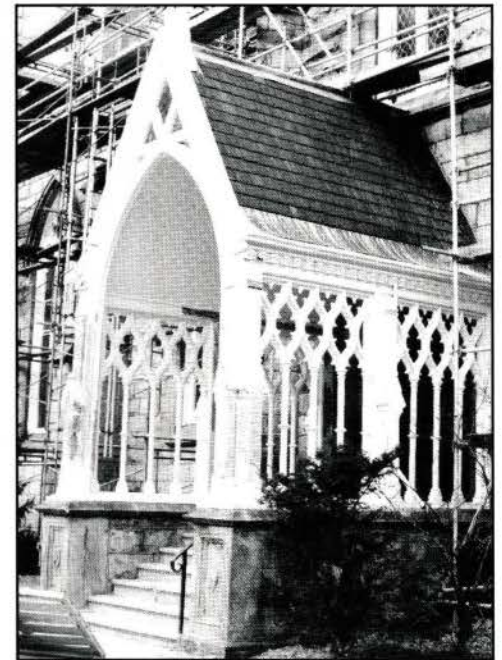
Figure 14 (bottom right). Restoration of one of the porches, in progress. (Alan Seymour)
