ASSESSMENT OF GRAND CAYMAN'S GEORGE TOWN LANDFILL AND
APPLICATION OF INTEGRATED COASTAL MANAGEMENT FOR IMPROVED
ENVIRONMENTAL SUSTAINABILITY

Submitted in partial fulfillment of the requirements
for the degree of
Master of Marine Management

Dalhousie University
Halifax, Nova Scotia
November 2014

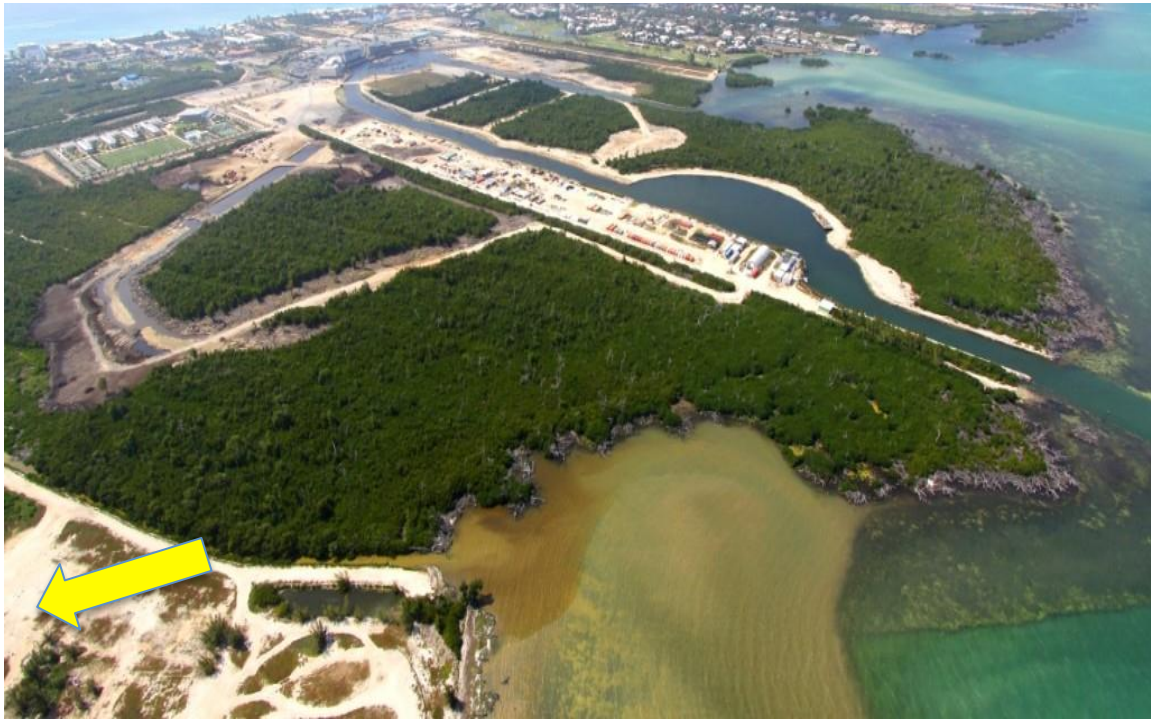
Figure 1.1. Areal view of North Sound water discoloration near GTLF. Areal view shows discoloration of North Sound near the GTLF. GTLF is located in the direction of the yellow arrow outside the scope of this picture. The North Sound is the featured body of water on the right, and Seven Mile beach can be seen at top left. (Source: CardnoENTRIX, 2013).

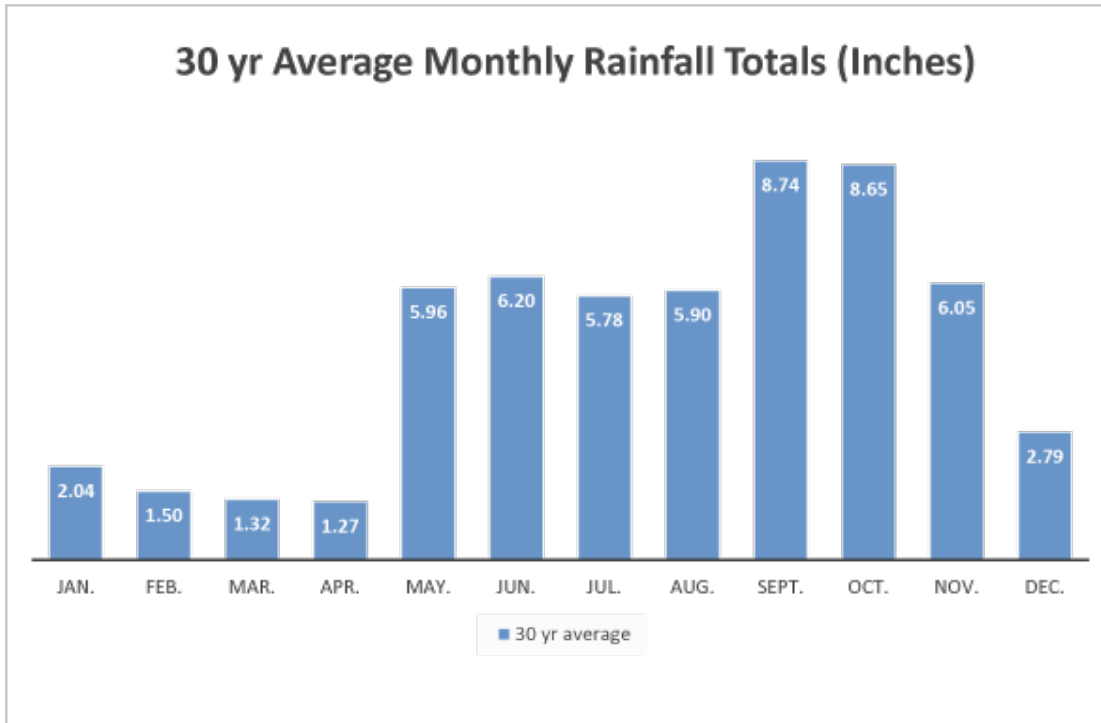
Hurricane season officially begins June 1st and ends November 30th (Cayman Prepared, 2010). These months have the highest rainfall during the year and highest number of storms, figure 1.5. December- April is dryer with less precipitation, lower humidity and temperatures, and few storms (Cayman Prepared 2010; and CIG, 2011a). Storms, especially hurricanes, pose a threat to the island as rainwater, storm surge and increased winds aid in contaminant transport (CardnoENTRIX, 2013; Williams, 2005).

Figure 1.5. Average monthly rainfall (inches). Graph shows the monthly average rainfall as calculated from averages over the past 30 years. Yearly average= 118.9mm (4.68in). December-April average= 45.2mm (1.78in). May- October average= 174.5mm (6.87in). (Source: National Weather Service, 2014).

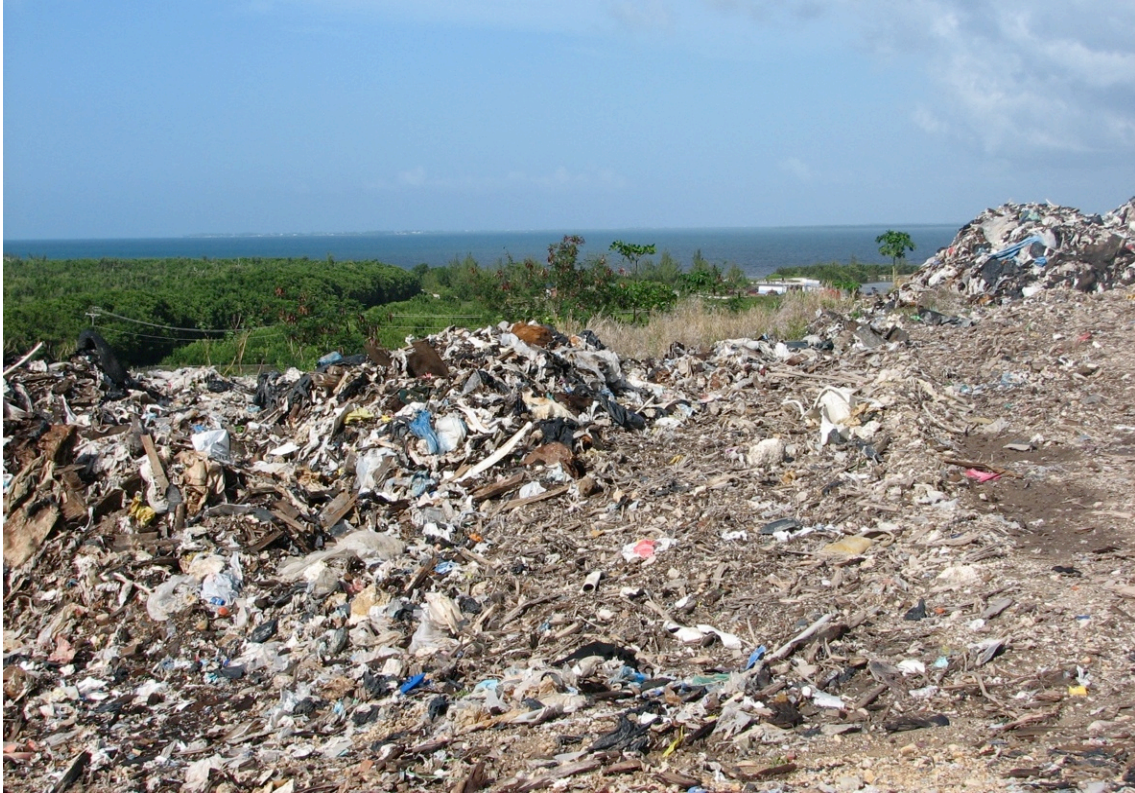
no clear date, reason, or mandate explaining the decision. Today the landfill remains uncovered, figure 1.7, which does not reflect best practices. Uncovered landfills allow rain to increase leachate production, allow trash to blow off into nearby ecosystems, have increased odor, attract insects and vermin, and are unattractive to look at (CardnoENTRIX, 2013; Tammemagi, 1999; Williams, 2013).

Figure 1.7. Top of 'Mount Trashmore'. Image was taken at the top of the GTLF (80m above sea level). Image shows uncovered compacted trash, surrounded by mangrove forest and the North Sound in the foreground. (Personal Collection).

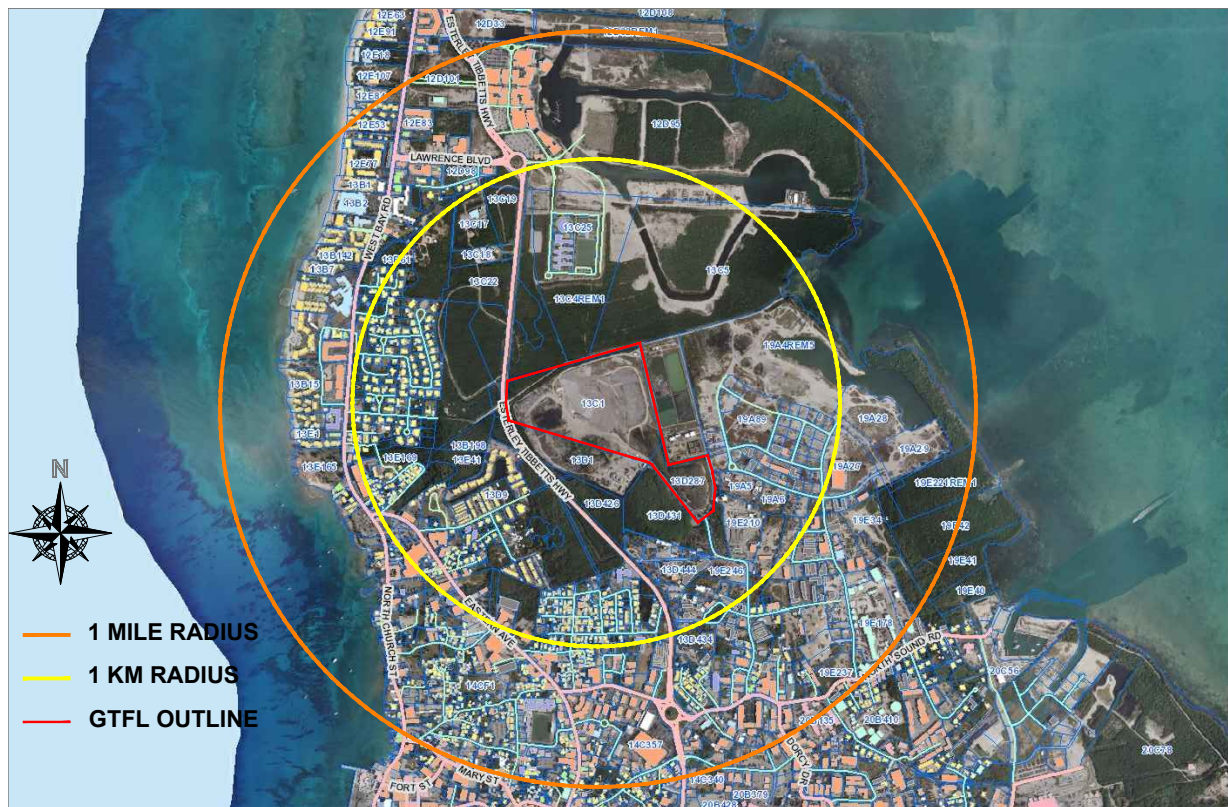
The GTLF is located in George Town, Grand Cayman, approximately 1 km west of the North Sound, figure 1.8. The North Sound is enclosed by a barrier reef to the north, and by Grand Cayman to the south, east, and west. The North Sound houses sea grass beds, sand, sand with coral heads, and patch reef ecosystems. Additionally there are tourist destinations including Stingray City and the Sandbar (Post, et al,1992a).

Figure 1.8. One mile radius surrounding GTLF. Orange outer circle indicates the 1 mile radius surrounding GTLF. Yellow inner circle indicates 1 km radius. GTLF is outlined in red. The North Sound (right) and Seven Mile Beach (left) are approximately 1 km from the GTLF. Note the mangrove forest surrounding the GTLF. (Source: Terry- Swaby, 2014).

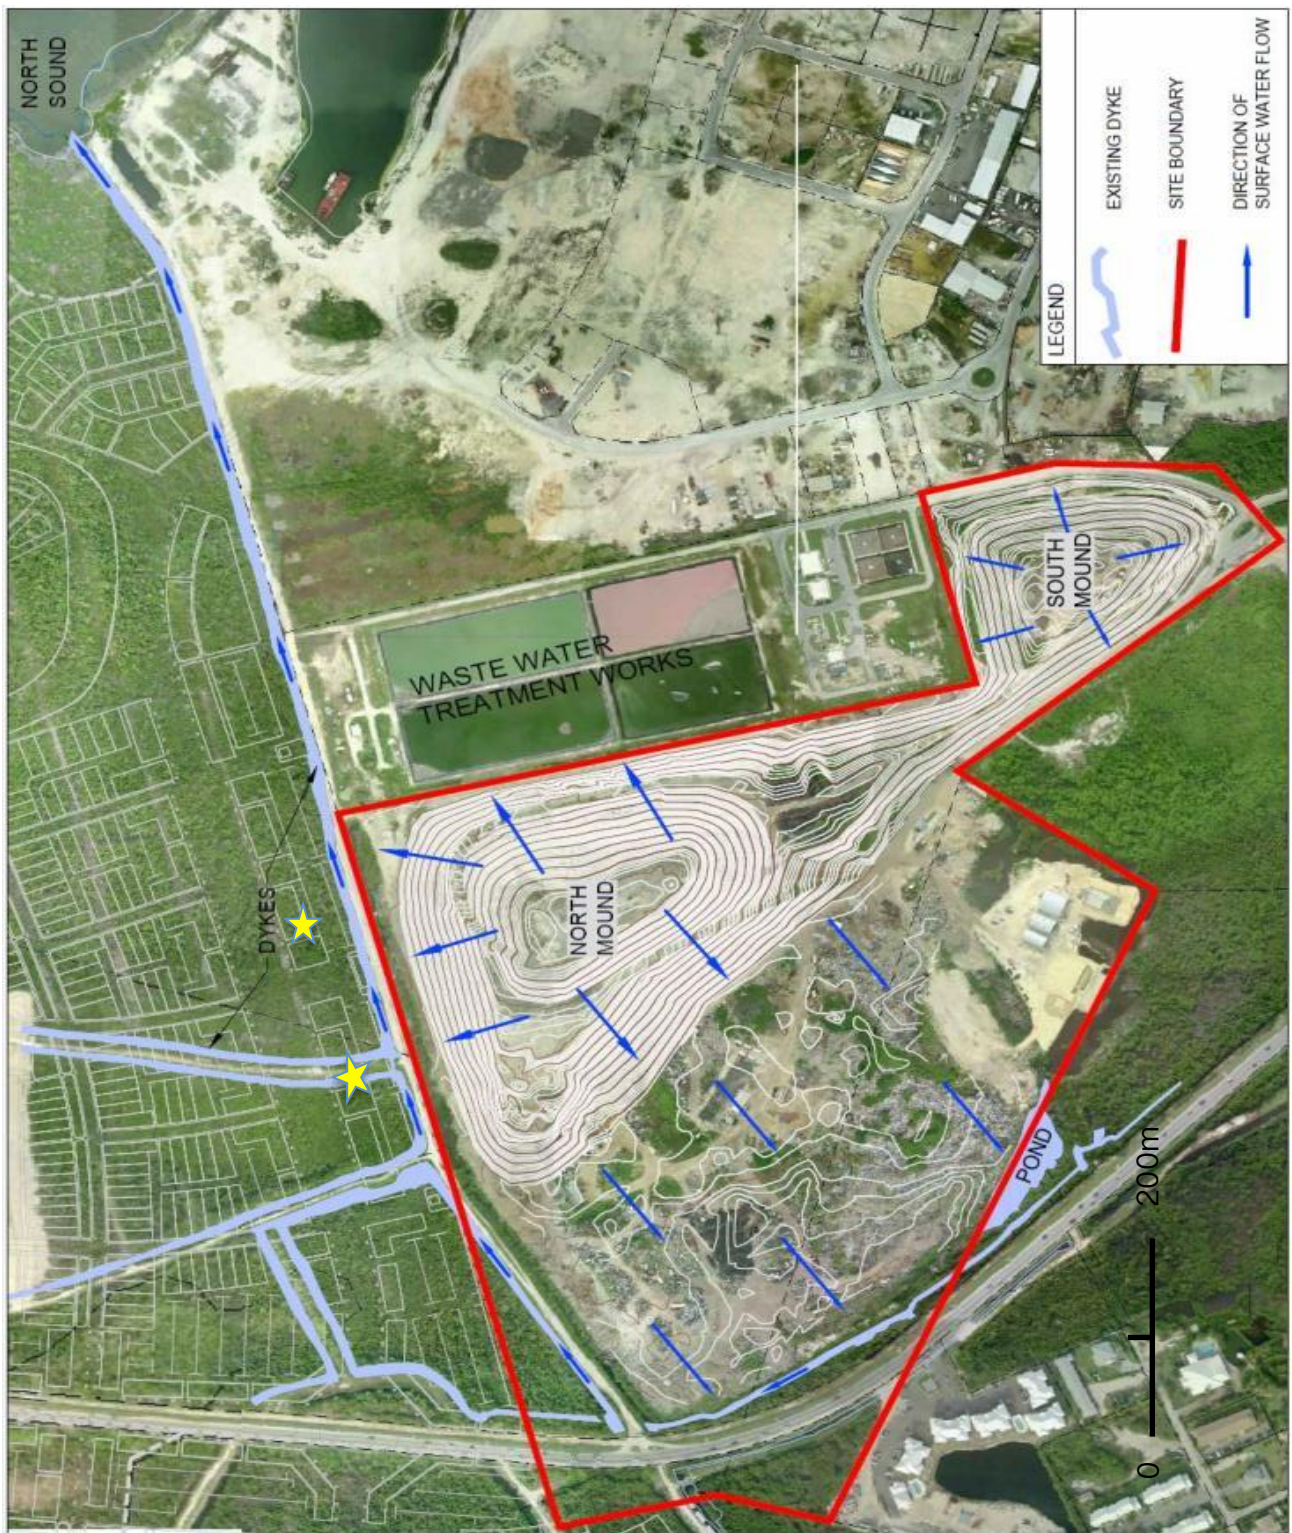
As the GTLF is surrounded by mangrove wetlands, and canals. Surface run off is a major concern for contamination as there are several pathways for contaminant migration into the North Sound. Figure 1.9 shows the direction of surface water runoff, and the canals that are connected to the North Sound (CardnoENTRIX, 2013). I personally observed the GTLF after a heavy rain and saw an increase in surface water runoff. The surface water was flowing into the nearby canals and dikes, which were openly connected into the North Sound, figure 1.10

Figure 1.9. Areal view of GTLF showing direction of surface run off and canals. Figure shows the direction of surface water run off into the canals and dikes surrounding the GTLF. Blue arrows indicate direction of surface water flow. Light blue outlines water ways, and red is the boundary of the GTLF. Note the canal on the northern boundary that provides a direct link to the North Sound. Stars shows where figure 1.11 next page, was taken. (Source CardnoENTRIX, 2013).

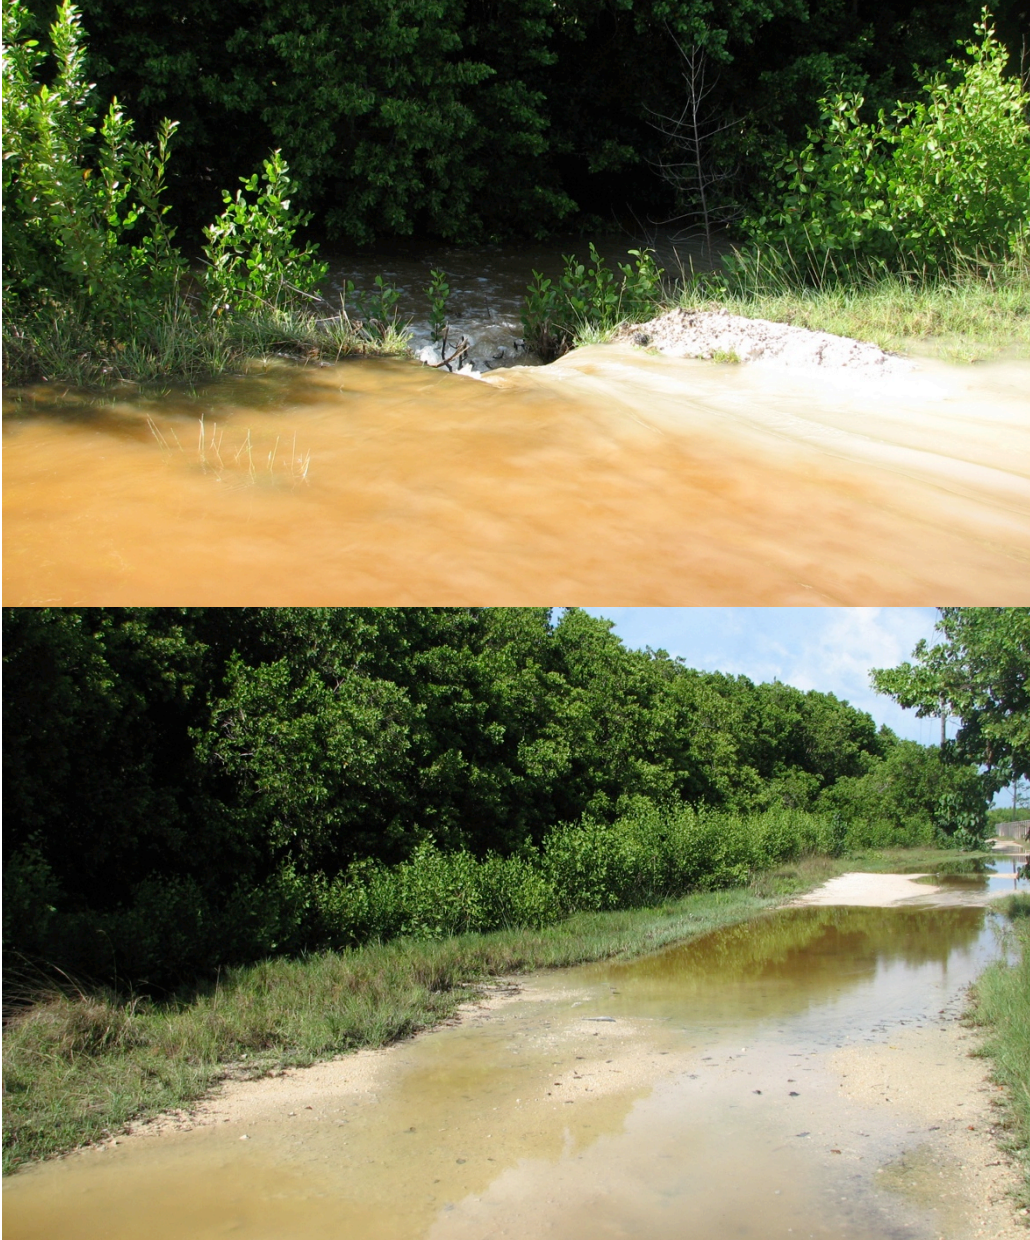
Figure 1.10. Surface water after rain event. Images show surface water on a road near GTLF after a rain event. Image on top shows surface water flowing into a tidal canal connected to North Sound. Image on bottom shows standing water. Images were taken where stars are on Figure 1.10 previous page; top image is the left star, bottom image is right star. (Personal Collection)

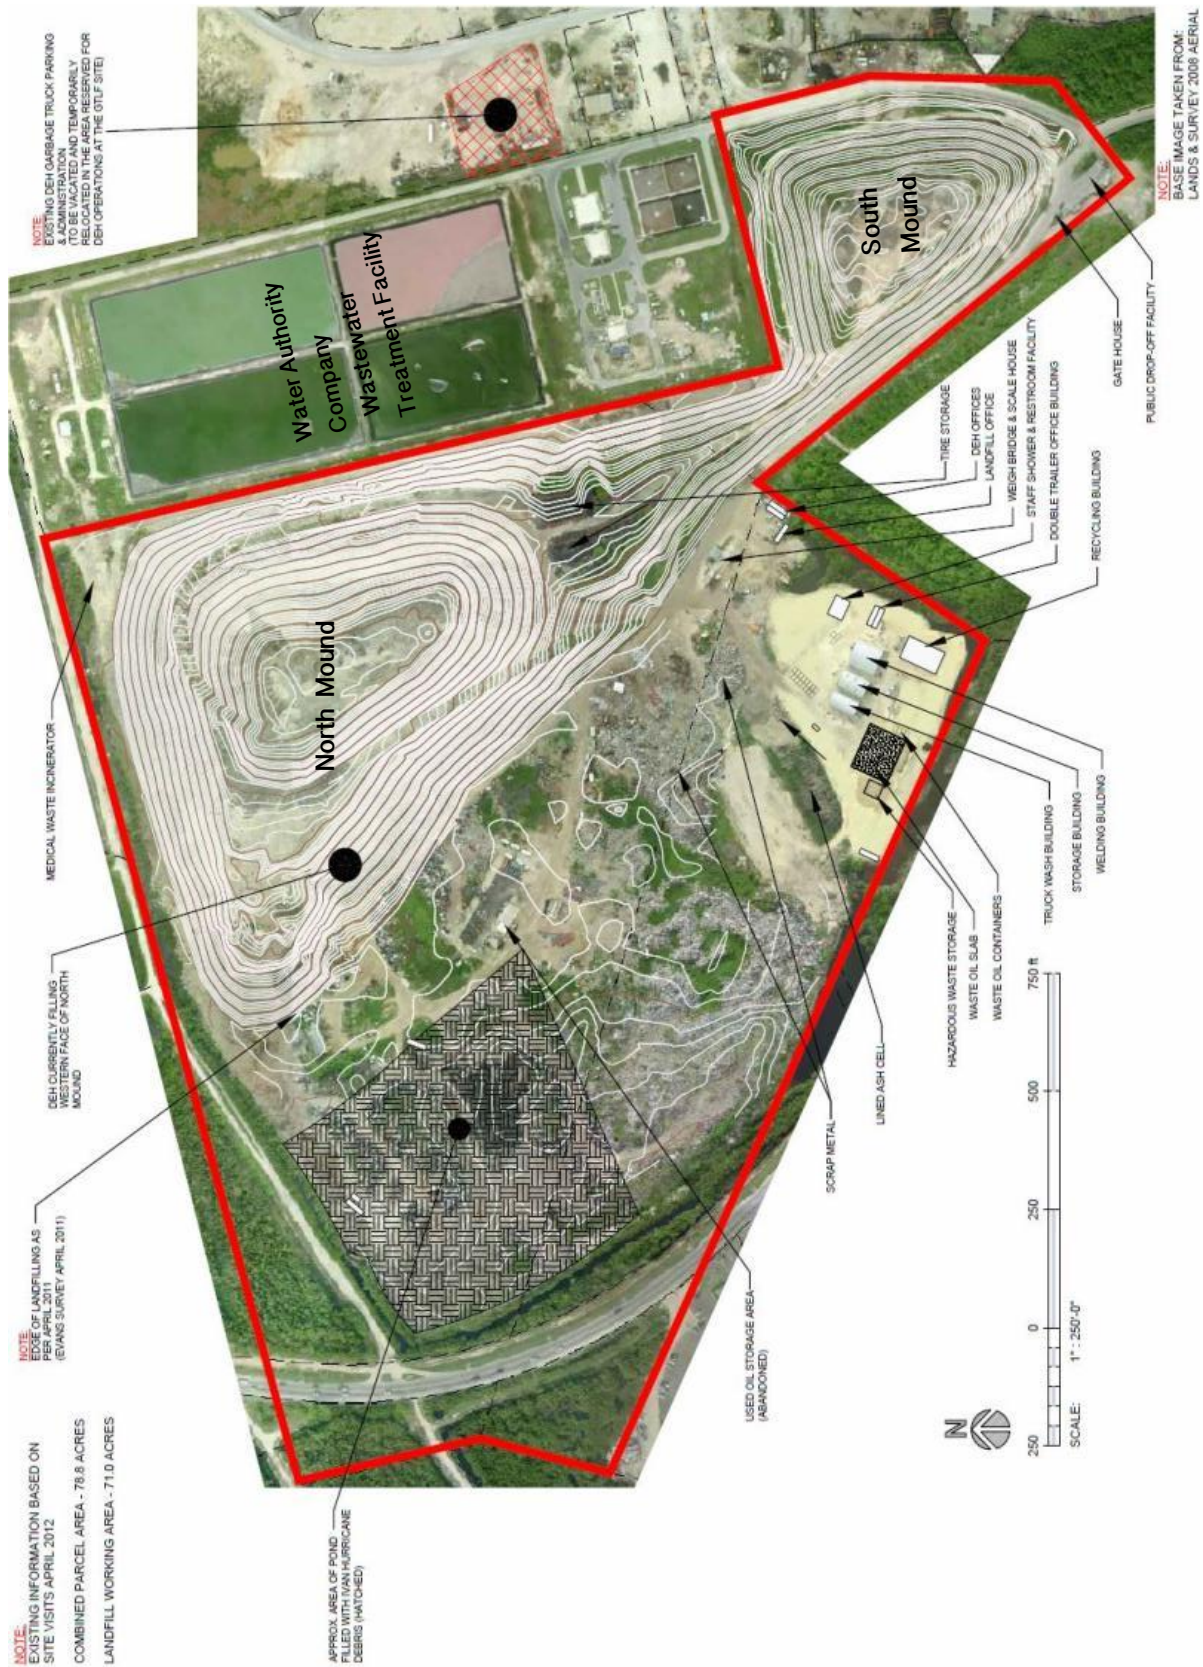
The GTLF is in violation of US and UK landfill regulations, and would be closed if in those countries. Basic landfill operations in UK and US require a liner, leachate collection, storm water management system, and an impermeable cover to capture landfill gas, none of which the GTLF have (CardnoENTRIX, 2013; Tammemagi, 1999; Williams, 2005).

Figure 1.11. Operational schematic of GTLF. Image shows the operational design of the GTLF, and lists the current North Mound, old South Mound, and other organizational features such as waste oil containers (Source: CardnoENTRIX, 2013).

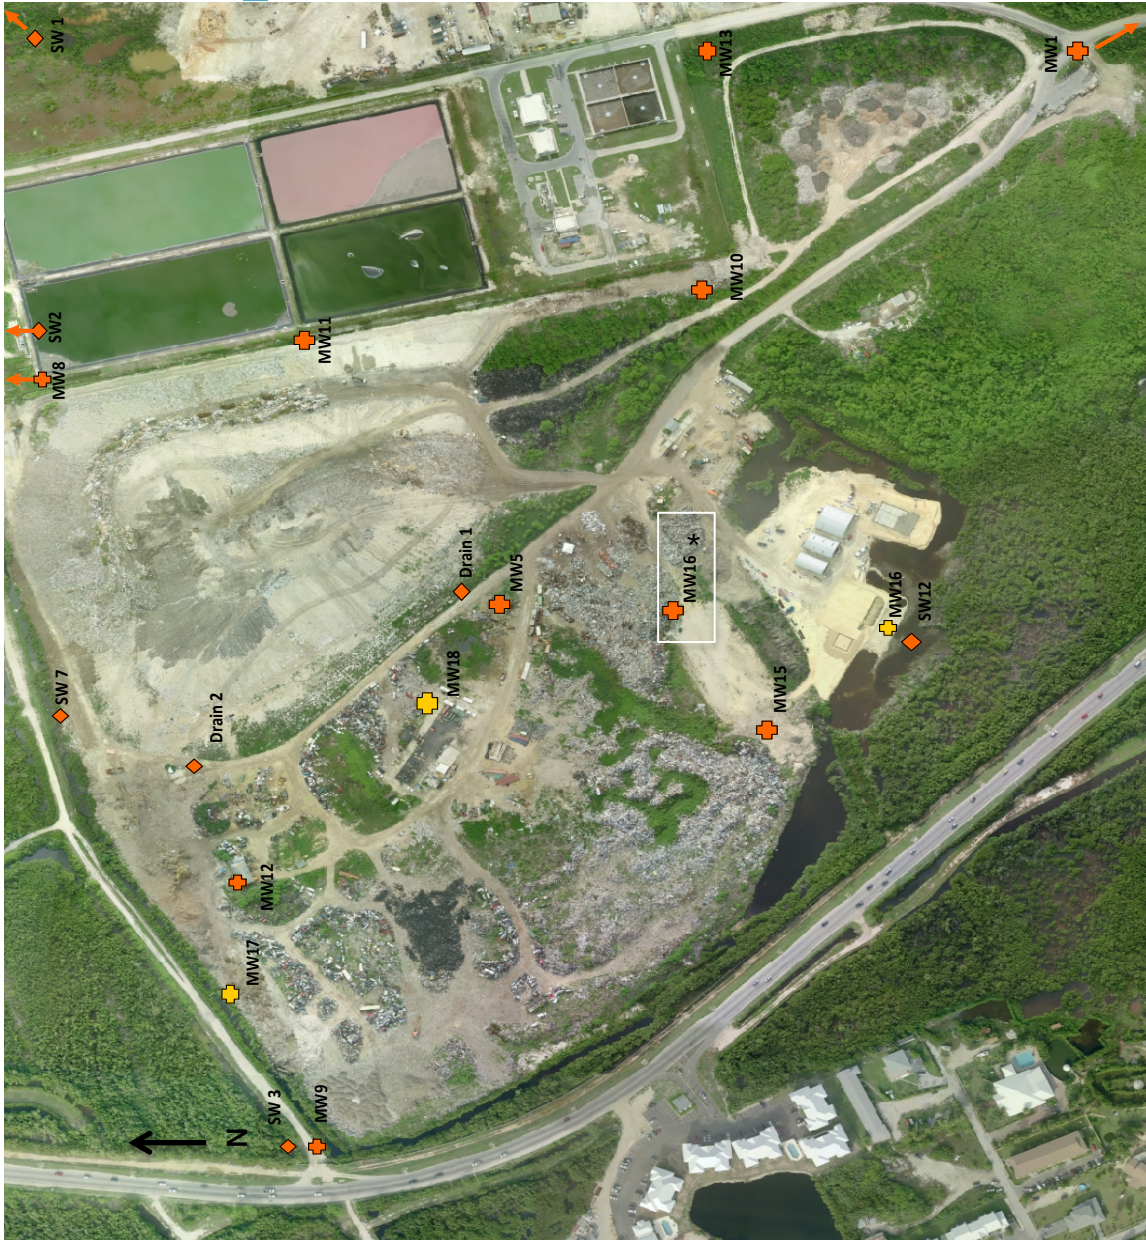
Figure 2.1. Map of DEH's GTLF monitoring sites. Figure shows map of monitoring sites used by DEH for water quality testing at GTLF. Surface water is analyzed at SW sites [surface water]. Groundwater is analyzed at MW sites [monitoring well]. Note that *MW16, should say MW14. (Source: Johnson, 2014).

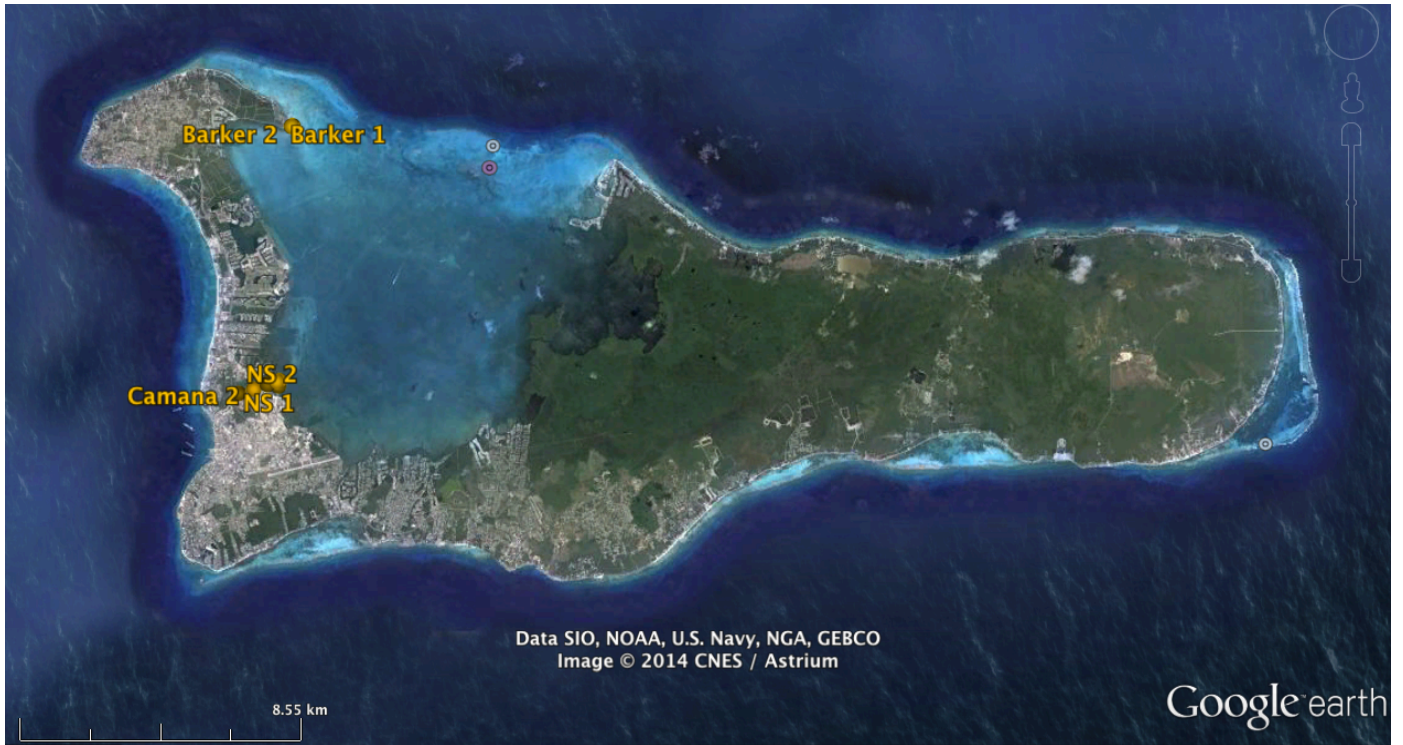
Figure 2.2. Map of tissue sample collection sites. Tissue samples collected at Barkers serve as a baseline. All other tissue samples: NS, GTLF and Camana, were collected from the GTLF to test for contamination, shown in more detail in Figures 2.3. and 2.4 (Google Earth, 2014.)

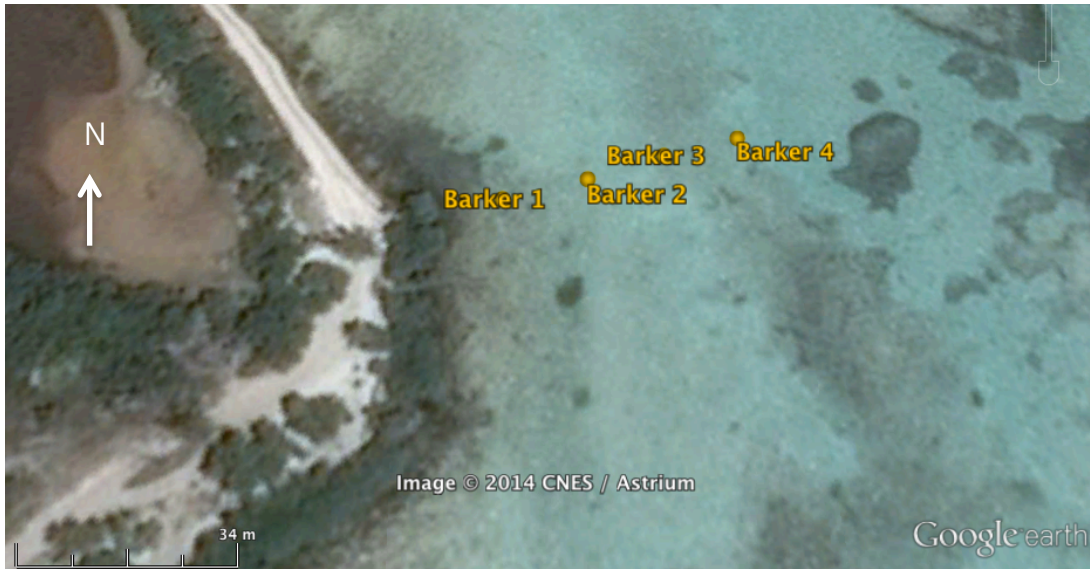
Figure 2.3. Barkers Beach baseline tissue sample collection sites. Image shows where the Barkers Beach samples were collected. Samples taken from Barkers were used for baseline levels. (Google Earth, 2014).

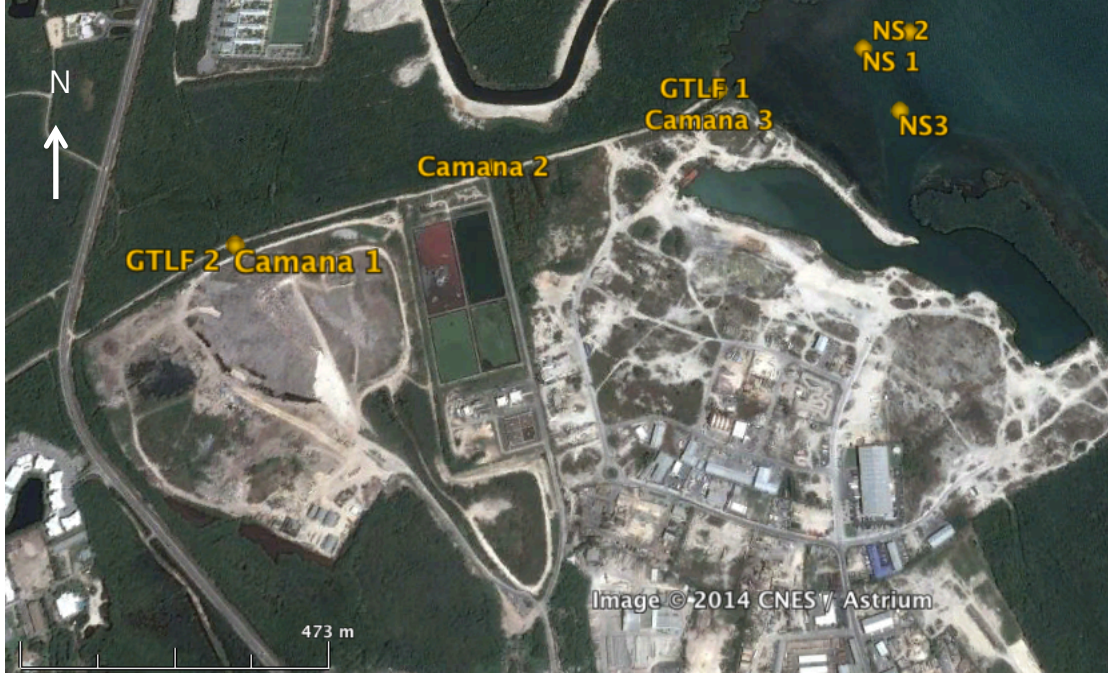
Figure 2.4. GTLF tissue sample collection sites. Image shows where tissue samples were collected for GTLF contamination analysis. Note that “Camana” sites were tested to the north of the canal, and “GTLF” sites were tested on the south of the canal (Source Google Earth, 2014).

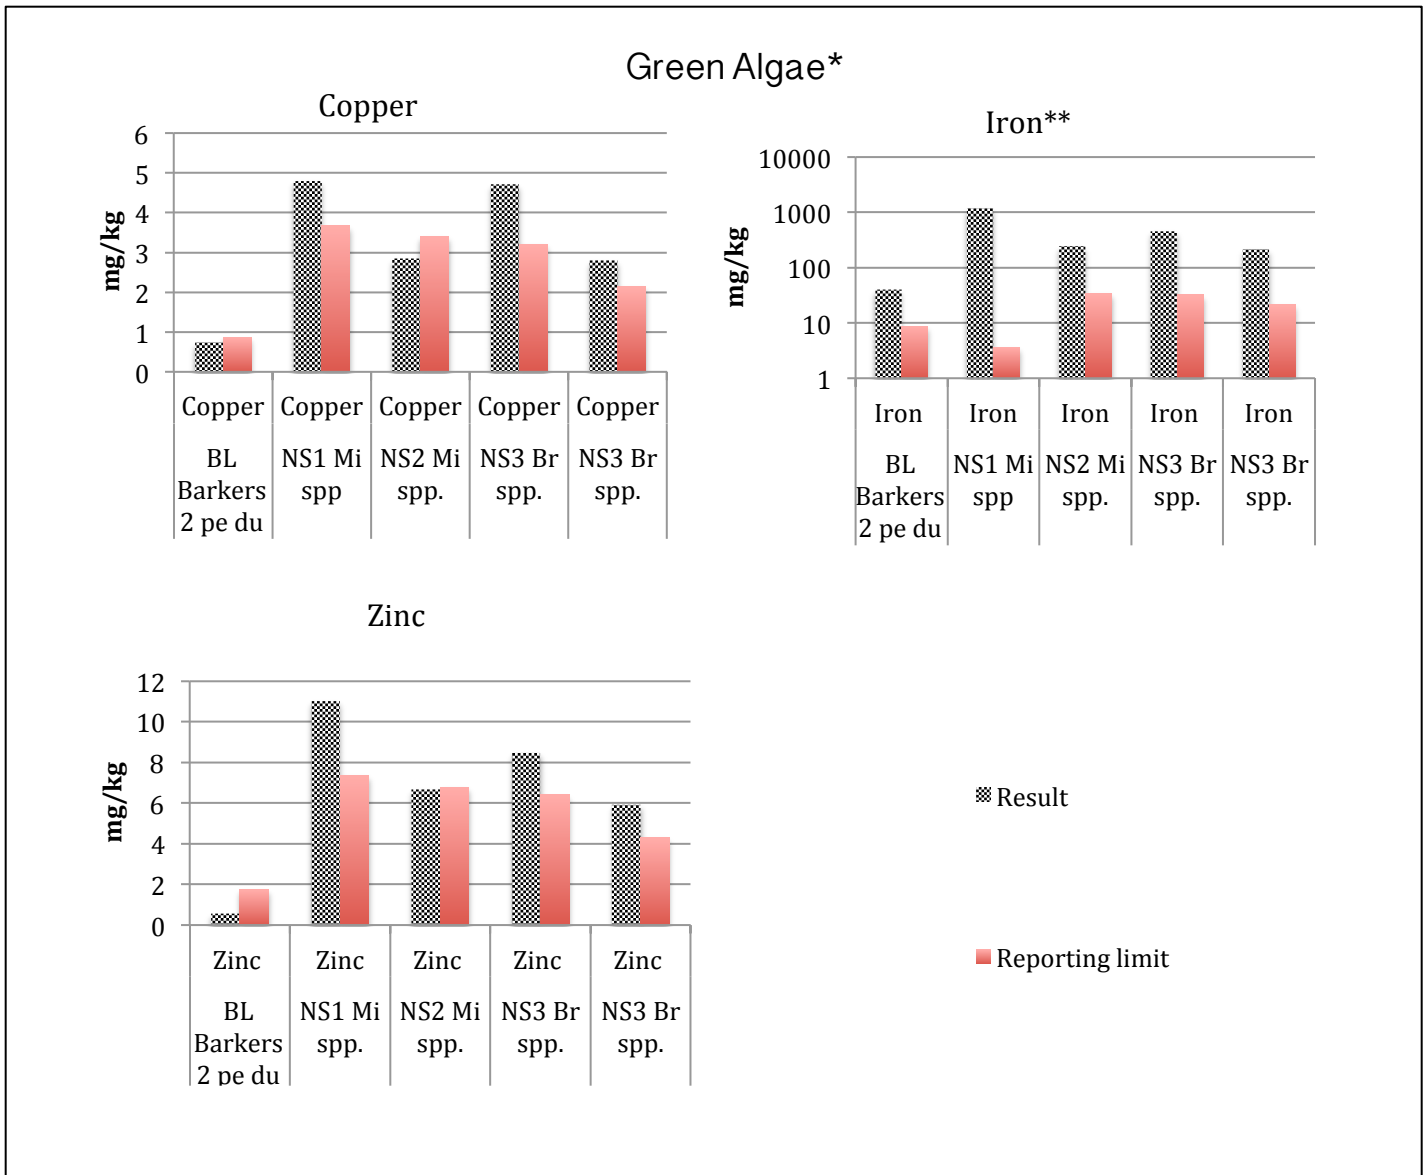
*Green Algae: three different species of green algae were tested: Microdictyon spp.= Mi spp., Penicillus dumetosus= pe du., and Bryopsis spp.= Br spp.

Figure 2.5. Results for Green Algae tissue analysis. Copper, iron and zinc GTLF results are higher than baseline levels.

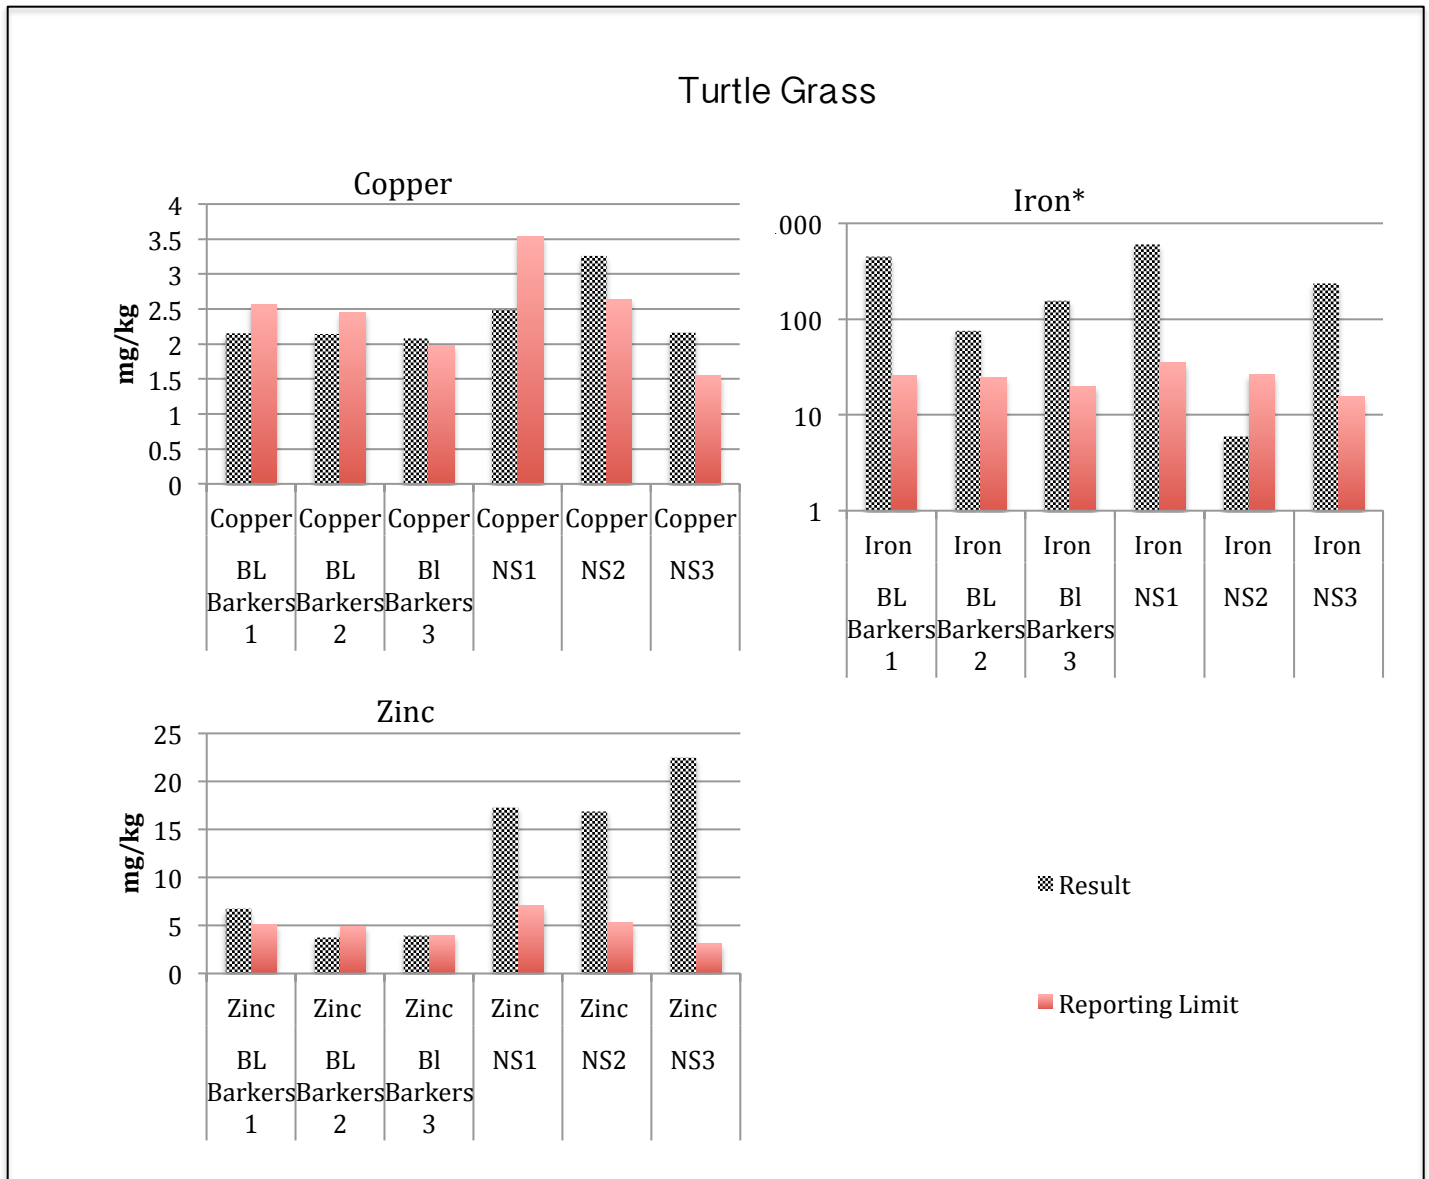
* Iron: iron is displayed on a log scale.

Figure 2.6. Results for Turtle Grass tissue analysis. Copper, iron and zinc results are higher at GTLF than baselines. Note that Iron has a high baseline value at Barkers 1 compared to Barkers 2 and 3. BL=Baseline.

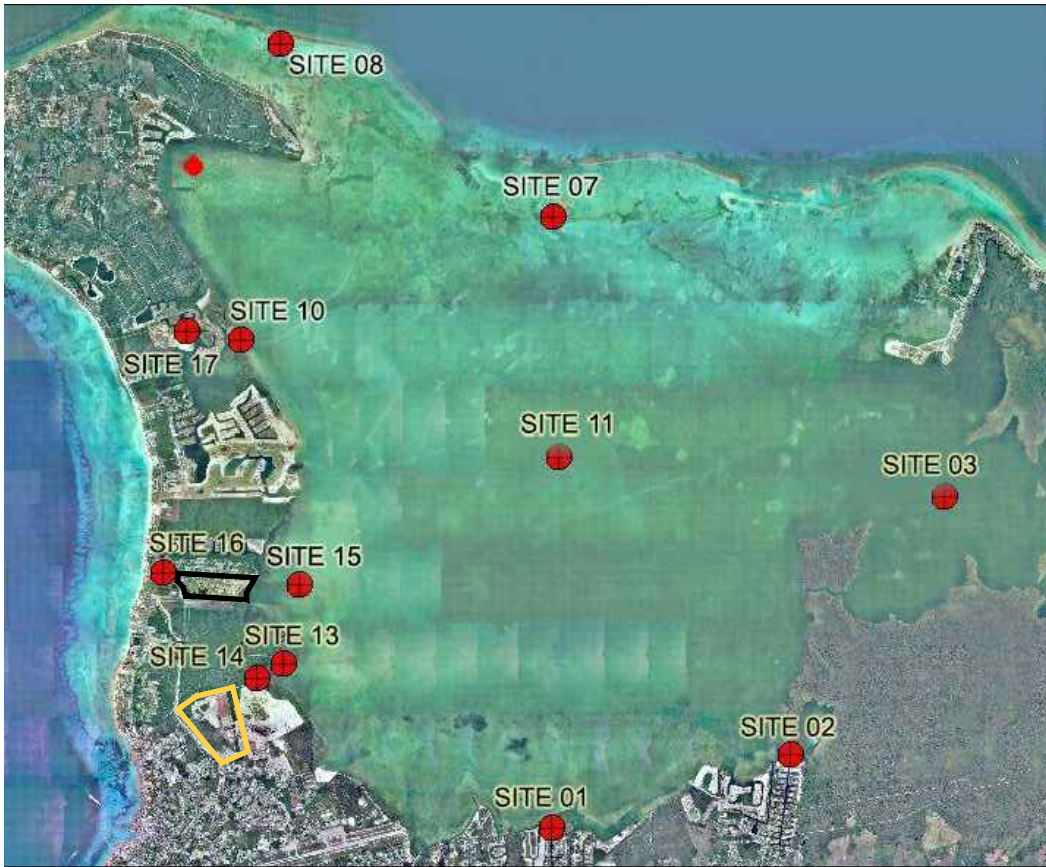
Figure 2.9. North Sound water quality test sites. Map shows DOE North Sound water quality monitoring sites (red circles). GTLF is outlined in yellow, Site 13 and 14 are used to investigate GTLF influenced water quality. Site 11 is used as a baseline as it is centrally located in the Sound. Black outlines a golf course near site 15 and 16. (Source, Source: Terry-Swaby, 2014; modified from DOE, 2013a).

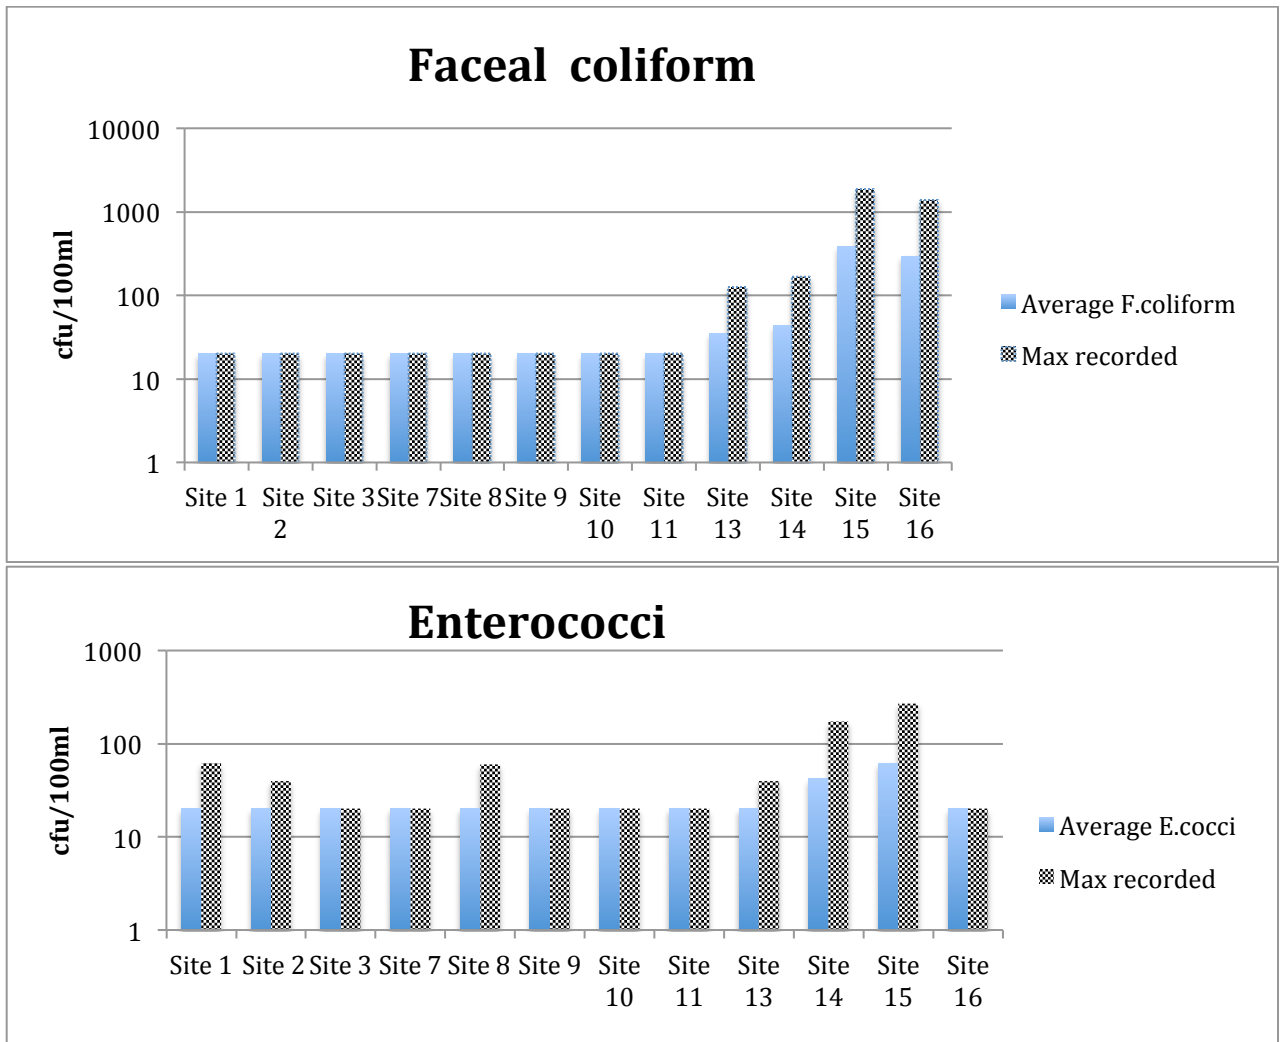
Figure 2.10. North Sound water quality bacteriological results. Figure shows bacteriological analysis for Faceal Coliform on top, and Enterococci on bottom. Sites 13 and 14 represent the GTLF. The average was calculated from five most recent data sets, and the max recorded taken from the averaged data sets. Solid blue is average, grey pattern is highest recorded. Data is displayed using a log scale.

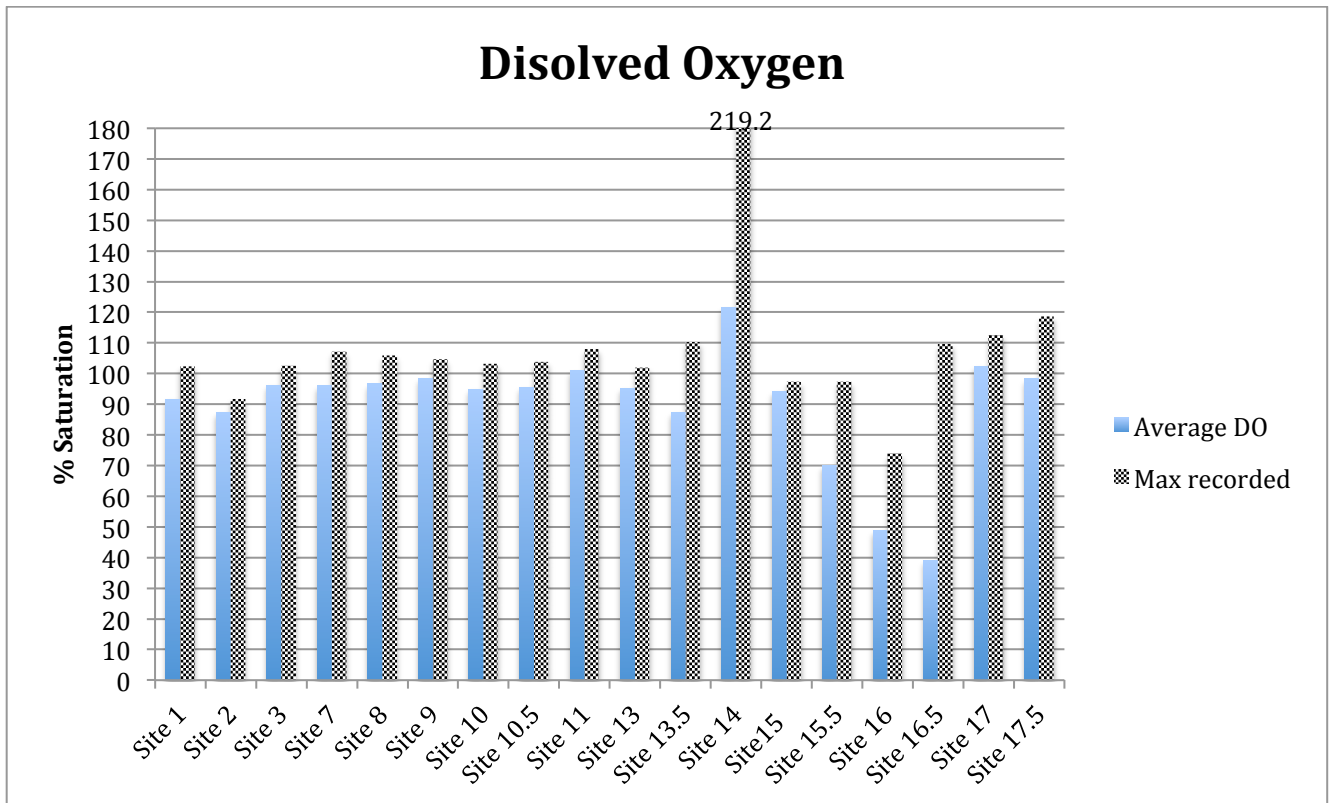
Figure 2.12. North Sound water quality dissolved oxygen results, % saturation. Graph shows average recorded dissolved oxygen and highest recorded dissolved oxygen for North Sound. The average was calculated from five most recent and complete data sets. Dissolved Oxygen % saturation is in the solid, and maximum recorded is in black and white pattern. Site 14 has the highest, oversaturated, dissolved oxygen at 122% on average and a maximum recording of 219.2%. Site 16 has the lowest at 39% on average. *Note that dissolved oxygen levels fluctuate with the time of day. Variances in readings could be related to the time samples were taken from different locations.*

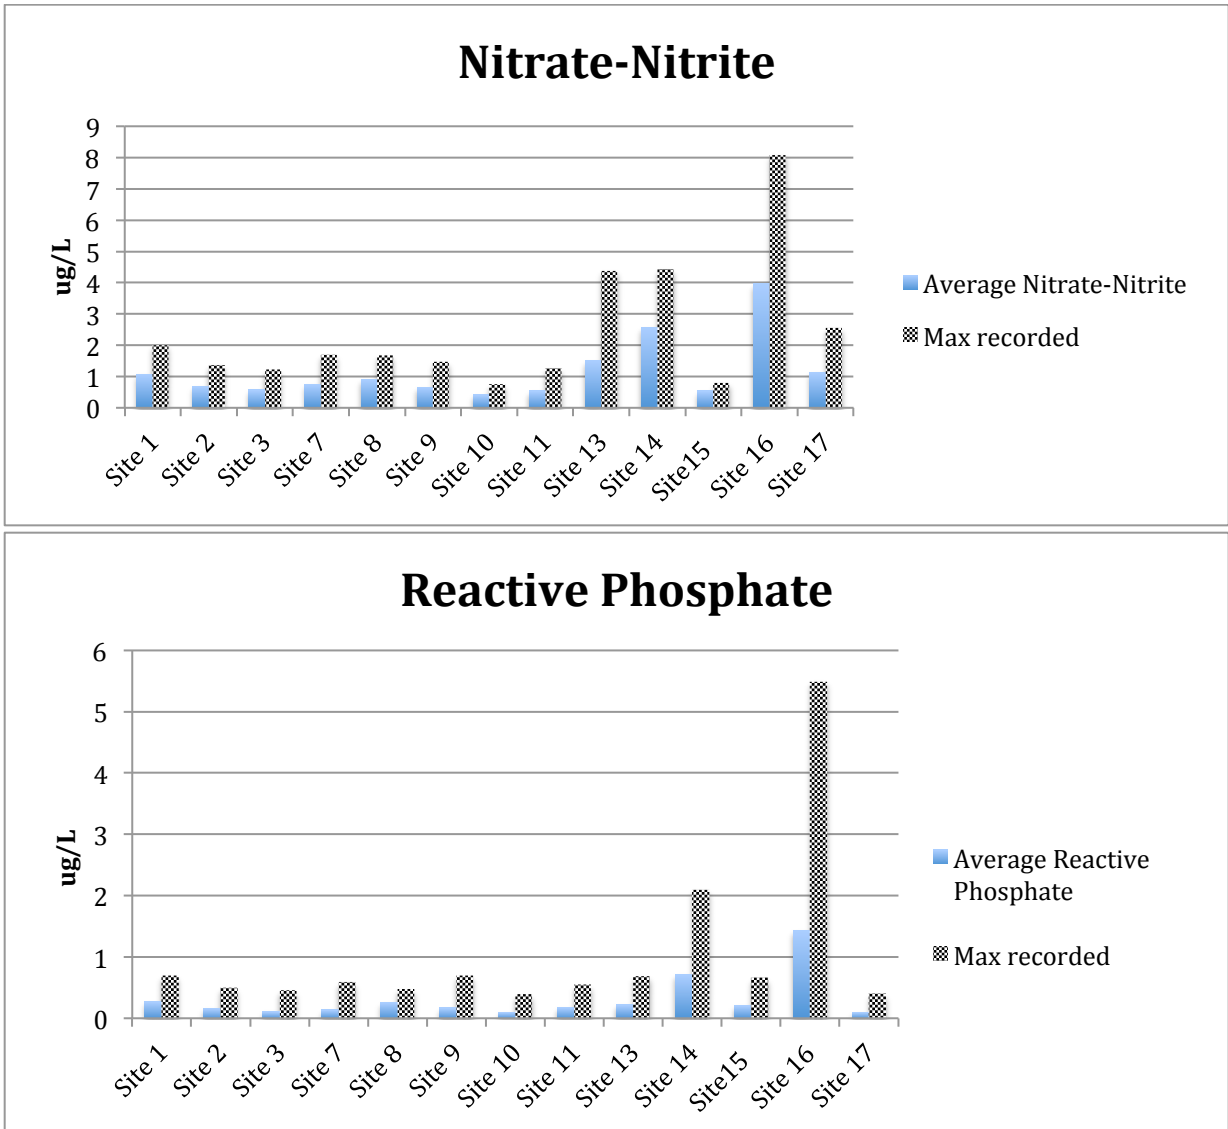
These results are also in agreement with CardnoENTRIX's report from 2013. CardnoENTRIX wrote that the water in the North Sound near GTLF had elevated chlorophyll a, total suspended solids, nitrates/nitrites, and decreased salinity levels. CardnoENTRIX hypothesized that the decreased salinity level was associated with an increase in surface water run off, an idea supported by this data (2013). CardnoENTRIX also reported an ongoing phytoplankton bloom in the North Sound, near the GTLF (2013) which positively correlates with the elevated nutrient levels seen in figure 2.14, and high suspended solids, figure 2.13

Figure 2.14. North Sound water quality nitrate-nitrite and reactive phosphate results. Figure shows averages and recorded maximums of Nitrate-Nitrite on top, and Reactive Phosphate on bottom. Averages were calculated from five most recent and complete data sets. Averages are solid and maximum recorded is in black and white pattern. Site 13 and 14 have elevated Nitrate- Nitrite levels. Site 14 also has elevated phosphates. Site 16 has exceptionally high Nitrate-Nitrites and high Phosphate results.
