Towards adaptive management of mooring systems to reduce the threats of yachting
tourism in marine protected areas.

Submitted in partial fulfillment of the requirements for the degree
of
Master of Marine Management

Dalhousie University
Halifax, Nova Scotia

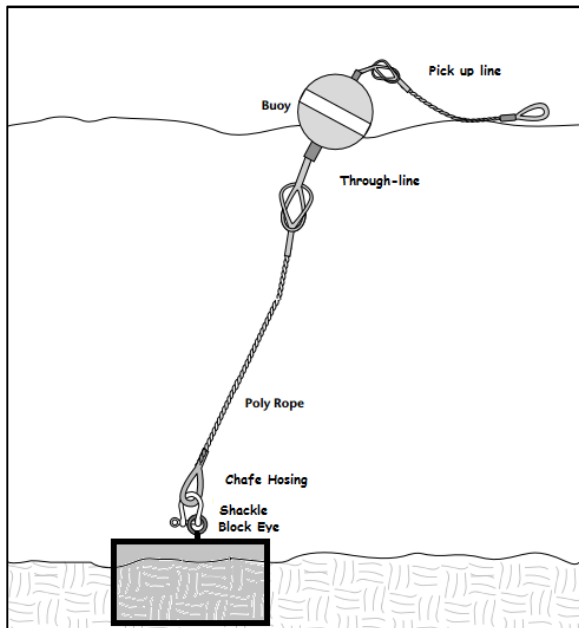
Figure 3. Typical Halas style mooring system design (Fairhead and Baldwin, 2015).

Mooring systems consist of three primary components, (1) a permanent fixture on the seafloor, (2) a floating buoy at the surface, and (3) a series of lines attaching the bottom fixture to the surface buoy (Breda and Gjerde, 1996). The Halas principle of mooring design, which involves an anchor and a three part rope and buoy system (Figure 2), is widely used in marine parks due to its simple construction methods and practical maintenance costs (Fairhead and Baldwin, 2015).

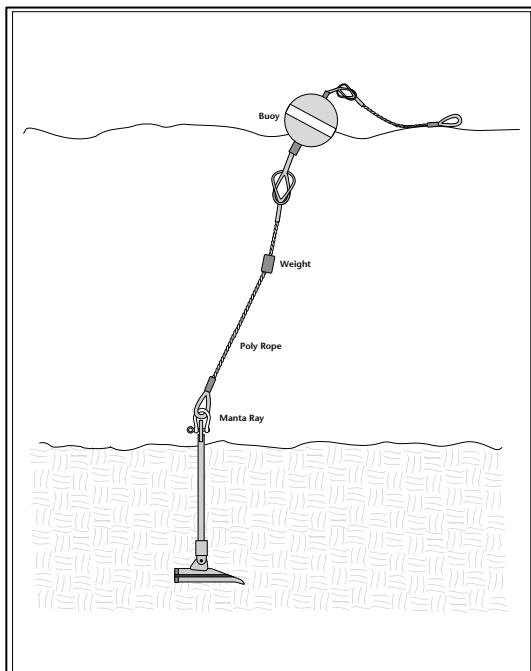
Figure 4. Manta and pin mooring system (Breda and Gjerde, 1996).

SCUBA divers then attach the down line to a thimble eye nut that is screwed to the anchor. The thimble eye nut should be welded to the anchor to keep the system from unscrewing. Manta systems can be deployed in approximately 30 minutes or less so labour costs are minimal (Breda and Gjerde, 1996). A disadvantage of this design is that once the anchor is positioned within the substrate, it can be tremendously difficult to reposition (O. Harvey. personal communication, November 11, 2016).

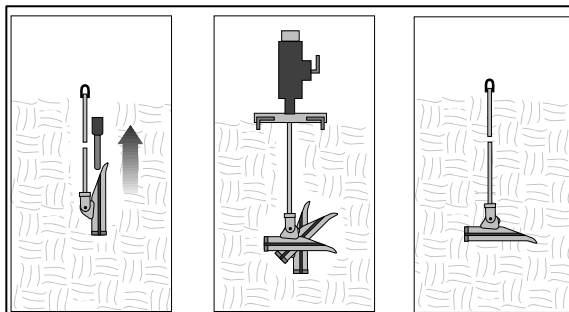
Figure 5. Manta anchor securement stages in seafloor (Breda and Gjerde, 1996).

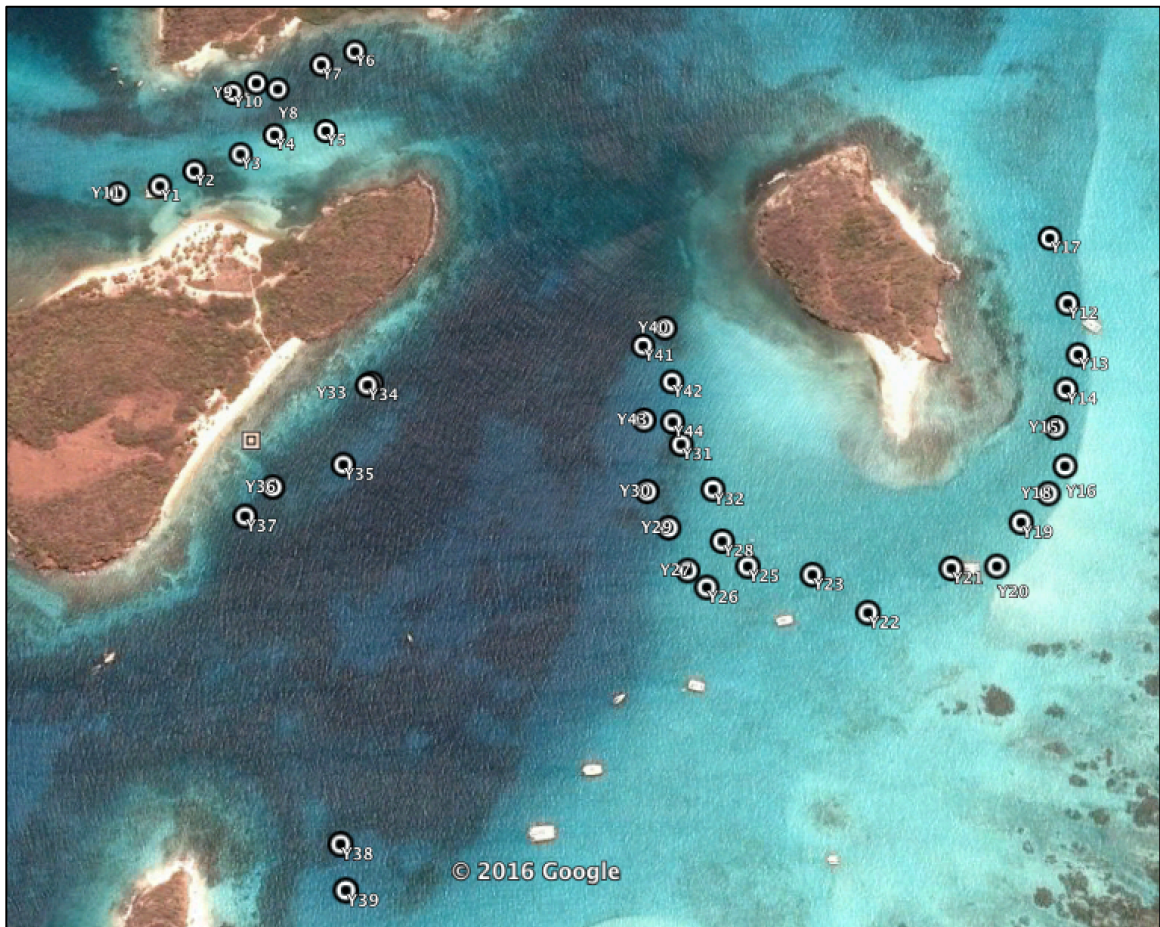
Figure 9. Map showing locations of existing yacht moorings (black and white rings) near Baradal (top right), between Petit Bateau and Petit Rameau (top left) and east of Jamesby (bottom left), RCMP (Google Earth, 2016).

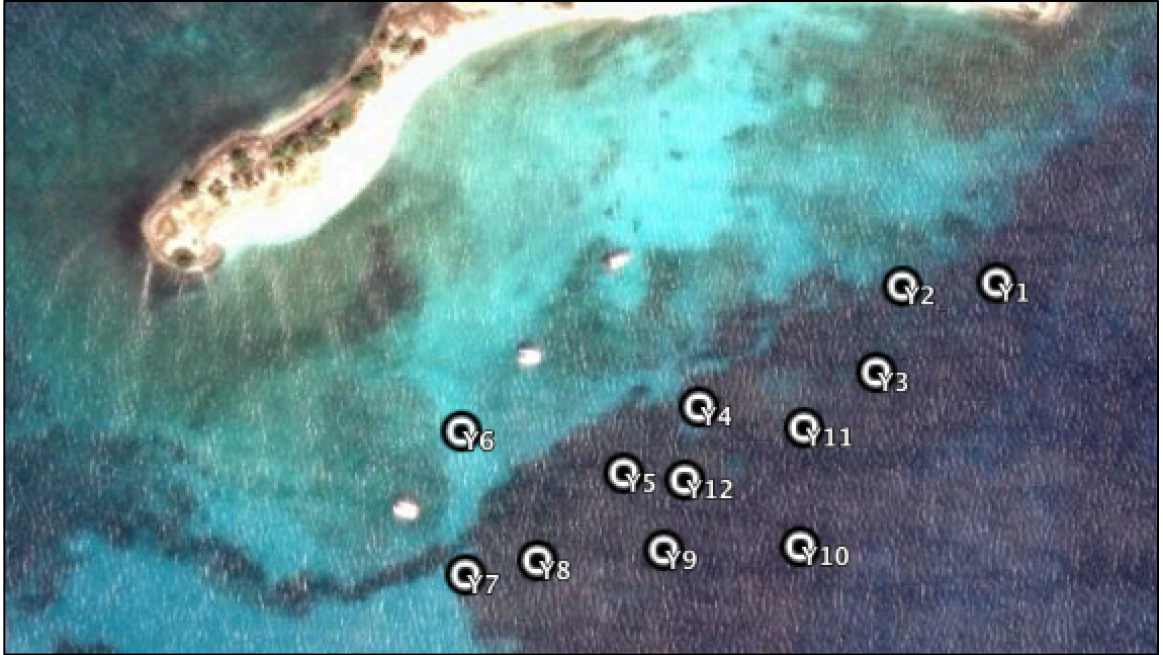
Figure 11 Current overnight yacht moorings located south of Sandy Island, SIOBMPA (Google Earth, 2016).

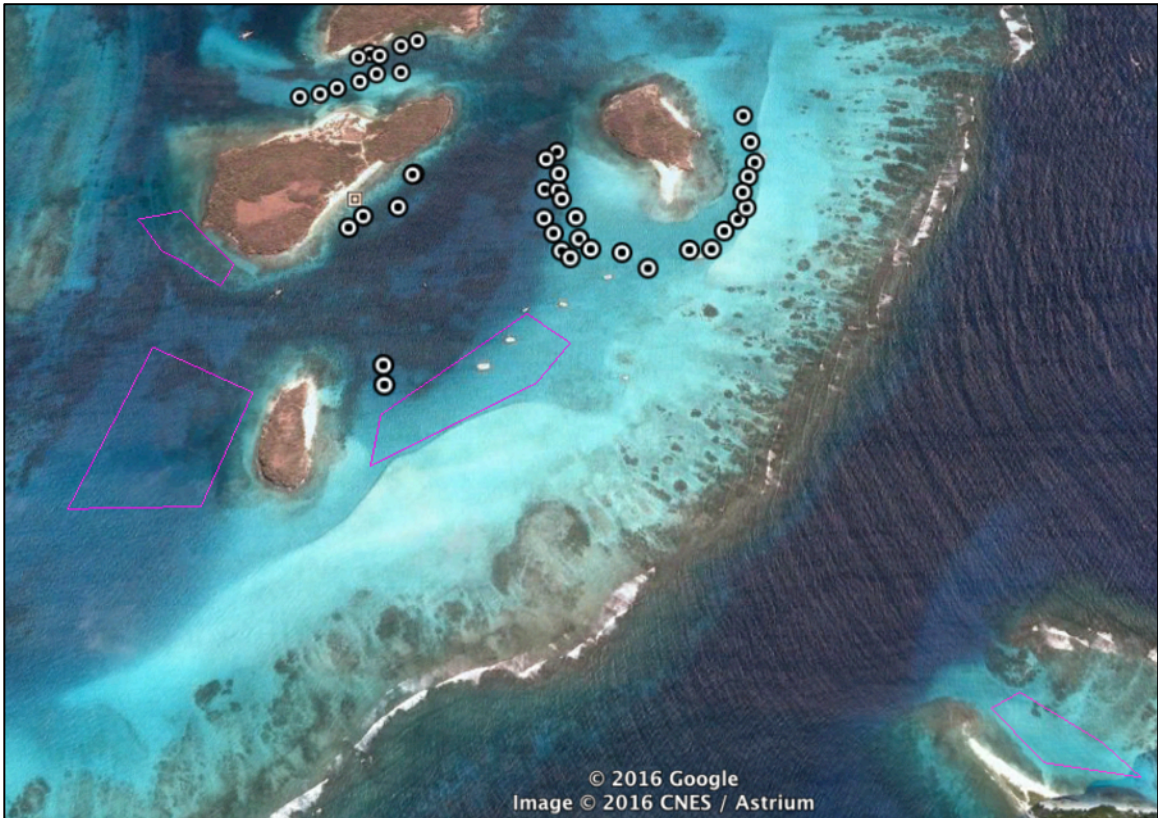
Figure 16. Zones with potential for new mooring installations (pink polygons) and current yacht mooring sites (black and white rings; GoogleEarth, 2016).

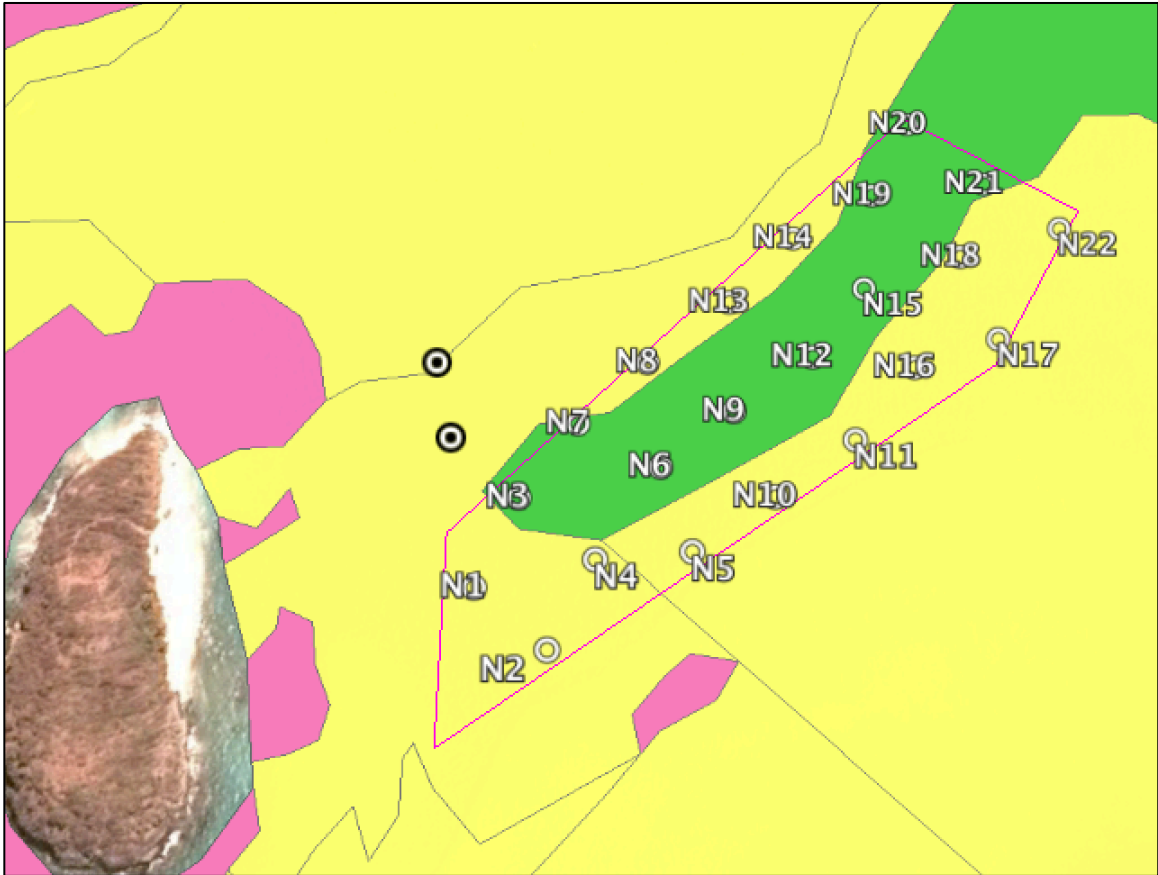
Figure 17. Map showing locations of current yacht moorings (black and white rings) and the potential sites for new yacht moorings (white rings) northeast of Jamesby, TCMF. MarSIS habitat layers show areas dominated by sand in yellow, seagrass in green and coral in pink (GoogleEarth, 2016).

Within the identified zones, twenty-two sites have been identified as potentially suitable for the addition of new yacht mooring systems. These sites do not conflict with the current mooring systems as they are a minimum of 130 feet from any existing mooring system and so can accommodate yachts up to 65 feet. Figure 19 displays their locations as well as the existing mooring systems near the cays (See Appendix A for a summary of the recommended mooring sites' features).

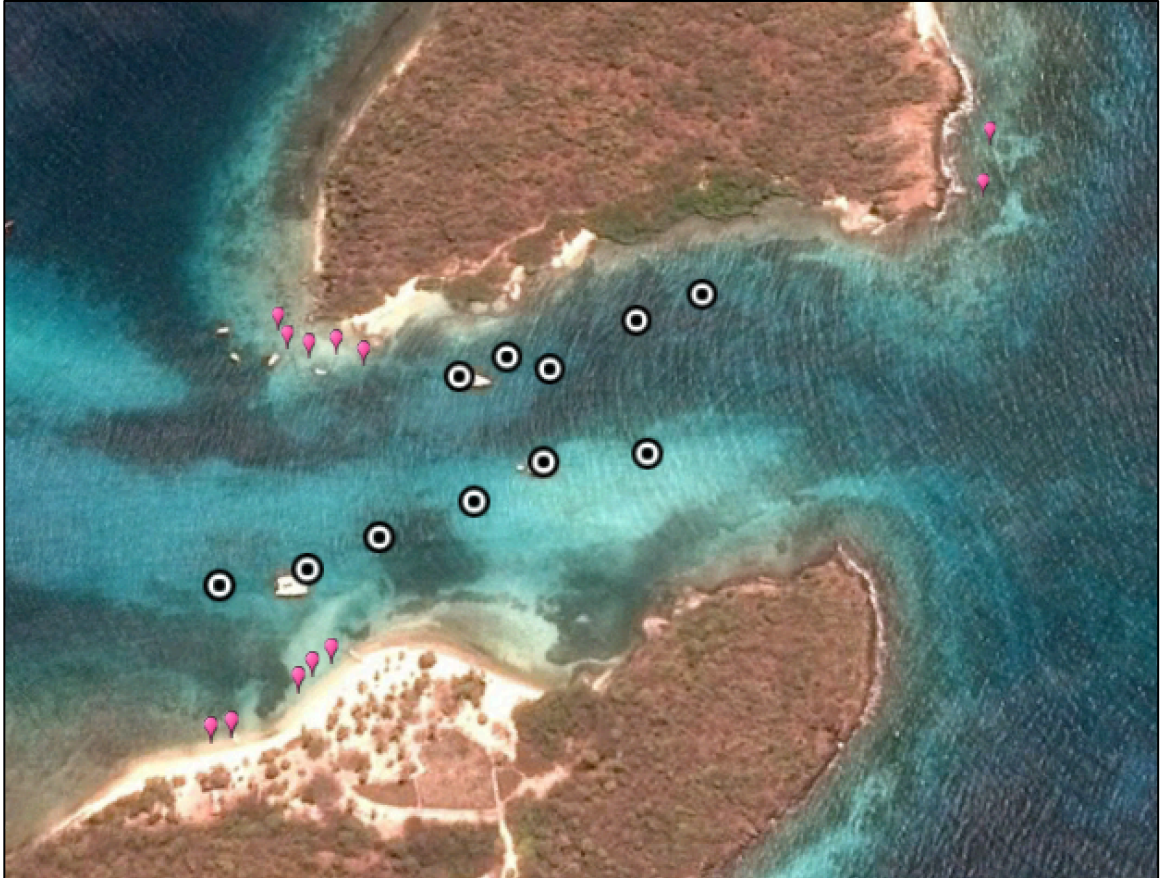
Figure 18. Map showing current yacht moorings (black and white rings) and sites for small boat moorings near beaches of Petit Bateau and Petit Rameau (Google Earth, 2016).

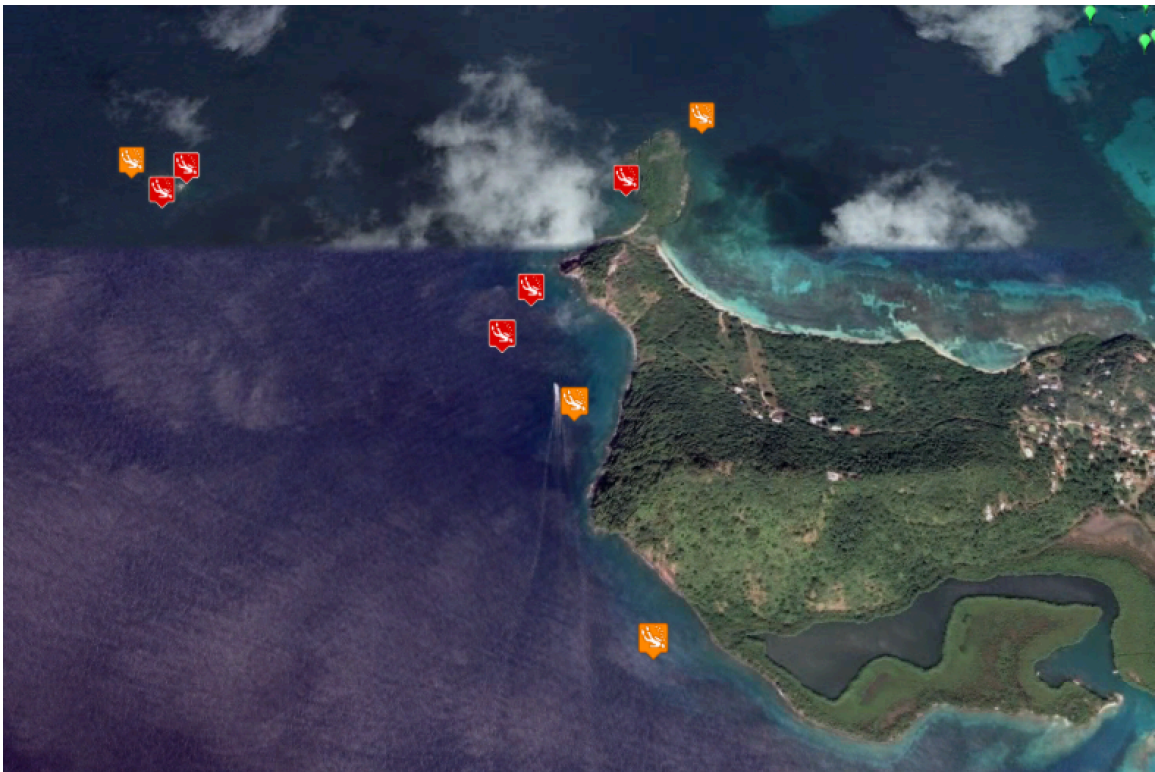
Figure 22. Map showing current dive mooring sites (red flags) and dive sites requiring mooring systems (orange) near Sister Rocks (top left) and around Cistern Point, SIOBMPA (Google Earth, 2016).

Dive mooring GPS coordinates were provided by Richard of Lumba Dive. Red dive flags indicate current moorings, while the orange dive flags indicate sites requiring dive moorings (Figure 23, 24). The current anchorage zone is the area within the green placemarkers shown in Figure 23. This sandy area is where boats anchor that exceed the size limit of the mooring systems.

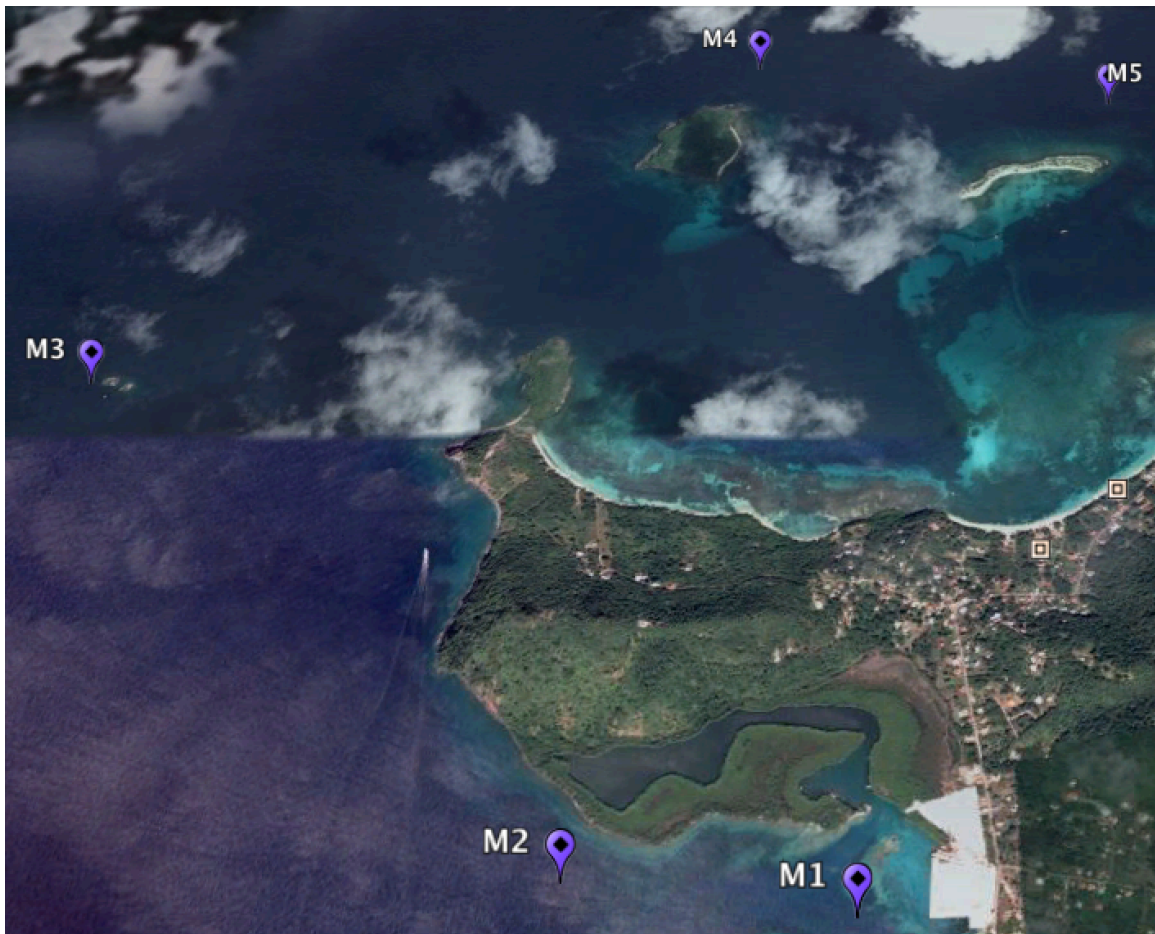
Figure 23. Map of SIOBMPA with suggested boundary demarcation mooring sites (purple flags; Google Earth, 2016).

From Lumba Dive’s records of past mooring system locations, five key sites requiring mooring systems for boundary demarcation buoys were identified (Figure 25). These sites were identified based on the record’s notes that indicated SIOBMPA staff had requested the removal of other demarcation buoys and the upkeep of the moorings at these five sites. SIOBMPA has demarcation buoys, which can be redeployed once the mooring systems have been installed at the five sites.

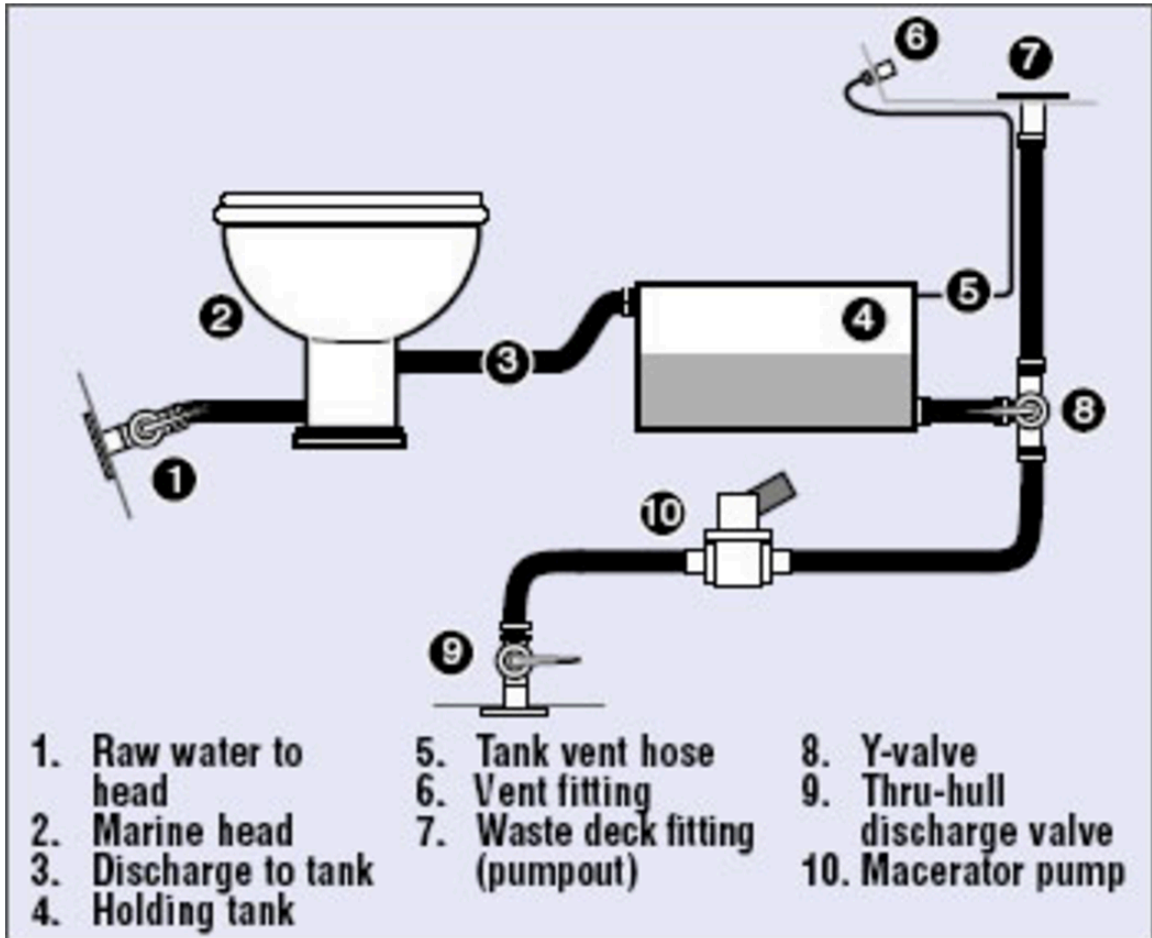
Figure 16. Diagram showing a holding tank system with multiple discharge options (Burden, 2016).

Almost all new yachts are built with holding tanks (T. Second, personal communication, July 18, 2016). Also termed ‘black water tanks’, holding tanks are storage containers that connect to toilets on yachts and other vehicles (Figure 16-18).

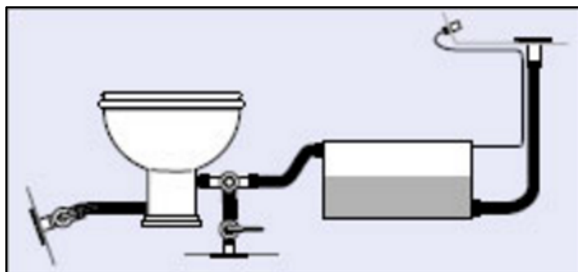
Figure 17. Holding tank with optional overboard discharge (Burden, 2016).

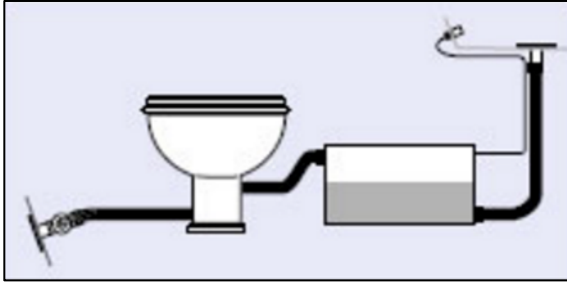
Figure 18. Holding tank without self discharge option (Burden, 2016).

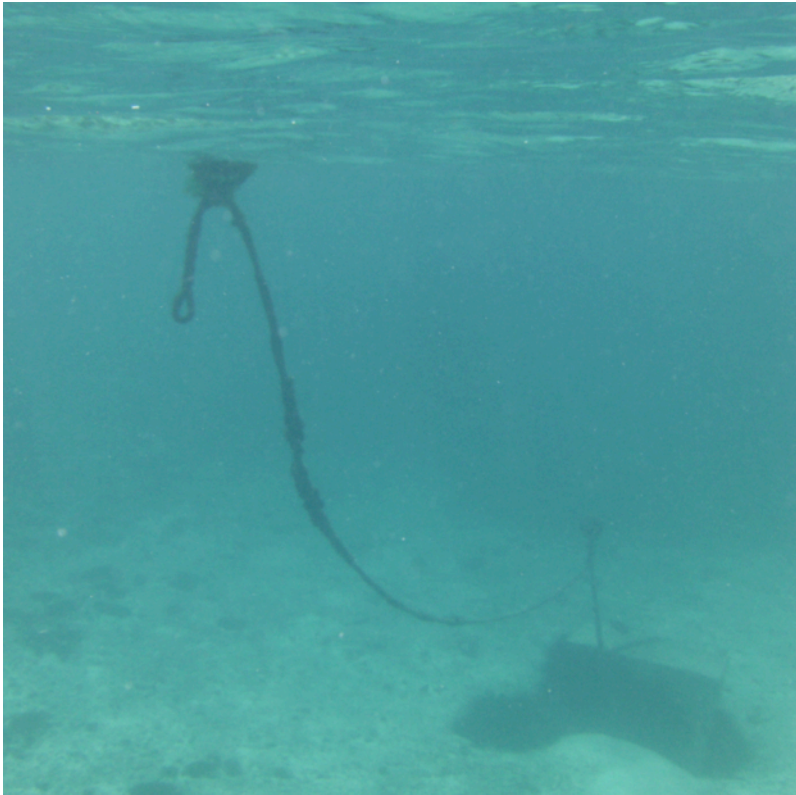
Figure 25. Image of the Halas mooring system with a pick-up line, buoy, through line, down line, float and concrete block anchor in the TCMP (Reed, 2016).

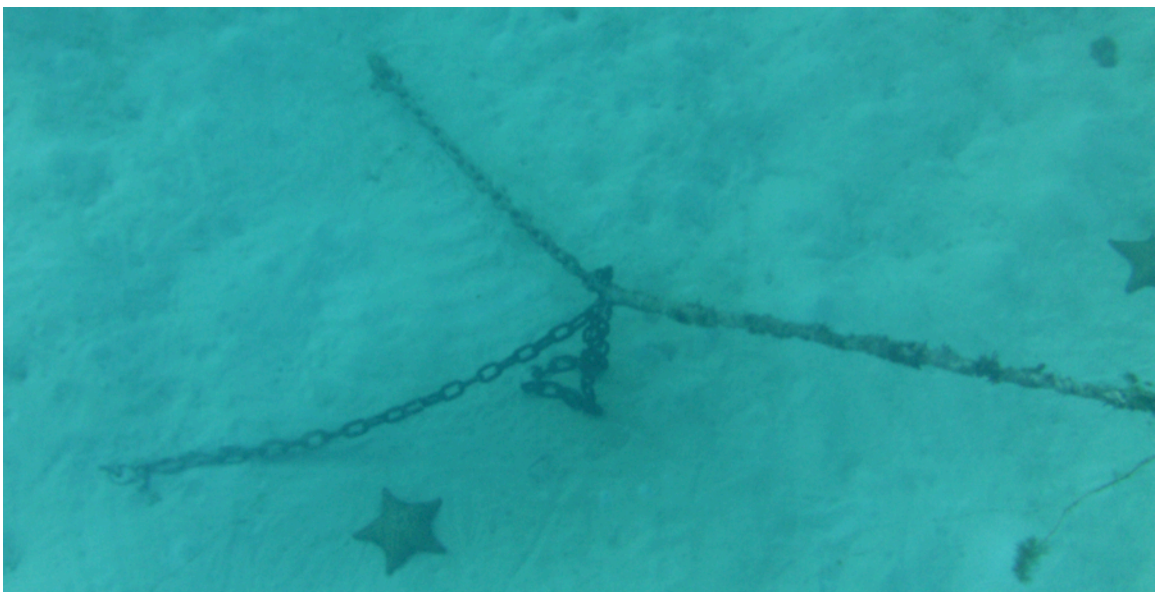
Figure 26. Image of manta and pin anchor with two pins, TCMP (Reed, 2016).

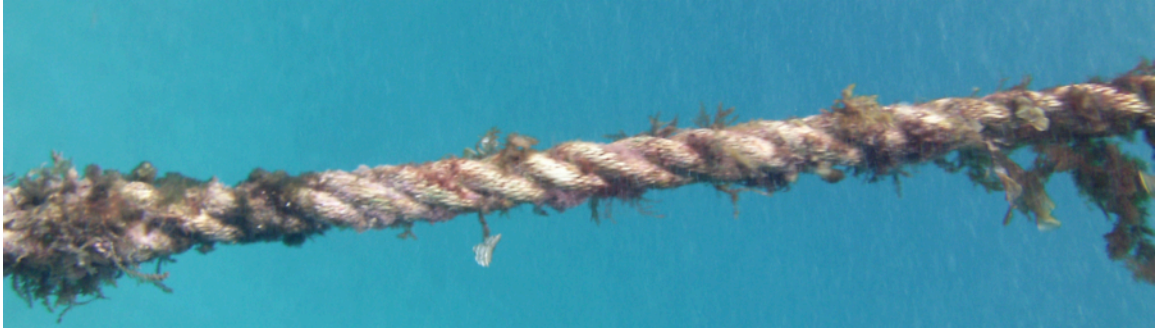
Figure 27. Image of downline with moderate fouling, TCMP (Reed, 2016).

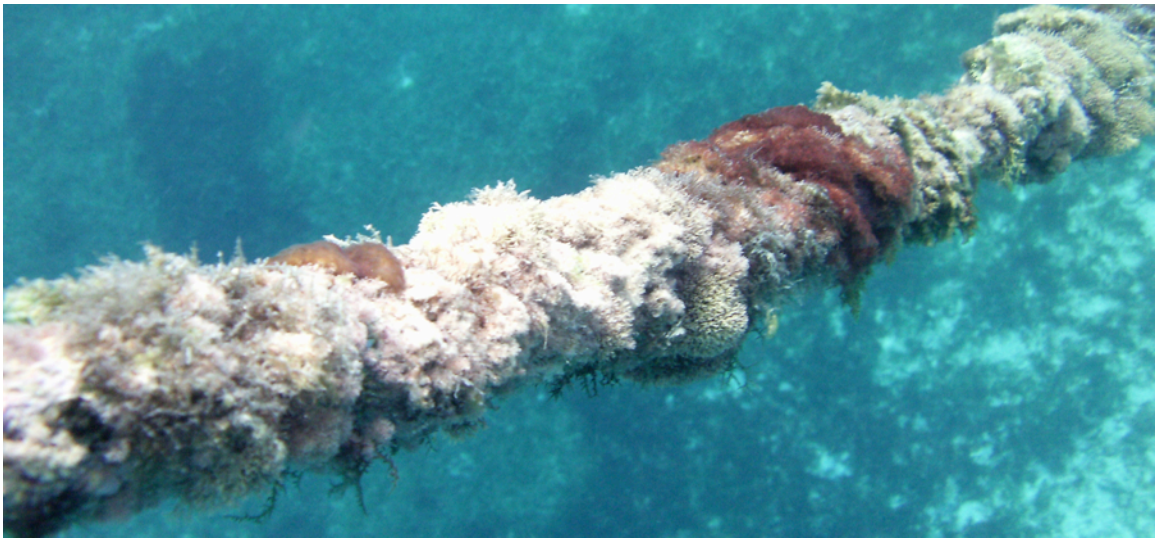
Figure 28. Image of downline with significant fouling, TCMP (Reed, 2016).

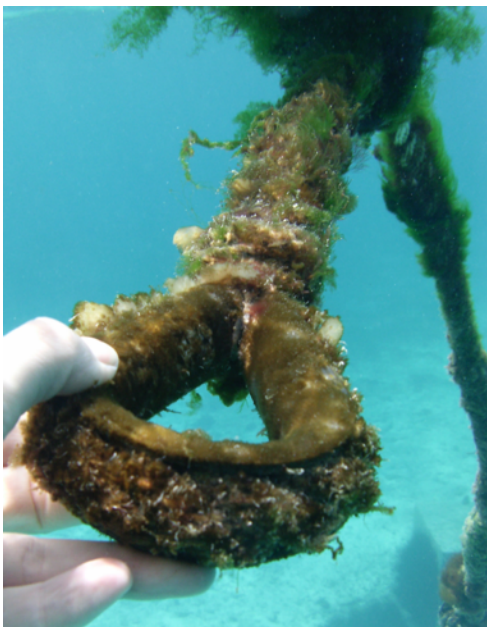
Figure 29. Image of the standard pick-up line with steel timble spliced into the looped rope to prevent abrasion, TCMP (Reed, 2016).

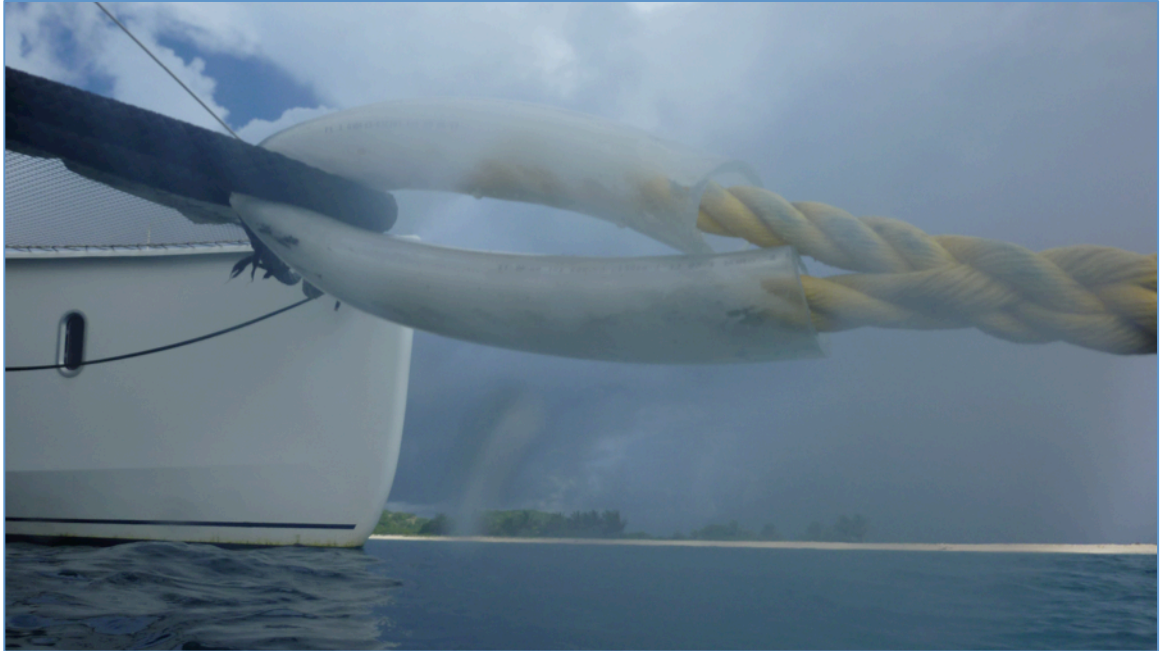
Figure 30. Image of the standard pick-up line with spliced rope loop reinforced with plastic piping to reduce abrasion from vessel lines (Reed, 2016).

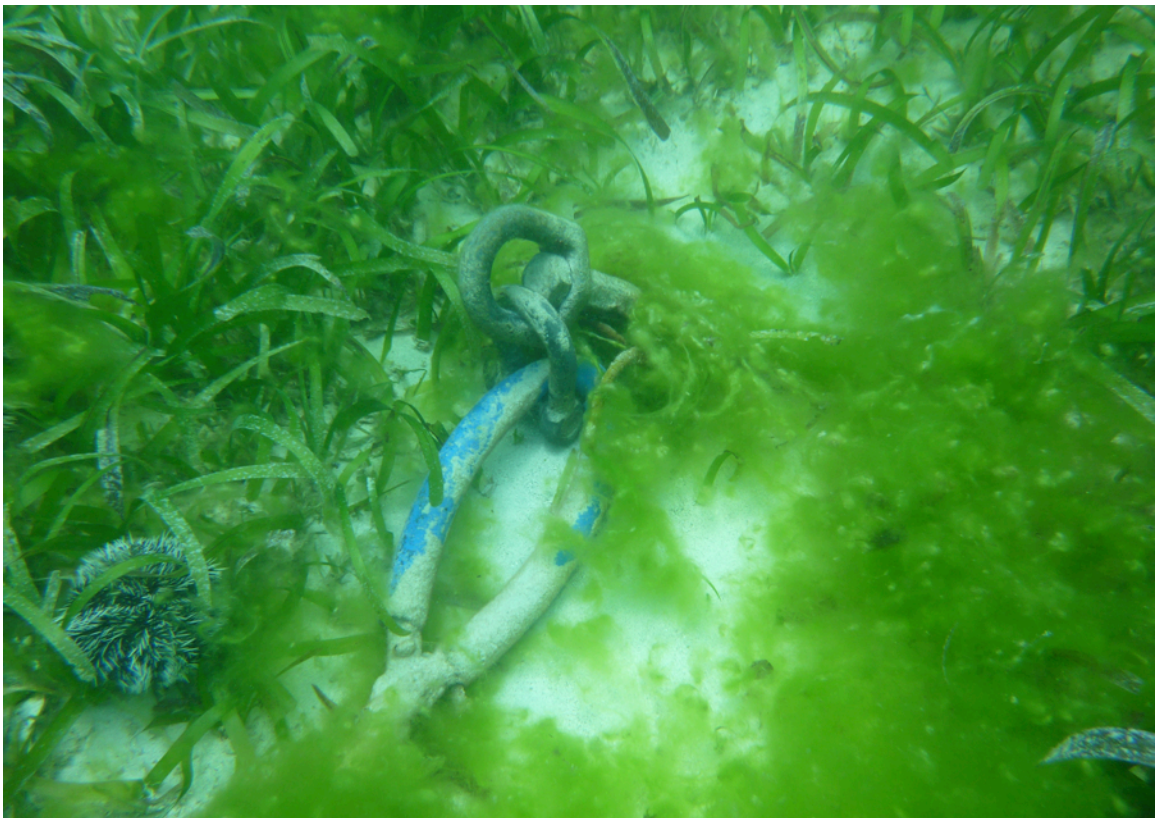
Figure 31. Image showing a single manta pin anchor with downline attached, surrounded by seagrass and green algae (Reed, 2016).

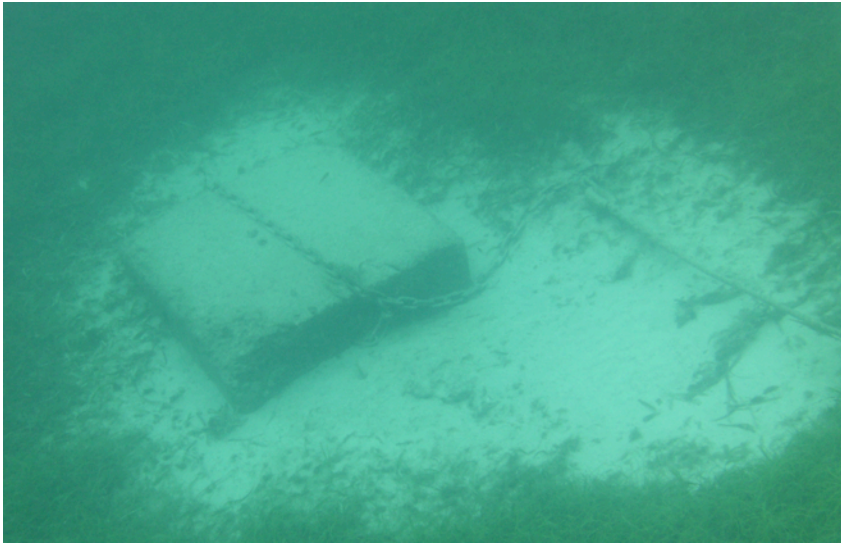
Figure 32. Image showing scouring of seagrass from anchor chain without a float, Salt Whistle Bay, TCMP (Reed, 2016).

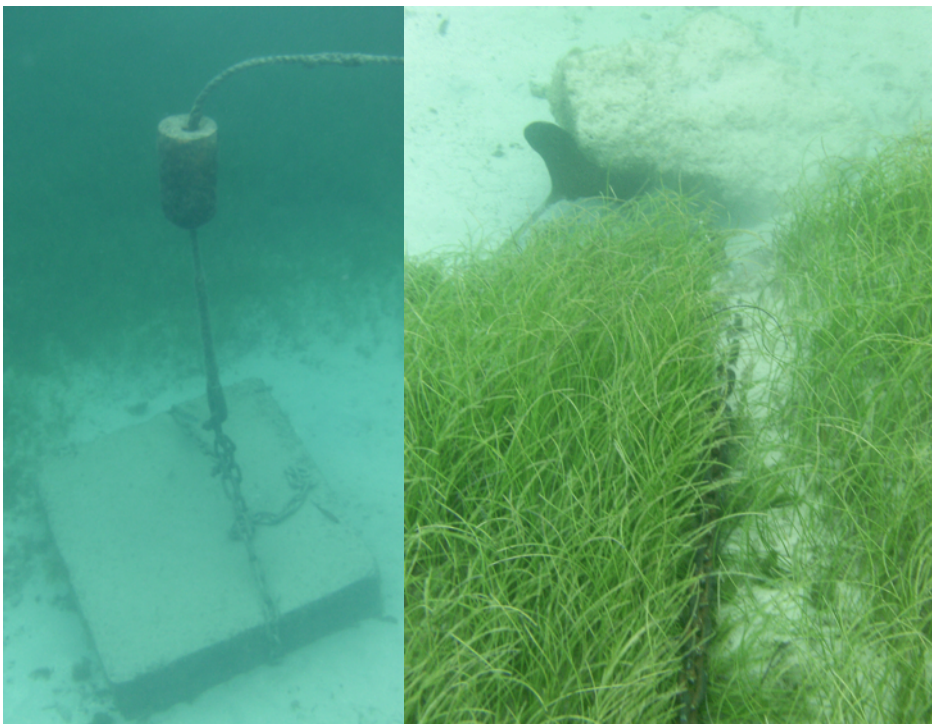
Figure 33. Image (left) showing concrete block anchor with chain and float that is preventing scouring of the surrounding seabed, TCMP (Reed, 2016).

Figure 34. Image (right) showing a yacht anchor and chain that is damaging a seagrass bed, TCMP(Reed, 2016).

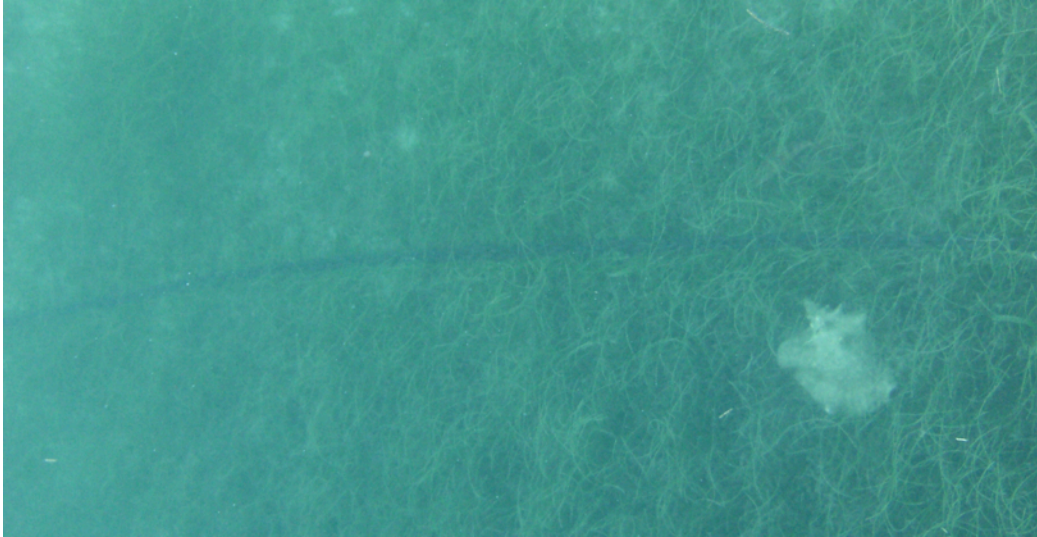
Figure 35. Image showing chain from yacht anchor lying on top of a seagrass meadow next to a conch (Reed, 2016)

Threat	MPA	Identified in Management Plans	Highlighted by Management Staff	Observed During Field Survey
Improper sewage waste disposal	SIOBMPA	<input checked="" type="checkbox"/>	<input checked="" type="checkbox"/>	<input checked="" type="checkbox"/> *green algal bloom off of Paradise Beach suggesting nutrient pollution (Appendix B, Figure 34)
	TCMP	<input checked="" type="checkbox"/>	<input checked="" type="checkbox"/>	
Anchoring	SIOBMPA	<input checked="" type="checkbox"/>	<input checked="" type="checkbox"/>	-
	TCMP	<input checked="" type="checkbox"/>	<input checked="" type="checkbox"/>	<input checked="" type="checkbox"/> *anchor in seagrass, uprooting and breaking stems (Appendix B, Figure 37,38)
Mooring lines without floats	SIOBMPA	-	<input checked="" type="checkbox"/>	<input checked="" type="checkbox"/> *no scouring of seagrass observed but lack of floats suggests risk
	TCMP	-	<input checked="" type="checkbox"/>	<input checked="" type="checkbox"/> *line on seabed with scoured seagrass surrounding mooring anchor (Appendix B, Figure 35)

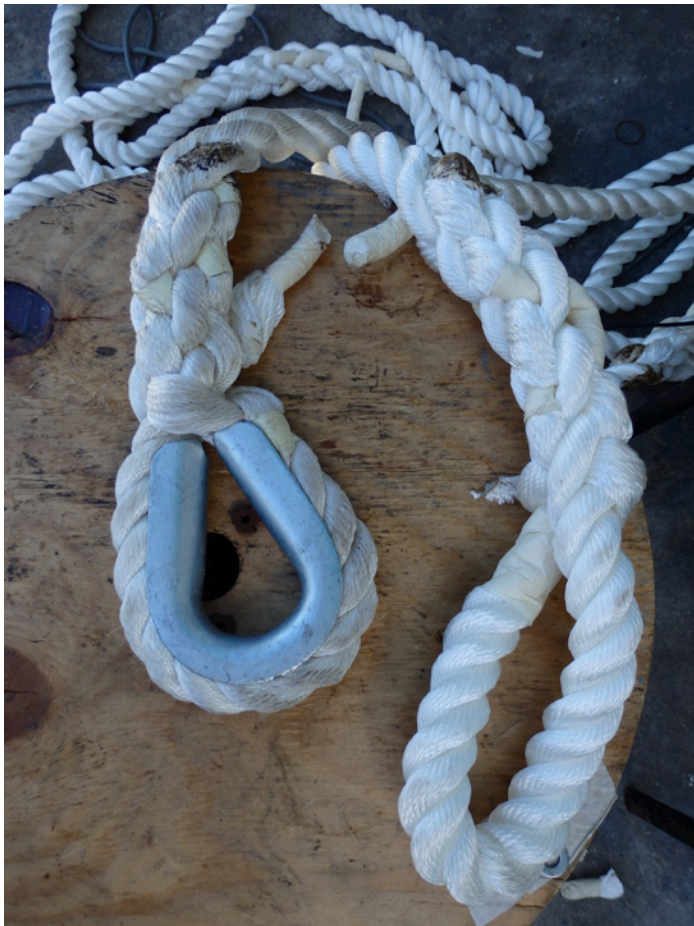
Figure 36. Image of a pickup line being made with spliced rope and a loop reinforced with steel, TCMP office, Union Island, SVG (Reed, 2016).

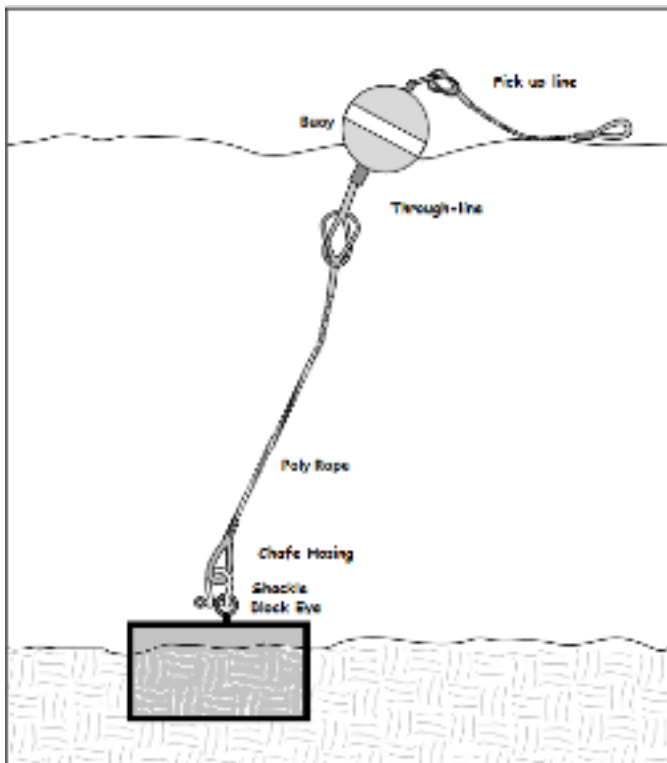
Figure 1. Typical "Halas" style mooring setup

The Halas system of mooring design (Figure 1) has become very popular worldwide in marine parks areas due to its simple construction methods and practical maintenance costs. The Halas system generally uses a commercial 18-inch diameter buoy constructed from polyethylene plastic filled with polyurethane foam and treated with UV inhibitors. Embedded in the buoy is a PVC pipe through which a 3/4-inch buoy through-line can pass.

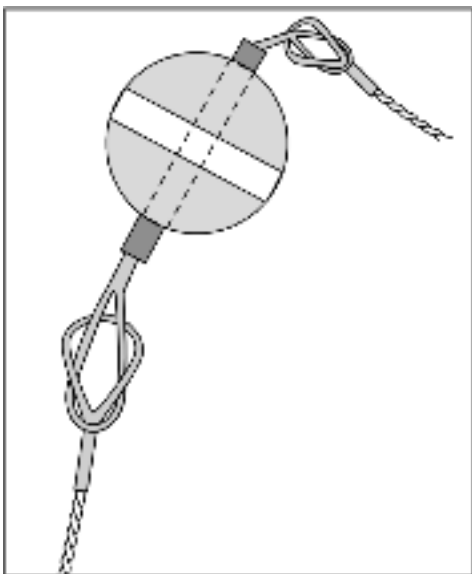
Figure 2. “Halas” 3-part system illustration

The Halas system is unique in that it uses a three-part rope system (Figure 2) instead of one continuous rope. One line leads from the anchoring system’s eye at the bottom to the buoy at the surface. A second line runs through the buoy and is attached with a loop to the anchor line at one end, and at the other end is attached with a loop to the third “pickup” line. This three-part rope system eliminates the need for shackles and thus decreases maintenance time and cost of the system. Maintenance is made easier because sections of the system can be replaced or repaired as needed without detaching the entire down line.

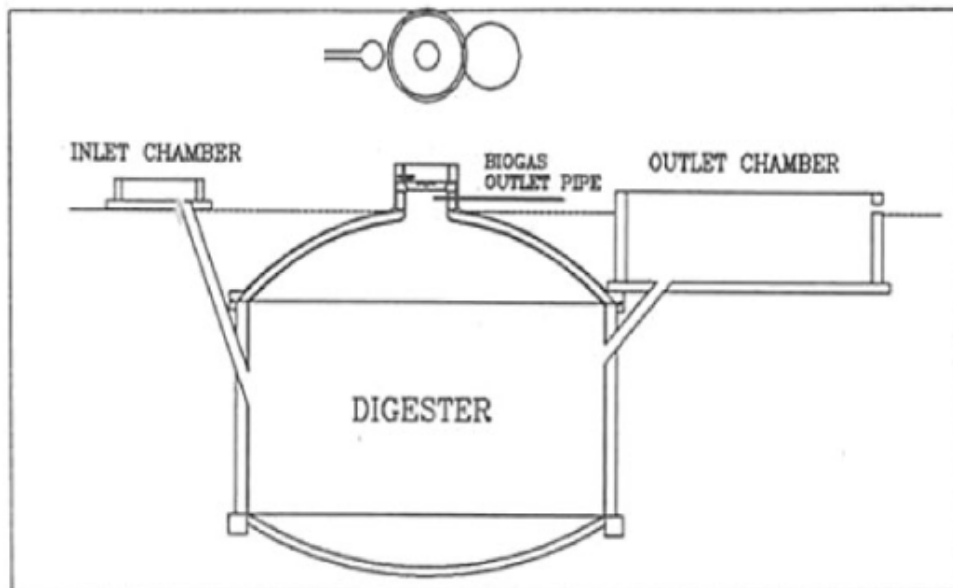
Figure 37. Diagram of a biogas-biofertilizer plant showing inlet chamber, digester, biogas outlet pipe and outlet chamber (CEHI, 2004).

As the bacteria break down the organic material, biogas comprised of methane and carbon dioxide is produced and collects in the dome of the digester. An outlet pipe connects to PVC pipelines that transport the gas to be scrubbed and provided to various energy consuming devices (e.g. refrigerators, stoves, diesel engines). When the capital and operating costs of a digester were considered against the cost of conventional fuels, the comparisons showed that biogas may be a feasible alternative when (1) biogas can replace a conventional fuel, (2) the conventional fuel is more expensive than the biogas, and (3) all of the produced biogas is used (Homan, 2016).
