**Publisher's version:** Corkum AG, Martin CD (2004). Analysis of a rock slide stabilized with a toe-berm: A case study in British Columbia, Canada. *International Journal of Rock Mechanics and Mining Sciences* 41:1109–1121.

# Analysis of a rock slide stabilized with a toe-berm

During the construction of the Revelstoke project between 1977 and 1983, excavation of a large highway cut triggered movement of a 250,000 m<sup>3</sup> rock mass. The sliding mass, referred to as the 731 Block (Fig. 1), was extensively monitored and a temporary 15,000 m<sup>3</sup> toe-berm of rock fill placed against the northern half of the slope face stabilized the

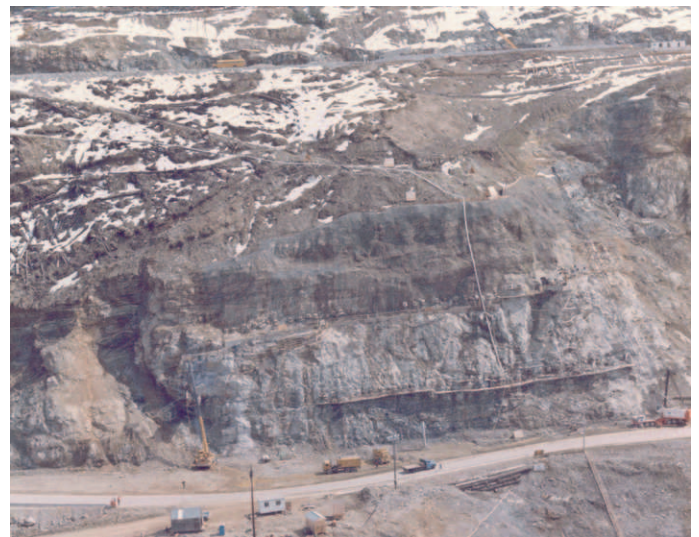
Fig. 1: Photo of the 731 Block shortly after remedial measures were completed in 1980. Photo courtesy of B.C. Hydro.

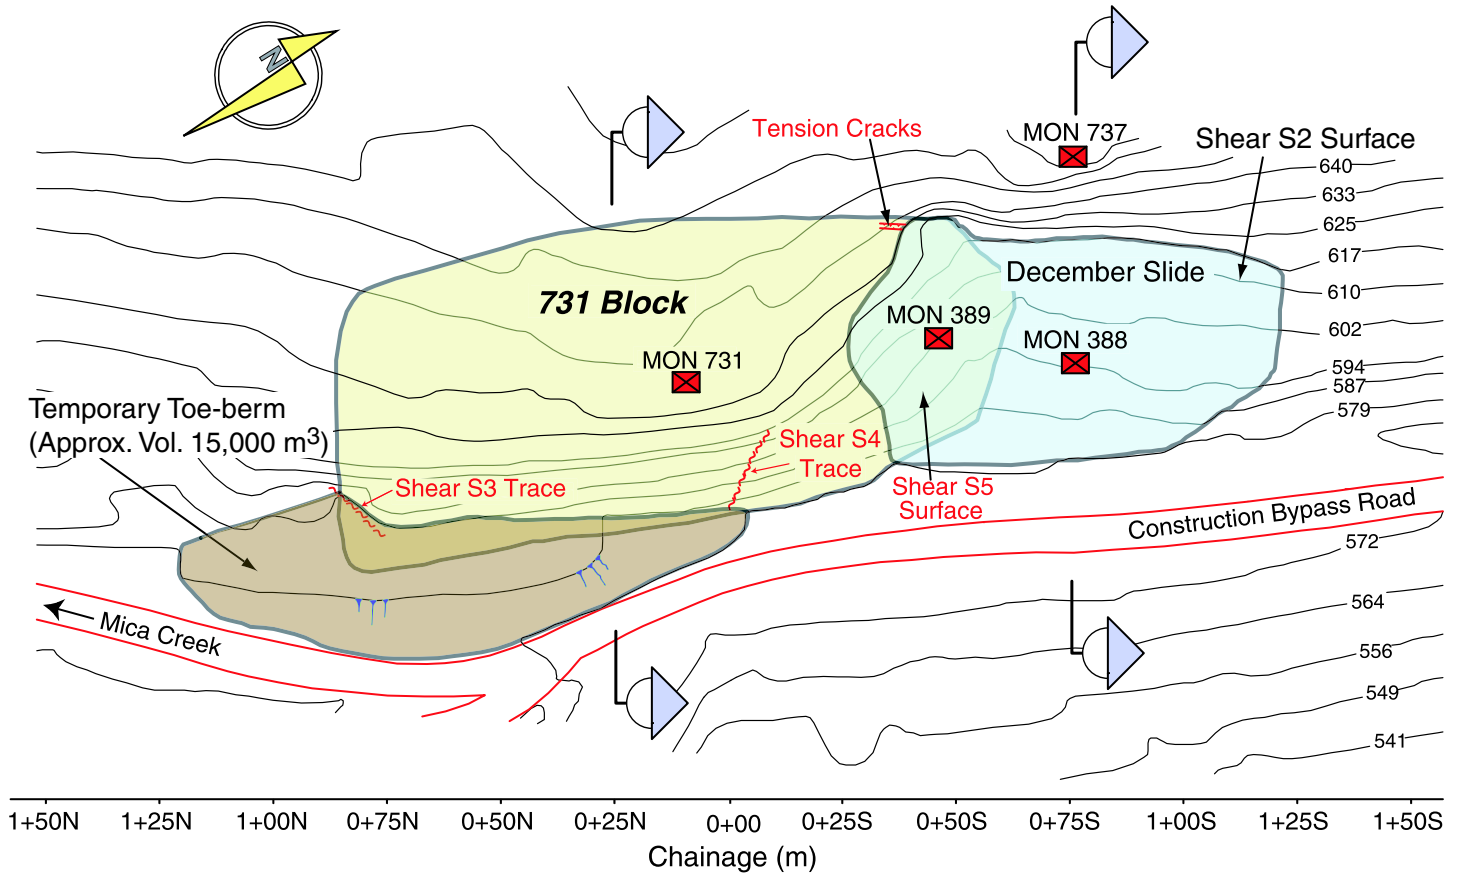
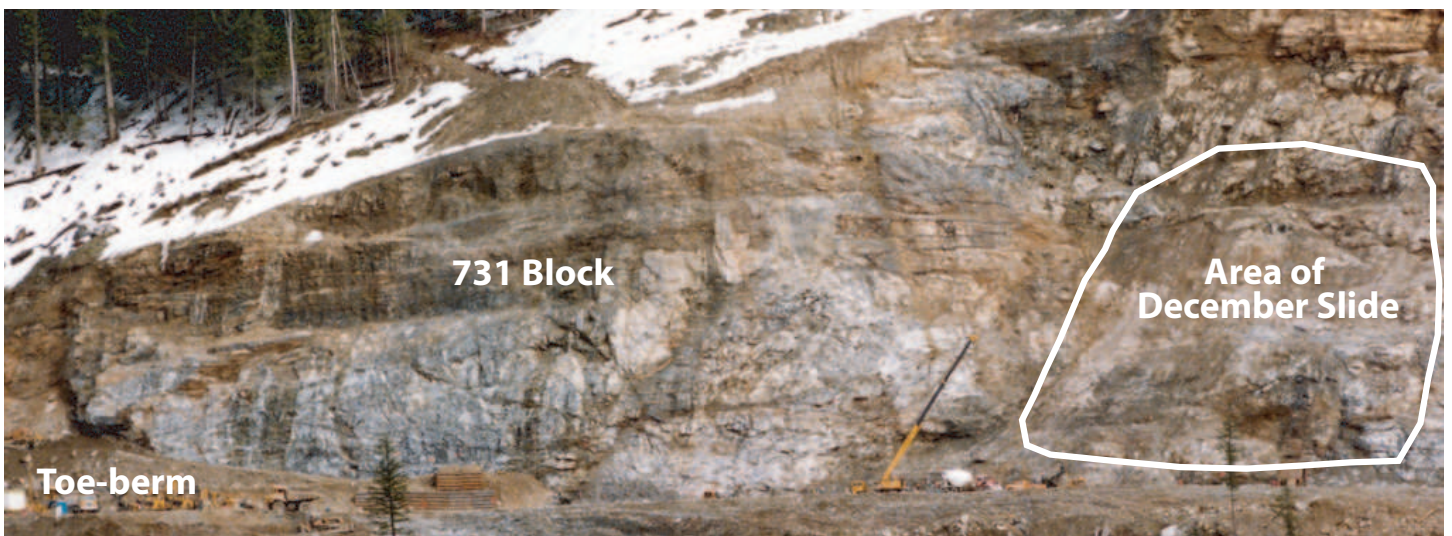
(a) Plan view

(b) Photo of the study area

Fig. 2: Location plan and photograph of the December Slide, the 731 Block and the toe-berm used to control the 731 Block movements.

After the December Slide, monitoring of the rock slopes associated with the highway reallocation revealed that significant movement was occurring in the rock mass located immediately upstream of the December Slide. An oblique photograph of this block, known as the 731 Block, and the toe-berm used to stabilize the 731 Block is shown in Fig. 2.

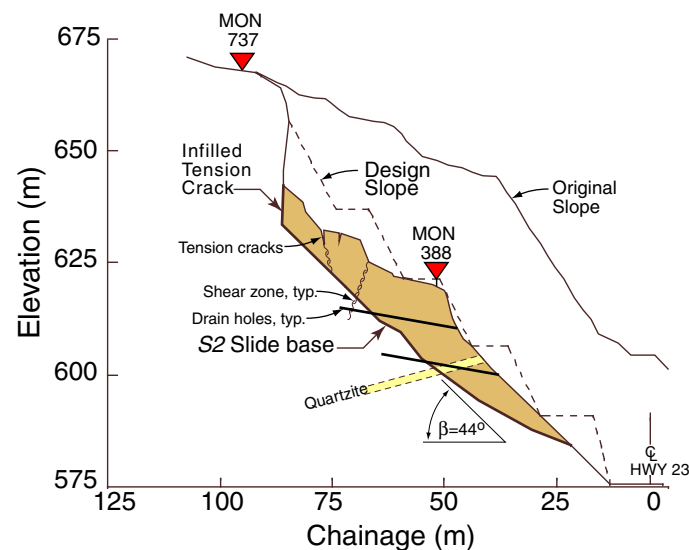
Fig. 3: Section of the December Slide. The movement was triggered by blasting near the toe of the slope and the slide base was determined after excavating the slide rock mass. See Fig. 2a for location.

*S2* (Fig. 3). No attempt was made to stabilize this slide and eventually the slide mass was completely removed and the geometry and condition of the slide base exposed. Gouge samples taken from *S2* contained approximately 55 percent fines (silt and clay) and hydrometer analysis indicated approximately 40 percent of this fine material was clay sized.

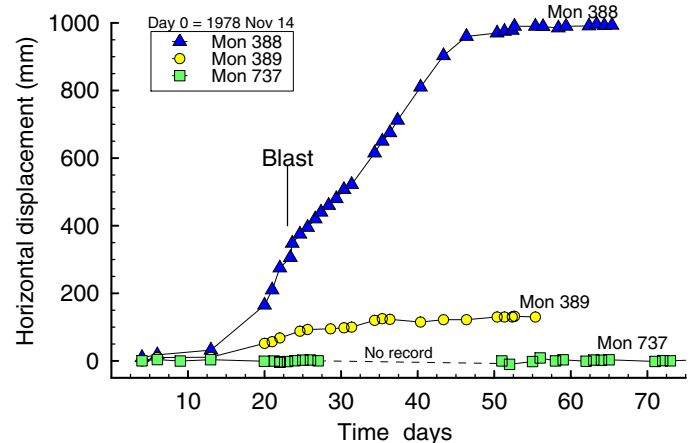
Fig. 4: Horizontal movement at Monuments 388 and 389 located on the December Slide and Monument 737 located off the slide. See Fig. 2a for monument locations.

Monitoring of the slope was carried out using traditional survey techniques. Monument 388 was located in the middle of the slide while Monument 389 was located at the northern limit of the slide and Monument 737 was located above the slide, i.e., on the stable side of the infilled vertical fracture. Total horizontal movement recorded by Monument 388 was approximately 1000 mm, while only 130 mm was recorded by Monument 389 and no movement was recorded by Monument 737 (Fig. 4). During the active movement period the average velocity was approximately 28 mm/day and prior to the triggering ‘blast’ (see Fig. 4) reached a maximum velocity of 45 mm/day, based on Monument 388. The large amount of horizontal displacement resulted in the formation of a significant number of tension cracks in the sliding mass, particularly above elevation 610 m (Fig. 3). In essence the moving mass became a series of blocks sliding on an upper surface of approximately 44 degrees. Movement of the slide eventually slowed after all construction activity near the toe of the slide was stopped. The deformed slope with somewhat flatter toe geometry, in conjunction with the work stoppage, is thought to have contributed to the reduction in velocity to approximately 1.2 mm/day. Drain holes were installed as part of the excavation design and some of the drain holes did initially produce water. However at the time of the slide the slope was considered dry, and groundwater was not a factor in the slope stability.

Intact hard rocks usually reach failure in laboratory testing at strains of less than 1 percent. The horizontal strain between Monuments 388 and 737 (differentiating the displacement field over horizontal distance) reached a maxi-

imum of approximately 3.5 percent by the time the movements stopped. Approximately 300 mm of horizontal displacement would produce a strain of 1 percent over the distance considered. Whether this amount of displacement was sufficient to declare the slope had ‘failed’ can only be judiciously speculated on. Certainly with this displacement the upper part of the slide had started to break into blocks, as indicated by the formation of tension cracks. Interestingly, using an extensively instrumented highwall slope in Upper Cretaceous soft sandstones and mudstones at Highvale mine, Small and Morgenstern [7] concluded that failure of the slope occurred when local horizontal strains reached a maximum of 1 percent. For the slope in question at the Highvale mine, movement rates ranged from 1-3 mm/day for a duration of 50-70 days.

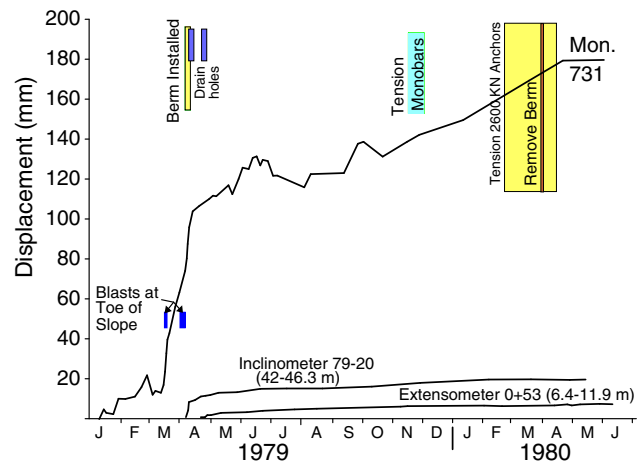
Fig. 6: Movement record for the 731 Block. It should be noted that Monument 731 was located at the crest of the block while the inclinometer and extensometer record movement across the shear zone at the base of the slide.

The 731 Block was extensively instrumented and closely monitored during the investigation and construction stages. Eight boreholes were cored within the immediate vicinity of the 731 Block and the December Slide with nested piezometers installed in five of these holes for groundwater monitoring purposes. Additionally, a total of 6 surface survey monuments, 12 inclinometers and 7 nests of extensometers were installed for deformation monitoring. Although the surface monuments provided the longest record of deformation, they were the least accurate method and were difficult to correlate to specific movement zones within the rock mass (Fig. 6).

Only minor creep movement, approximately 0.2 mm/day, was recorded during the early stages of excavation. However, as a result of blasting and excavation at the toe of the 731 Block, movement accelerated rapidly to 3.6 mm/day (Fig. 6). With construction of the 15,000 m<sup>3</sup> temporary toe-berm, movement slowed drastically to 0.2 mm/day until installation of the permanent anchor system stopped the movement. Various instruments recorded deformations ranging from 10 to 180 mm. It should be noted that only the surface survey monuments were in place prior to the large slope movement, hence the extensometers and inclinometers only record a portion of this movement. Consequently the amount of total movement and the velocities recorded by these instruments were considerably less than those recorded for the December Slide.

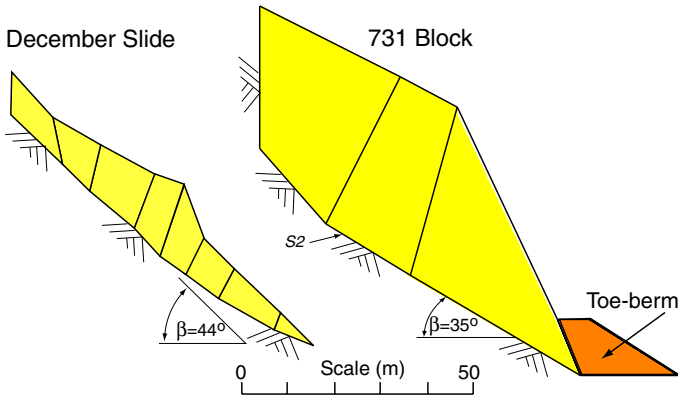
Fig. 8: Simplified sections of the December slide and 731 Block used in Sarma analyses.

Sarma Method and the strength parameters from the December Slide. This analysis also provided a Factor of Safety of approximately one. The simplified sections from these analyses are shown in Fig. 8.

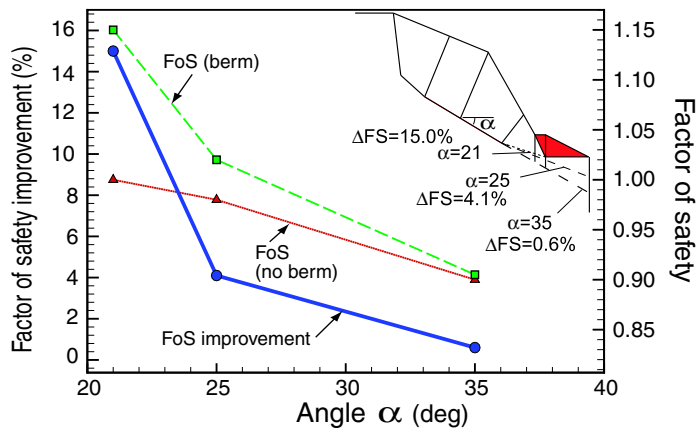
Fig. 9: Effect of the slope of failure surface  $S_2$  in the vicinity of the toe-berm on the factor of safety.

The orientation of the base ( $S_2$ ) of the 731 Block in the vicinity of the toe-berm is unknown. Visual observations of the slide area and vicinity suggested it probably occurred in a similar orientation to that shown for the December slide (see Fig. 8). Factor of safety sensitivity analyses were carried out using the Sarma Method to evaluate the effect of a change in the slope angle near the toe of the slide on the stabilizing effects from the toe-berm. Fig. 9 presents the results from these analyses and shows that as the slope of  $S_2$  decreases from  $35^\circ$  to  $21^\circ$  the factor of safety improves from less than 1% to 15%.

From these analyses, the effect of the toe-berm is estimated to improve the stability of the 731 Block between 1% and 15% for the various slide plane geometries. If the change in the  $S_2$  slope angle is similar to that observed for the December Slide, it is likely that the improvement

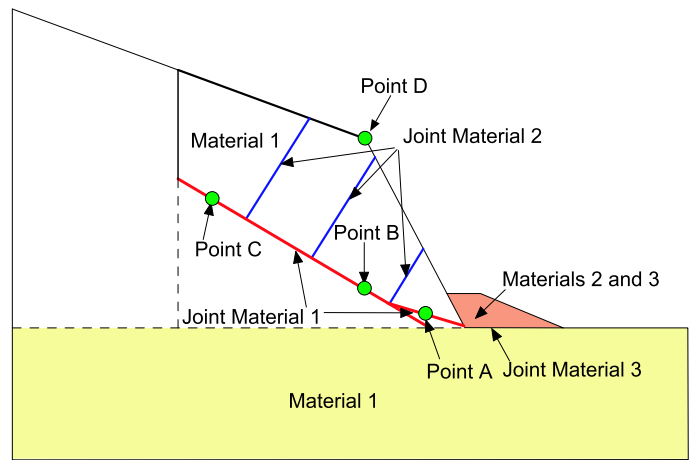
Fig. 10: Location of the various material models used in the  $3DEC$  model and the key observation points.

The properties for the joints used to describe the 731 Block geometry given in Fig. 10 are given in Table 3. Joint Material 1 represents the basal Shear S2 where the majority of deformation occurs while Joint Material 2 represents the near vertical internal discontinuities within the 731 Block. Joint Material 3 represents the contact surface between the toe-berm and the rock surface at the base of the slope.

The model geometry used to simulate the 731 Block is shown in Fig. 10. Tetrahedral zones were generated by *3DEC* for each block, and material and constitutive properties were assigned to the appropriate regions of the model (see Fig. 10). A zero displacement boundary condition was applied to the base and far-field sides of the model and gravity was activated. The model was then run for a sufficient number of time steps to reach equilibrium under gravity loading conditions. To prevent any slip or separation from occurring during initial gravity loading, high cohesion and tensile strength were temporarily applied to the joints while stepping to the initial state of force-equilibrium.

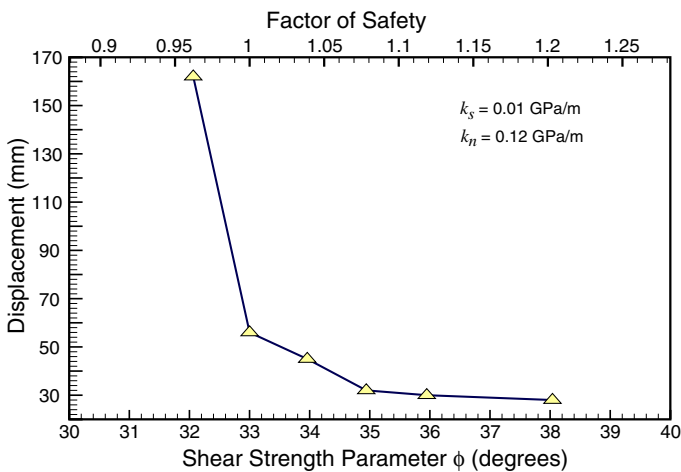
Fig. 11: Strength reduction method in *3DEC* to determine the strength along shear *S2*.

The results of the strength reduction technique are shown in Fig. 11 and shows that  $\phi$  is approximately 33 for a strength reduction factor of safety of unity. This is in reasonable agreement with the Limit equilibrium results which

gave a factor of safety of unity for  $\phi = 35^\circ$ . It should be noted that the shear surface in the *3DEC* model is planar, with no strength component due to roughness.

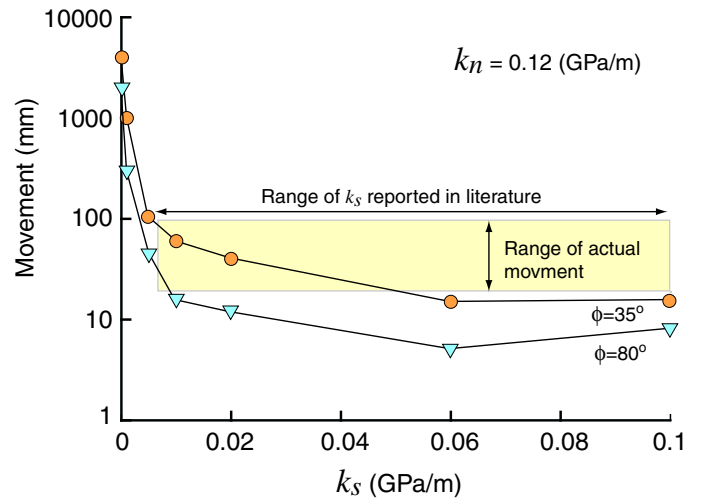
Fig. 12: Movement versus shear stiffness ( $k_s$ ) with constant normal stiffness ( $k_n$ ).

Since the shear stiffness of *S2* directly influences the slope deformations, a sensitivity analysis was carried out to assess the likely value of  $k_s$ . For these analyses  $k_n$  was held constant and  $\phi$  was initially set at  $35^\circ$ . The resulting displacements for various values of  $k_s$  are given in Fig. 12. It is apparent from Fig. 12 that deformation increases rapidly for  $k_s < 0.005$  GPa/m. It can also be seen in Fig. 12 that  $k_s$  values in the range reported by Infanti and Kanji [14] resulted in deformations similar to those recorded from actual field measurements. For comparison, the model was also run with  $\phi = 80^\circ$  in order to evaluate the component of total deformation due to plastic yielding. The results indicate that a significant portion of displacement is due to elastic deformation.

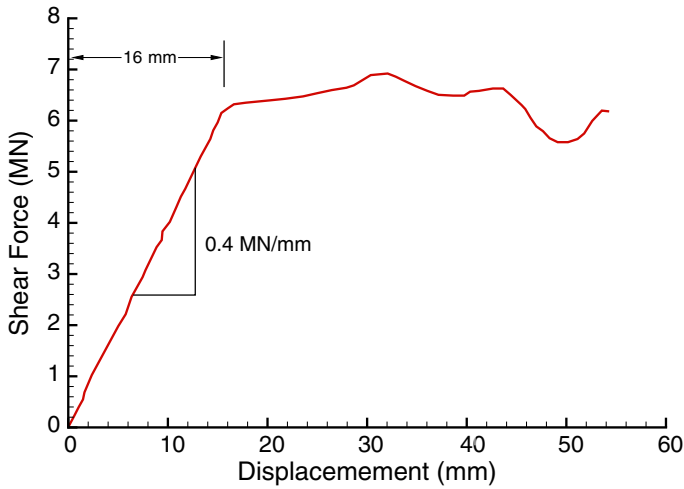
Fig. 13: Shear force versus shear displacement along shear *S2* (mid-block region), demonstrating the onset of plasticity along the failure surface.

The effect of elastic-plastic behaviour of *S2* can be seen by tracking the shear force versus shear displacement at Point B, in Fig. 10. For this analysis the following properties for the basal shear *S2* were used, based on the findings from the sensitivity analyses above:  $k_s = 0.01$  GPa/m,  $k_s = 0.12$  GPa/m, and  $\phi = 33$  degrees. The results are given in Fig. 13 and show that the basal shear undergoes elastic deformation at a rate of about 0.4 MN/mm until 16 mm of deformation is reached. The beginning of plastic deformation is clearly defined in Fig. 13 and indicates, for these *S2* properties, the majority of slope movement can be attributed to plastic deformation.

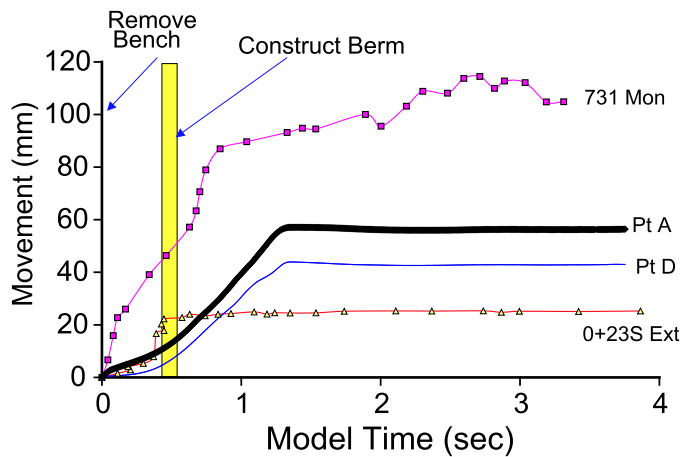
Fig. 14: Movement with time: Comparison of *3DEC* model results with actual field measurements.

the movement of the two key monitoring points were tracked in the *3DEC* model (Point D corresponding to the 731 Monument and Point A corresponding to Extensometer 0+23S, see Fig. 10). Fig. 14 shows the *3DEC* movement record for the two monitoring points compared to the actual movement. Clearly the deformation pattern generated by the model is not consistent with the measured deformations. In particular, the movement at the top of the slope (Point D) is less than that at the toe of the slope (Point A). This is in contrast to the measured displacement trends. It is perhaps unrealistic to expect the model displacements to match the measured displacements as the amount of model displacement is significantly dependent on the geometry and number of discrete blocks used to build the model and the dilation that occurs as the blocks displace. These issues will be explored further in the following section.

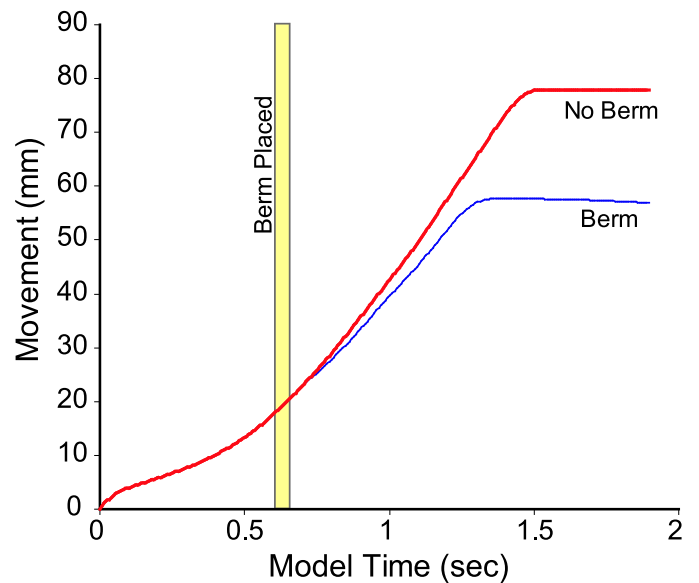
Fig. 15: Movement with time: with and without the berm.

When the *3DEC* model was allowed to run without placing the toe-berm, the 731 Block appears to eventually reach a state of ‘natural’. Fig. 15 shows that placement of the toe-berm reduced the total movement by approximately 20 mm at the toe, compared to not placing a berm. The results are similar for all locations tracked in the model. The equilibrium of the model being reached without the toe-berm is a consequence of the failure plane geometry at the toe of the slope. It implies that the geometry in the model does not permit the kinematic freedom necessary for the blocks to continue sliding. Whether the toe-berm provided that restraint in conjunction or independently of the slide toe geometry is unknown. Nonetheless Fig. 15 does show that even this small toe-berm was effective in reducing the total movements.

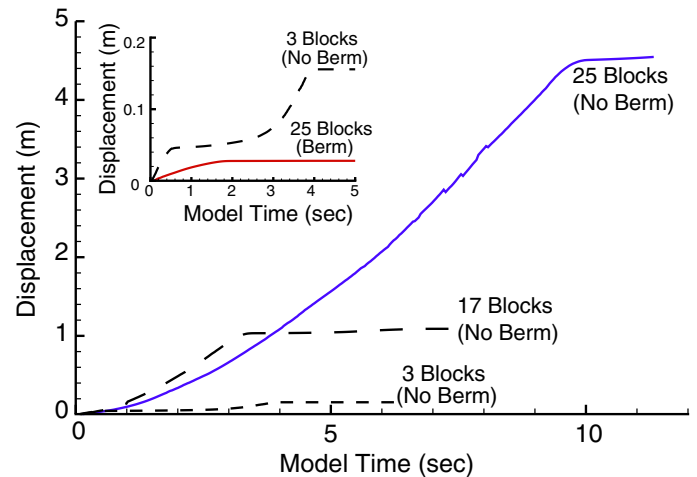
Fig. 17: Average slope displacement recorded at points A, B and C for various multi-block models using the undulating basal failure surface.

parison. The effect of the toe-berm is also shown in Fig. 17 for the 25 Block Model and clearly shows that the toe-berm decreased the total movement in the 25 Block Model.

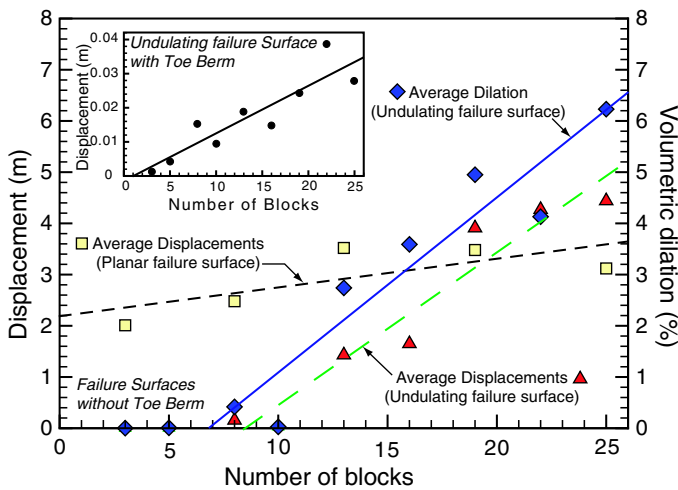
Fig. 18: Trends in the displacement and dilation patterns for slopes with different number of blocks without a toe-berm. The inset figure shows the effect of the toe-berm on the undulating failure surface.

Fig. 18 shows both the basal displacements and the volumetric dilation as a function of the number of blocks for both the planar and undulating failure surface without the toe-berm. For the planar failure surface the displacements were relatively constant and increased only slightly as the number of blocks increased. It was expected, for this case, that the number of internal blocks would have essentially no effect on basal plane displacements. However, the slightly sloping relation is likely due to the changes in kinematic freedom as the slide mass reached the bench located 1 m below the failure surface.

With the undulating failure surface, significant displacements (sliding) do not occur until the number of blocks is greater than 8. As the number of blocks increase from 10 to 25, the displacements and the volumetric dilation linearly increase. The inset in Fig. 18 shows the displacement with increased number of blocks for the undulating failure surface with the presence of a toe-berm. In all cases analyzed, the toe-berm was very effective in reducing the amount of displacements, particularly for those cases where the number of blocks was greater than 8.

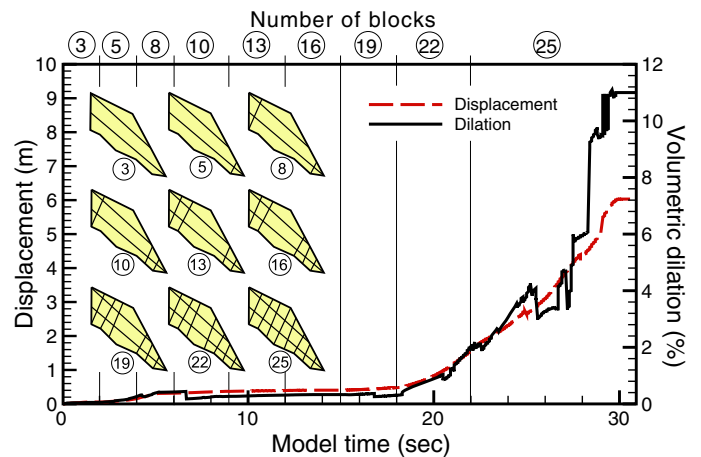
Fig. 19: Basal failure plane displacements and volumetric dilation as the sliding rock mass breaks-up into blocks.

Fig. 19 shows the trend of rapidly increasing displacement and volumetric dilation with down slope movement. Once the model contains more than 19 blocks, displacements rapidly accelerate. During the initial stages of sliding, the volumetric dilation tracks the failure surface displacements. This is not surprising because in this model all inter-block joints are planar, i.e. non-dilatant. However, with extremely large failure surface displacements, the rate of volumetric dilation accelerates suggesting large separation among the blocks. In a natural rock slope the roughness of the inter-block joints would likely cause this phenomena to occur at much smaller displacements along the basal failure-surface. In addition all the joints were modelled with a constant Coulomb-slip model, a strain-weakening slip model could also produce accelerating displacements at much smaller strains.
