Post-Impact Residual Strength and Resilience of Sandwich Panels with Natural Fiber Composite Faces

Dillon Betts¹, Pedram Sadeghian², and Amir Fam³

ABSTRACT: In this paper, the post-impact residual flexural behavior of sandwich panels with flax fiber-reinforced polymer (FFRP) faces and polyisocyanurate (PIR) foam cores is investigated experimentally. The faces were manufactured using a wet lay-up procedure with a balanced bidirectional 2x2 twill flax fiber fabric and a bio-based epoxy with a bio-content of 30%. Each specimen was 1200 mm long x 75 mm wide x 80 mm thick. The main parameters in the study were the face thickness (one, two or three FFRP layers, representing core-to-skin thickness ratios of approximately 54, 28 and 20) and core density (32, 64 or 96 kg/m³); a total of nine combinations. In this study, 27 specimens (three specimens for each combination) were tested under impact loads and the surviving specimens were tested under monotonic three-point bending. Each of the three identical specimens was tested under different impact condition, namely 100%, 75% and 50% of the energy resistance of an intact specimen, with the last two impacted 50 times. The results of the pos

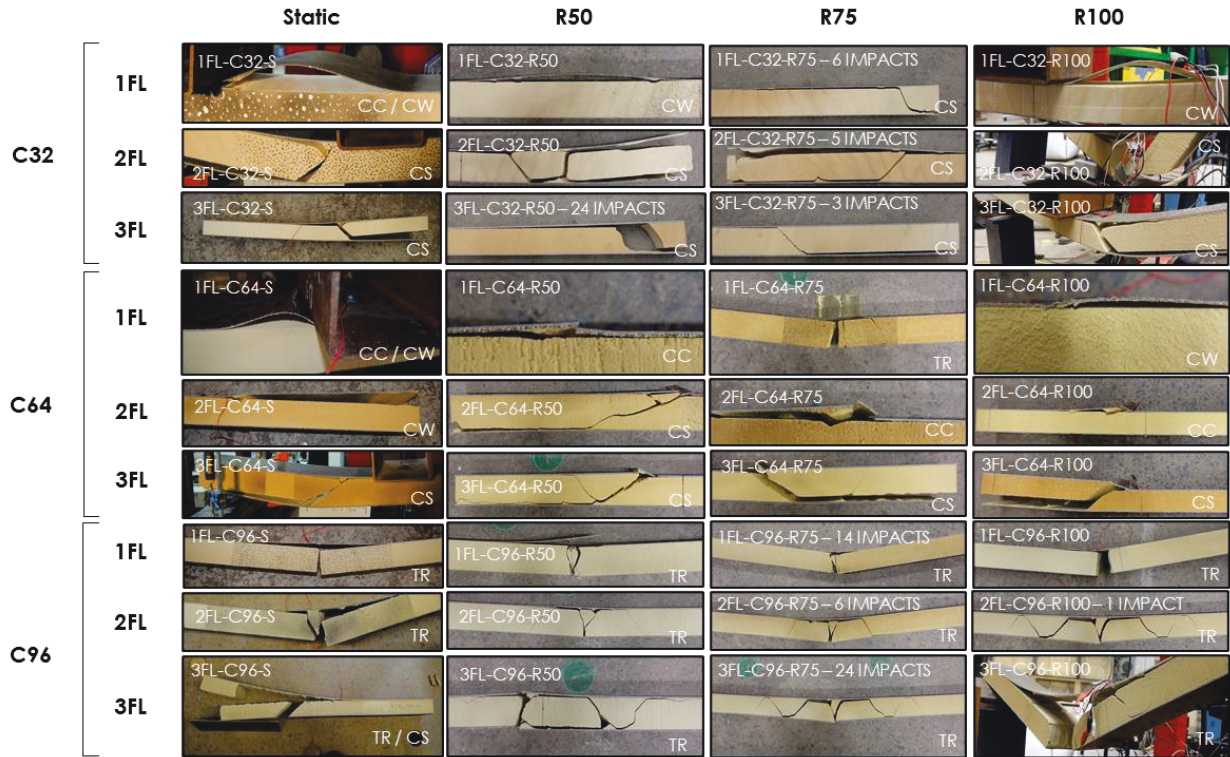
Figure 4. Failure modes of all specimens [Note static specimens were tested as a part of another study by Betts et al (2018)]

The failure modes of all specimens are presented in Figure 4. In order to compare the residual failure modes with the failure modes observed during static tests, photos of sandwich specimens tested as a part of another study by Betts et al [13] were presented. The only notable difference in failure mode between tests of similar specimens is the failure of 1FL-C64-R75. This specimen failed due to tensile rupture during the post-impact residual flexural tests whereas the intact static specimen failed due to crushing of the compression face. This can be explained by the fact that damage in the form of visible tensile cracks was observed on the bottom face of this specimen after the impact tests. Tensile cracks were also observed in the C96-R50 specimens, sample photos of which are presented in Figure 5. However, the static C96 specimens failed due to tensile rupture and therefore the failure modes of the C96 specimens were not affected. Interestingly, as shown in Table 2, the strength of 1FL-C96-R50 and 2FL-C96-R50 were reduced, however the load capacity of 1FL-C64-R75 was higher than its static counterpart by 19%. Further research is required to determine the cause of this increase in strength of the post-impact residual tests.
